REPORT OF THE DIRECTOR
BUREAU OF SAFETY

ACCIDENT ON THE
PENNSYLVANIA RAILROAD
AT
JEWETT, OHIO
ON
NOVEMBER 14, 1935

INVESTIGATION NO. 2020

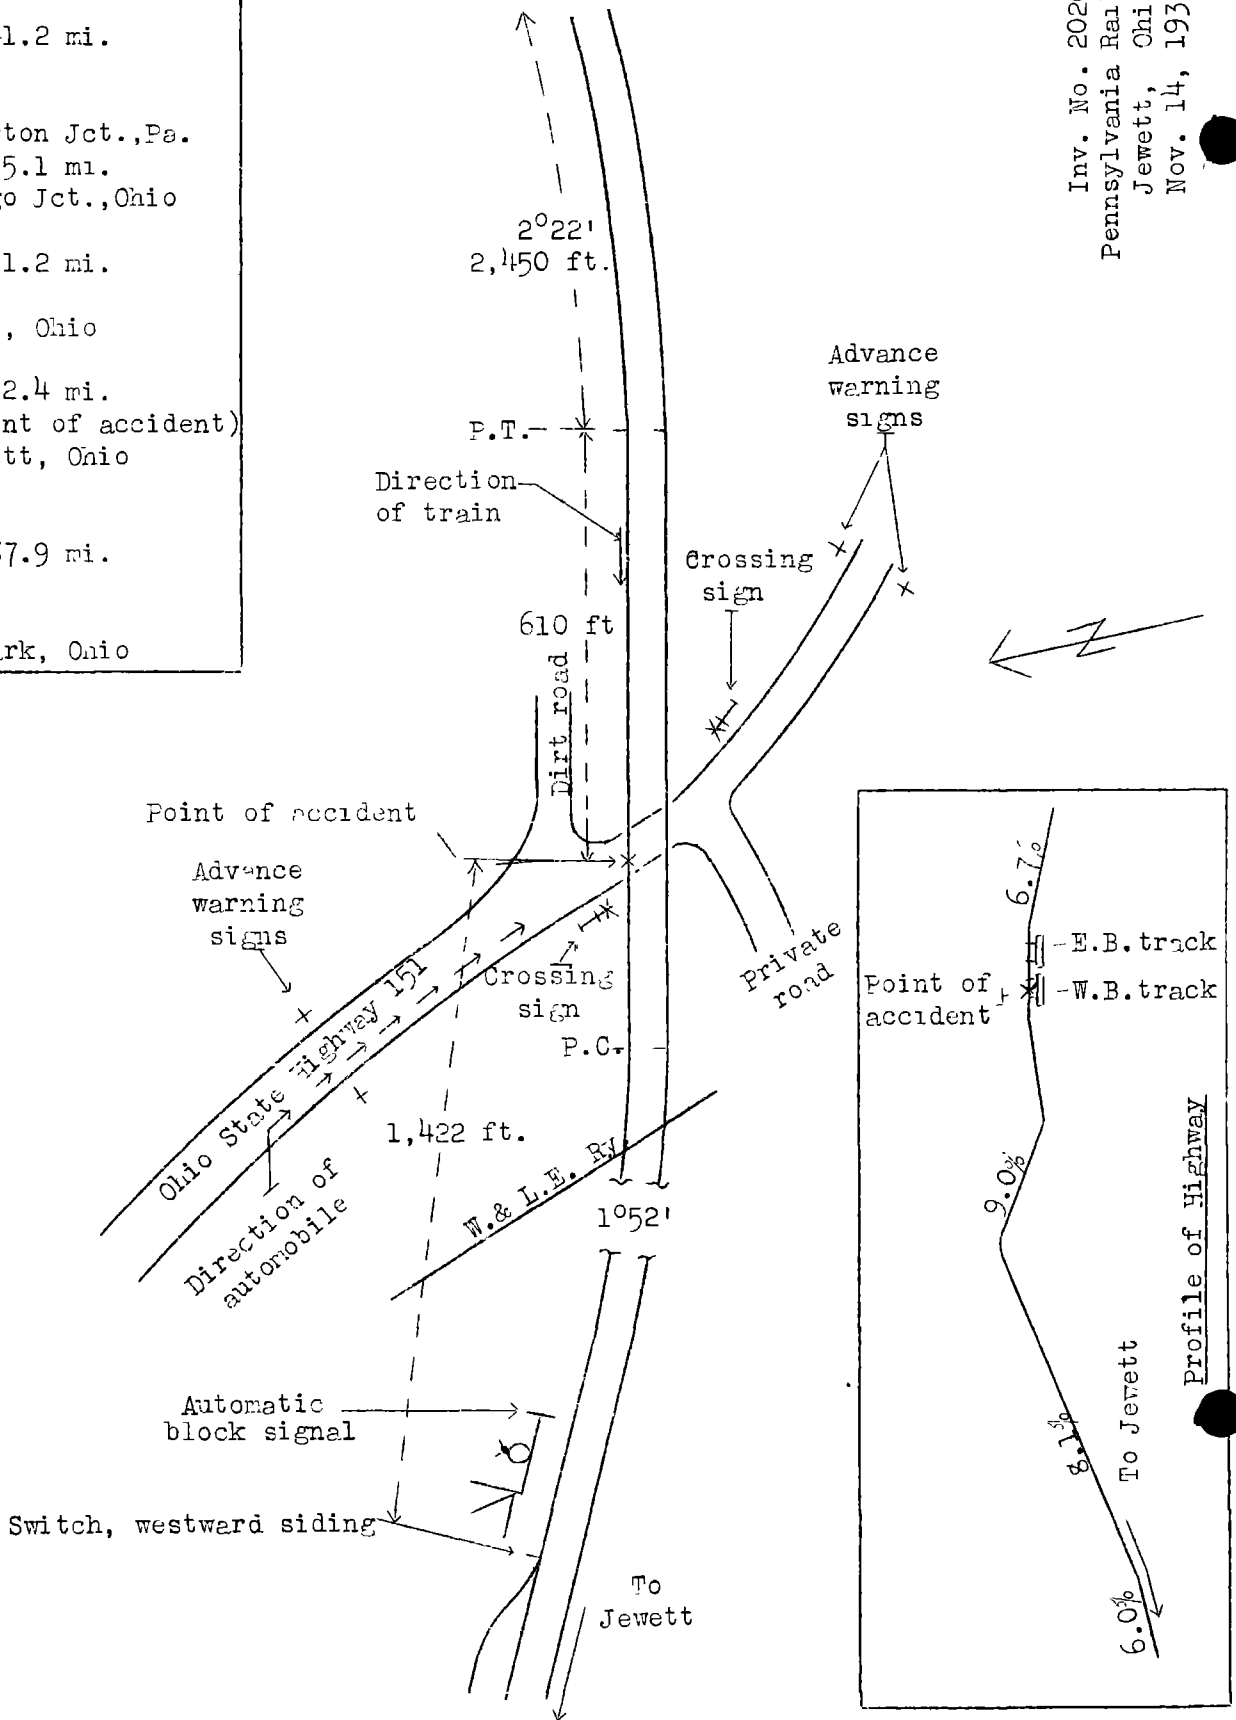
Inv. No. 2020
 Pennsylvania Railroad
 Jewett, Ohio
 Nov. 14, 1935

The highway involved parallels the tracks eastward from Jewett to a point about 370 feet from the crossing, and then it curves to the right and crosses the tracks at an angle of about 45° from northwest to southeast. Approaching the crossing from Jewett the grade is ascending, varying from 6 to 8.1 percent until a point about 90 feet from the crossing is reached, where it changes to 9 percent descending for about 60 feet, following which it again ascends a distance of 30 feet to the west-bound track, the highway being level over the crossing. The highway is of macadam construction and at the crossing the traveled portion of the roadway is about 15 feet wide.

The crossing is protected on each side of the tracks by advance warning signs of the disk type, with reflector buttons; on the north side of the tracks these signs are located on each side of the highway and opposite each other, about 250 feet from the crossing; the sign on the west side of the highway is 28 inches in diameter with the letters "RR" thereon, separated by diagonal crossed lines, while the sign on the east side of the highway has the letters "RR", separated by one vertical line and underscored with two horizontal lines. At a point 45 feet north of the crossing and on the west side of the highway there is located a crossing sign of the cross-bar type mounted on a mast, this sign reading "RAILROAD CROSSING", and underneath the crossed bars there is another sign reading "DANGER".

When a south-bound automobile reaches a point 75 feet from the tracks an approaching west-bound train can be seen for a distance of only 180 feet, due to an embankment in the northeast angle of the crossing; however, on reaching a point 15 feet from the tracks an unobstructed view of a train can be had for 1,118 feet.
