INTERSTATE COMMERCE COMMISSION

REPORT OF THE DIRECTOR OF THE BUREAU OF SAFETY CONCERNING AN
ACCIDENT ON THE PENNSYLVANIA RAILROAD NEAR LAUREL HILL,
PA., ON OCTOBER 21, 1934.

November 30, 1934.

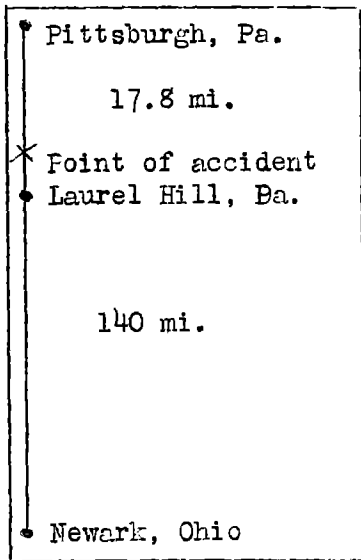
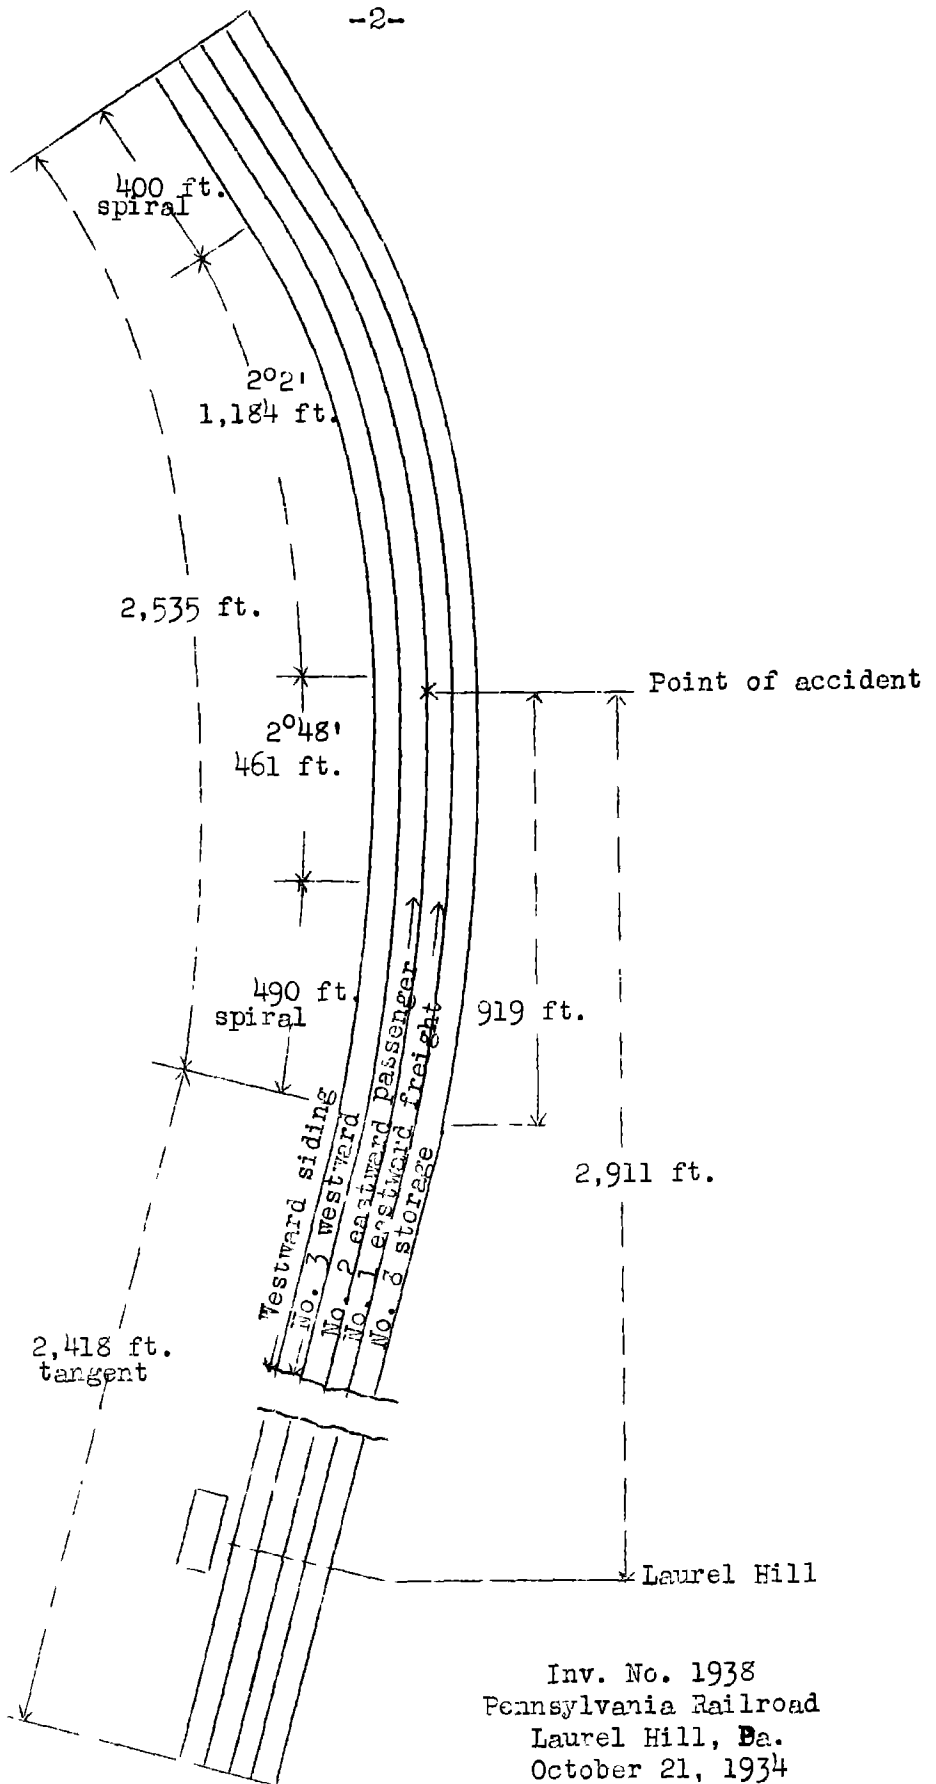
Inv. No. 1938
 Pennsylvania Railroad
 Laurel Hill, Pa.
 October 21, 1934

The statements of Superintendent Adams, Division Engineer Code, Assistant Division Engineer Boyer, Trainmaster Wisegarver, Supervisor of Track Geiser and Assistant Supervisor of Track McGhee, who examined the track soon after the occurrence of the accident, brought out the following conditions: The point of derailment was found under the rear car, where the left or low rail on the curve had been forced outward, permitting the equipment to drop between the rails. The rail-holding spikes had been removed on the outside of the low rail for its entire length and were lying in the adjacent cribs. There were marks under the heads of the spikes indicating they had been removed with a claw bar very recently, and the tieplates and ties also bore heel marks of a claw bar. There was evidence on two ties of ballast stone having been used as a fulcrum for the heel of the bar. The spikes on the gauge side of this rail had been raised from 1 to $1\frac{1}{2}$ inches and the rail was raised slightly and forced northward 3 or 4 inches while the tieplates remained held firmly in place by the plate-holding spikes. Immediately west of this rail the outside rail-holding spikes had been raised on four ties. Examination of the right rail, which extended approximately 19 feet west of the low rail, showed that for its entire length the spikes on the gauge side had been raised the same height as on the low rail. The first mark of derailment was on the gauge side of the low rail at a point approximately 12 feet from its western end; on the third tie beyond this point there was a mark on the head of the rail-holding spike and the shoulder of the tieplate, and opposite this point there was a tread mark on the gauge side of the angle bar of the right rail. In the immediate vicinity of the point of derailment portions of crushed brick were lying in the crib and there was brick dust on an adjacent tieplate, indicating that a brick had been used as a wedge to widen the gauge. A line stake also was found at

this point, crushed in such manner at its sharpened end as to indicate that it had been used beneath the rail on a tieplate to hold the rail above the outer shoulders of the plates. Two rail anchors also were found lying between the rails. Further search in the vicinity revealed a jack and claw bar concealed in the weeds, and examination of the claw bar disclosed marks of recent usage on its jaws; the marks on the rack and pawls of the jack indicated that it had not been in continuous use, but that it had been used recently in at least one operation, as indicated by bright marks on the superficial rust on the rack, and subsequent examination of the low rail showed jack marks underneath the base of the rail. The claw bar bore a PRR stamp, while the jack was a Duff-Barrett, 15-ton track jack of the type in use on this railroad, but it bore no PRR mark of identification. The track to the west was found to be in good condition and there was no evidence of dragging equipment or anything which might have contributed to the cause of the accident.

The investigation disclosed that the outside rail-holding spikes on the left or low rail on the curve had been removed for its entire length, while the spikes on the gauge side, as well as those on the gauge side of the opposite rail, had been raised from 1 to $1\frac{1}{2}$ inches; the low rail then was forced outward, permitting the wheels to drop between the rails. The tools with which this tampering was done were found in the immediate vicinity of the point of accident, together with various other articles which appeared to have been utilized, and while the claw bar which was found bore a PRR stamp and the jack was of the type used by this railroad, a check made by the railroad company indicated that there had not been any tools missing in that vicinity. At the time of this investigation it had not been determined by whom this malicious tampering was done.
