REPORT NO. 1958

INTERSTATE COMMERCE COMMISSION

REPORT OF THE DIRECTOR OF THE BUREAU OF SAFETY CONCERNING AN
ACCIDENT ON THE PENNSYLVANIA RAILROAD AT LINDEN, OHIO,
ON DECEMBER 27, 1934.

February 21, 1935.

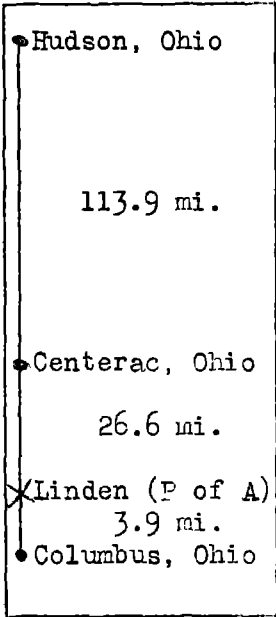
Inv. No. 1958
Pennsylvania Railroad
Linden, Ohio
Dec. 27, 1934

Point of accident
Switch No. 2
Switch stand

This accident was caused by an open switch, apparently due to malicious tampering.

After the accident the switch was found to be lined for the storage siding and locked, while the reflector which normally would have been visible to the engine crew of a south-bound engine had been removed from the lamp and was later found just north of switch No. 2 and about 20 feet east of the main track; all of the lenses were missing from the lamp and could not be found, and the burner and globe also were missing. The last train to pass over the switch on the main track was a south-bound freight train, about $3\frac{1}{4}$ hours before the accident occurred, at which time a north-bound passenger train was moving over the passing track, and members of these crews noticed nothing unusual nor did they see any outsiders in the vicinity. Under these circumstances it would appear that some one in possession of a switch key had opened the switch with malicious intent on the morning of the accident and also damaged the switch lamp in such a way as to make it impossible for any advance warning of danger to be given the approaching train.

In view of these facts the officers of this railroad company, and also local authorities, should give immediate consideration for the need of additional protection in order that the lives of employees and the traveling public will not be unnecessarily placed in jeopardy.
