Inv-2106

REPORT OF THE DIRECTOR

PENNSYLVANIA RAILROAD

MENLO PARK, N. J.

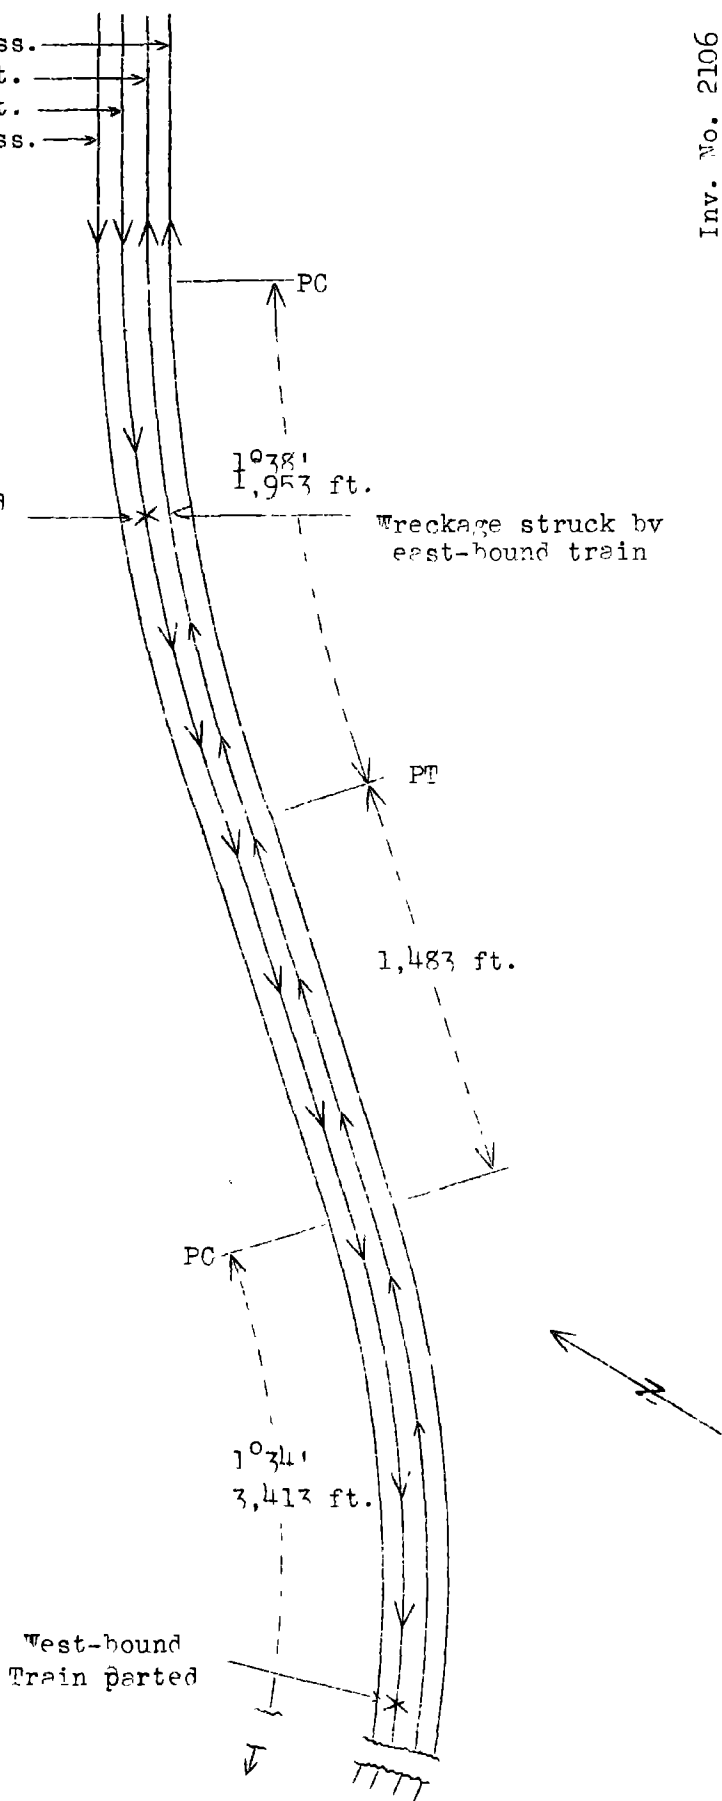
Inv. No. 2106  
 Pennsylvania Railroad  
 Menlo Park, N.J.  
 Oct. 21, 1936

West-bound  
 Train buckled

Wreckage struck by  
 east-bound train

West-bound  
 Train parted
