## INTERSTATE COMMERCE COMMISSION

REPORT OF THE DIRECTOR OF THE BUREAU OF SAFETY IN RE  
INVESTIGATION OF AN ACCIDENT WHICH OCCURRED ON THE  
PENNSYLVANIA RAILROAD AT MONON, PA., ON NOVEMBER  
21, 1931.

December 29, 1931.

Inv. No 1737  
Pennsylvania R.R.,  
Monon, Pa.,  
Nov 21, 1931.

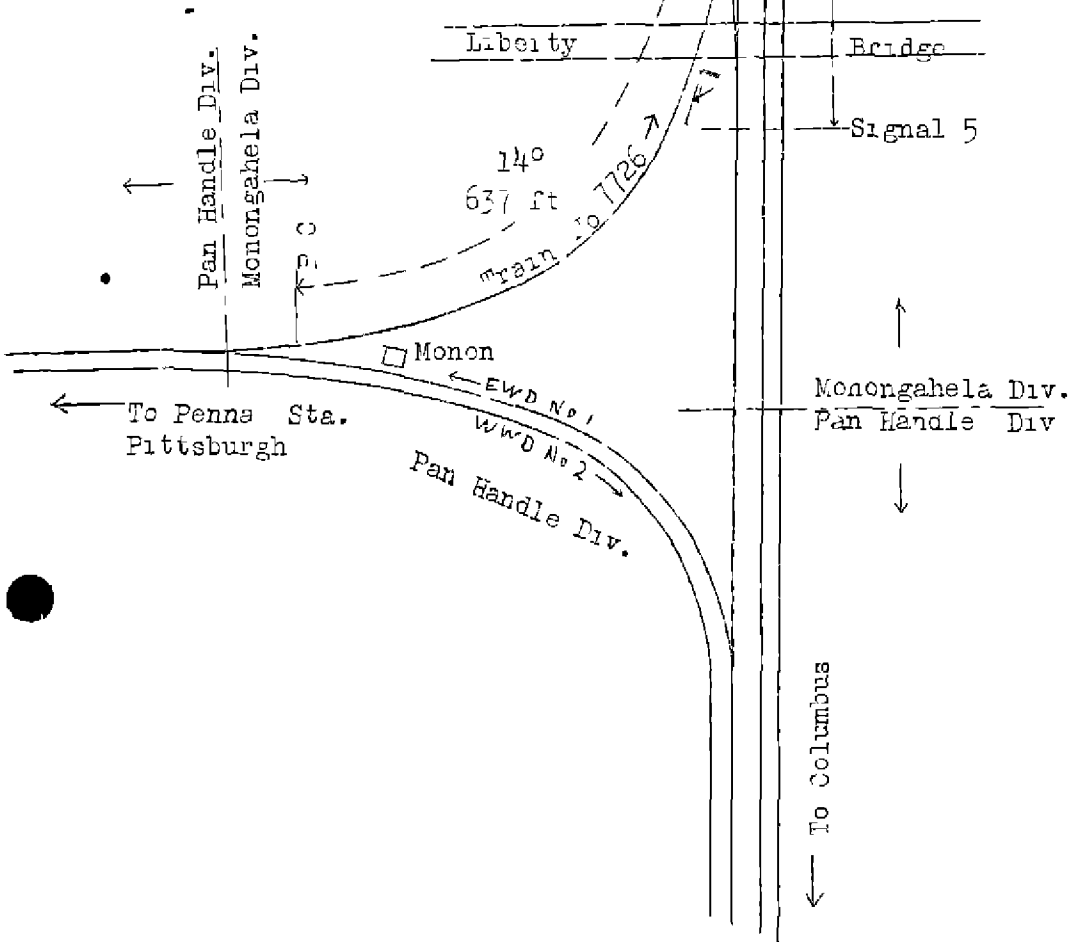
are of the position-light type, home signal 5, governing southbound movements off the south leg of the wye and through the crossover, is located 197 feet north of the north switch of the crossover, while approach or distant signal MO 7 and home signal 45, governing movements over track 1, are located 2,961 feet and 344 feet, respectively, south of the north switch of the crossover.

This accident was caused by the failure of Engineman Furney, of extra 6773, properly to obey signal indications.

The approach or distant signal, MC 7, and home signal 45 were displaying the proper indications, namely, an approach indication and a stop indication, respectively, as extra 6773 approached Monon, and Engineman Furney saw these indications. He made a light brake application at signal MC 7, to make sure that the brakes were working properly, at which time the speed of his train was about 30 miles per hour, and when about 15 car-lengths from home signal 45 he made another light application by means of the independent brake. He then took his eyes off the track ahead in order to see whether the fireman could get the injector on without the valve sticking, and when he again looked ahead his engine had nearly reached home signal 45, which was displaying a stop indication, he immediately applied the brakes in emergency and reversed the engine, but it slid by the signal and stopped fouling the crossover, where it was struck by train No. 7726.
