ACCIDENT ON THE
PENNSYLVANIA RAILROAD

MORRISVILLE, PA.

MARCH 24, 1937

INVESTIGATION NO. 2165

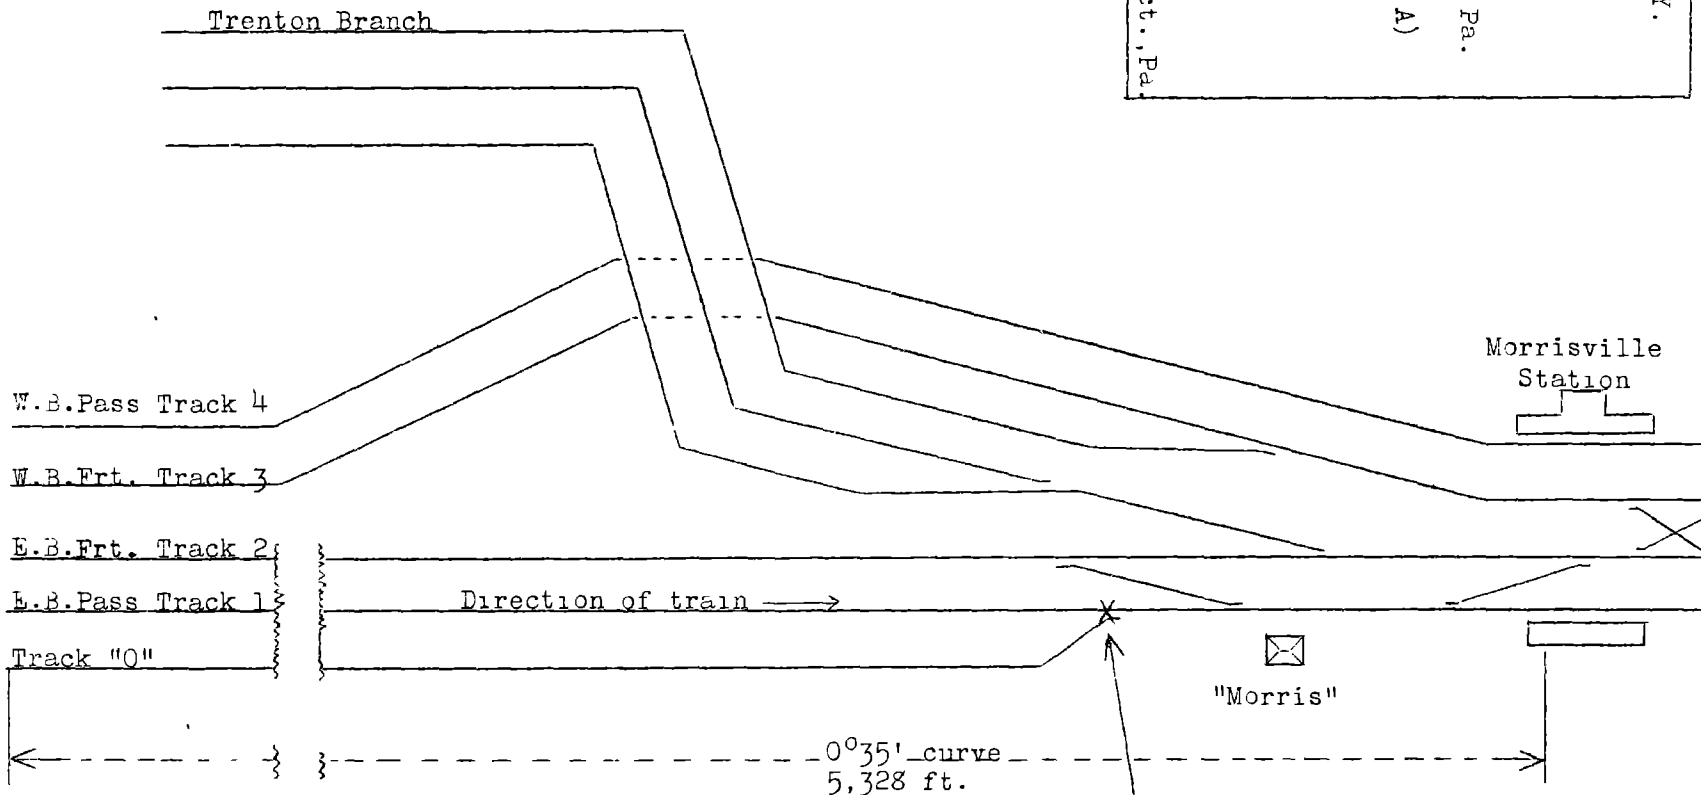
Inv. No. 2165
Pennsylvania R.R.
Morrisville, Pa.
March 24, 1937

Switch 20
Point of
accident
