INTERSTATE COMMERCE COMMISSION  
WASHINGTON

REPORT OF THE DIRECTOR  
BUREAU OF SAFETY

ACCIDENT ON THE  
PENNSYLVANIA RAILROAD

NEW GALILEE, PA.

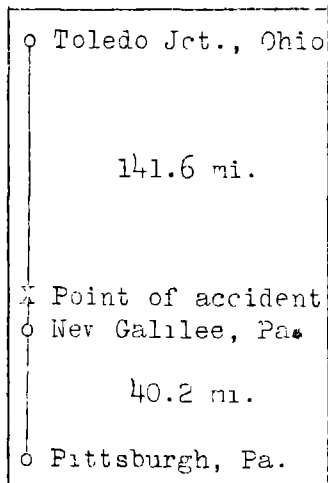
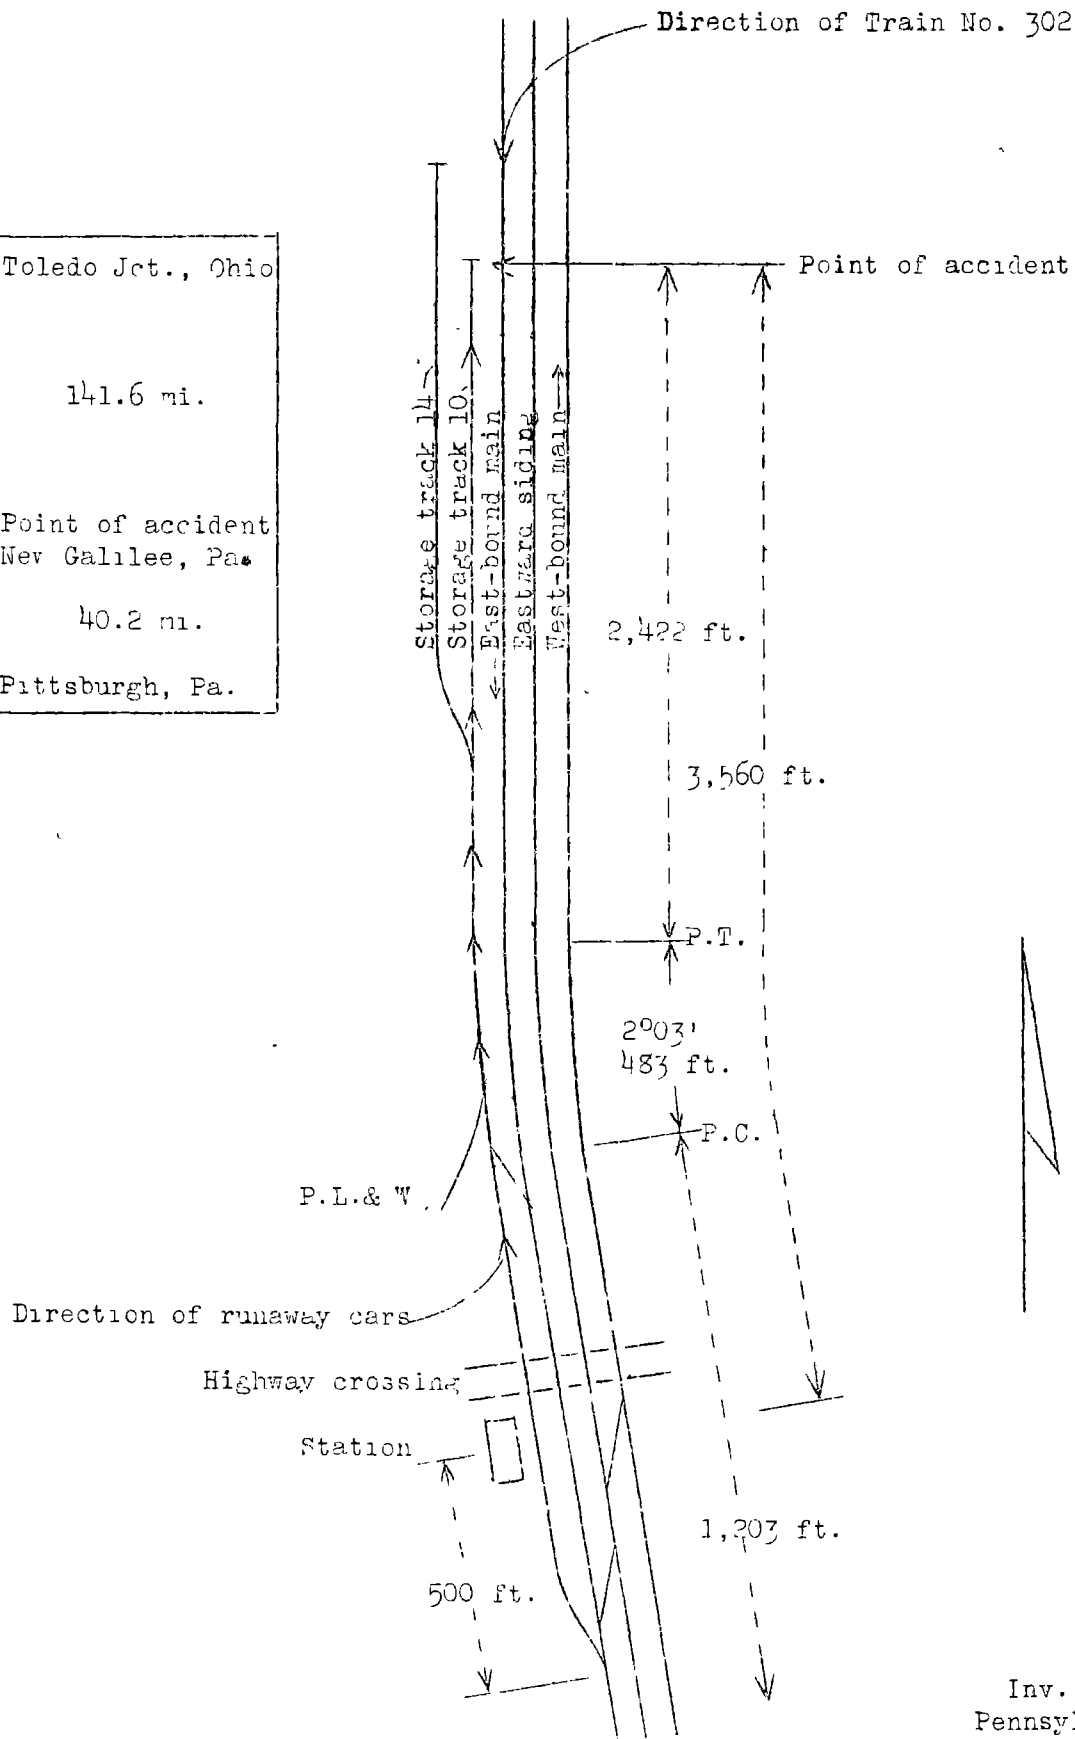
Inv. No. 2195  
 Pennsylvania R.R.  
 New Galilee, Pa.  
 August 18, 1937.

The derailed cars of the runaway cut had stopped with the rear end of the first car and the front end of the second car fouling the east-bound main. The passenger train raked the side of the first car at its rear or eastern end about 6 feet and the entire length of the second car. The passenger train was damaged its entire length on the right side; the engine cab was torn loose and badly damaged. No part of the train was derailed, however, and it stopped with the engine approximately 1,800 feet beyond the point of accident. The employees killed were the engineman and fireman of the passenger train.
