REPORT NO. 3425
THE PENNSYLVANIA RAILROAD COMPANY
IN RE ACCIDENT
NEAR NOTTAWA, MICH., ON
AUGUST 28, 1951

Date: August 28, 1951
Railroad: Pennsylvania
Location: Nottawa Mich.
Kind of accident: Derailment
Train involved: Passenger
Train number: 500
Engine number: Diesel-electric unit 5867A
Consist: 8 cars
Estimated speed: 55 m. p. h.
Operation: Timetable, train orders and manual-block system
Track: Single tangent; 0.33 percent ascending grade southward
Weather: Clear
Time: 12:50 a. m.
Casualties: 6 injured
Cause: Broken rail

Accident near Nottawa, Mich., on August 28, 1951, caused
by a broken rail.

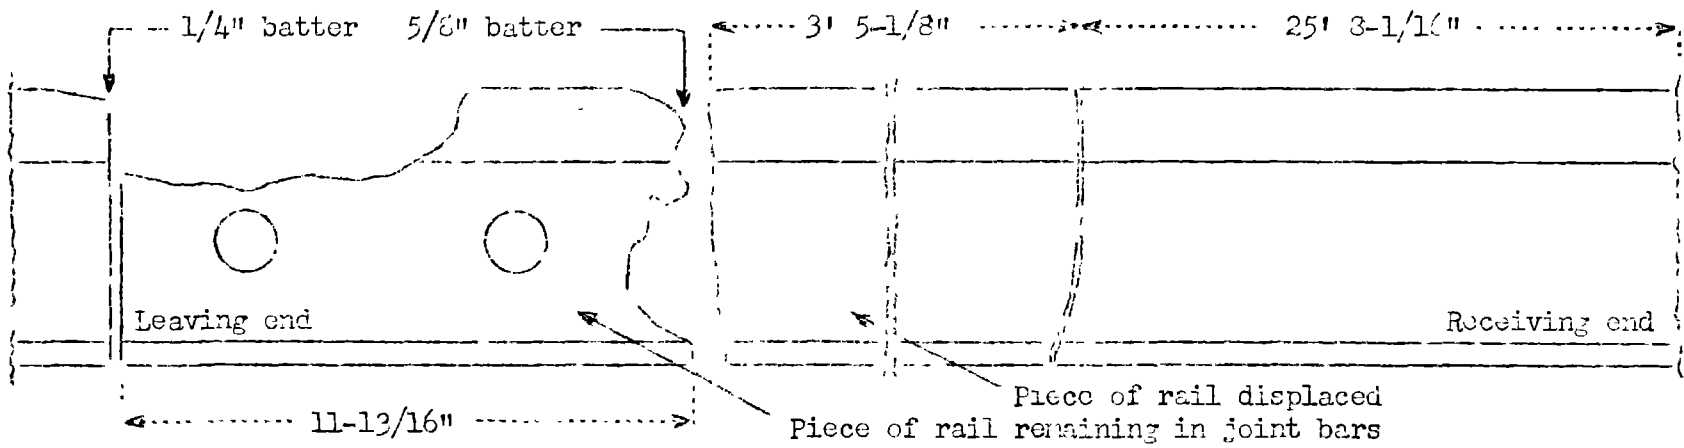
Sketch showing broken rail - west side of track

Examination of the track after the accident occurred disclosed no indication of dragging equipment nor of any obstruction having been on the track. The surface, alinement and gage were well maintained for the maximum authorized speed. At the point of derailment a broken rail was found on the west side of the track. This rail was broken into several pieces, three of which were recovered. From the north, in succession, the lengths of the three recovered pieces were 25 feet 8-1/8 inches, 3 feet 5-1/8 inches, and 11-13/16 inches. There was a portion between the second and the third pieces that was not recovered. The third piece of rail remained bolted in place. At the leaving end of this piece of rail, the head was broken out a distance of 7-1/4 inches. At the north end the head of the rail was battered downward a distance of about 5/8 inch. Small transverse fissures were found at

the break between the first and the second pieces, at the south end of the second piece, and at the north end of the third piece. None of the fissures extended to the surface of the rail. Flange marks on the pieces of rail which were recovered indicated that the section of rail immediately north of the third piece became displaced, and then the wheel flanges mounted the north end of the most southerly piece of rail.
