INTERSTATE COMMERCE COMMISSION

REPORT OF THE DIRECTOR OF THE BUREAU OF SAFETY CONCERNING AN
ACCIDENT WHICH OCCURRED ON THE PENNSYLVANIA RAILROAD AT
PERRYMAN, MD., ON OCTOBER 18, 1932.

December 21, 1932.

Inv. No. 1791
Pennsylvania Railroad
Perryman, Md.
Oct. 18, 1932

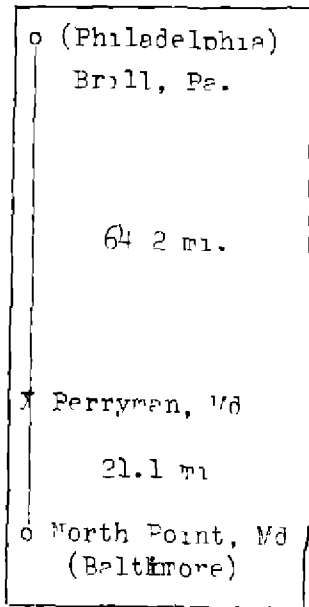
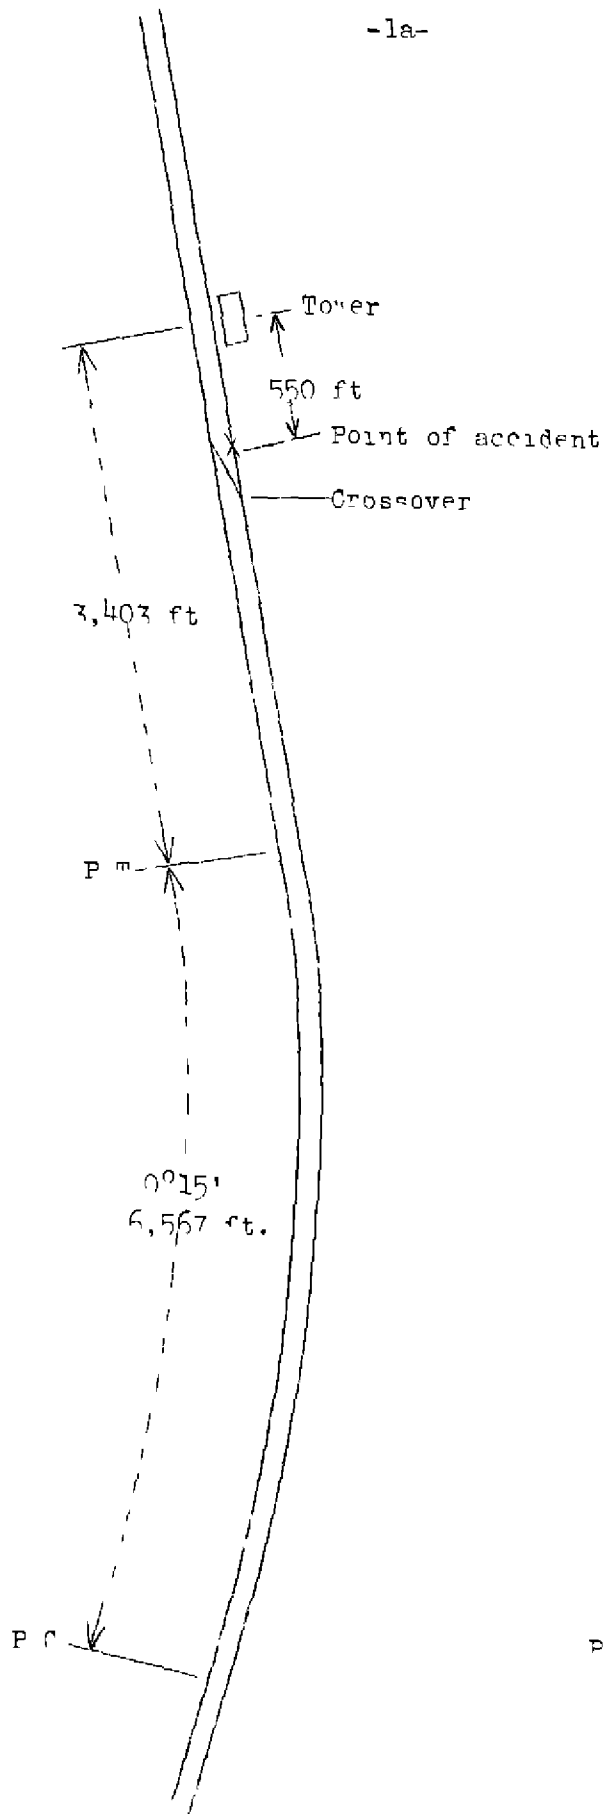
The engine and first 8 cars stopped with the head end of the engine 1,485 feet north of the tower; the rear truck of the eighth car and the following 16 cars were derailed and stopped in various positions within a space of 275 feet near the location of the tower. Some of the cars were destroyed, others badly damaged, the tower was demolished and the interlocking plant was badly damaged. The employee killed was a signalman and the employee injured was a block operator, both of whom were in the tower at the time of the accident.

An inspection of the track made by the Commission's inspectors subsequent to the accident revealed that the track was in good condition and nothing was found that could have contributed to the cause of the accident. A mark was found in the ballast at the Bush River Neck highway crossing which was 6 inches from the outside of the west rail; it was about 1 inch deep and extended entirely over the crossing. The next mark was on the west rail of the crossover south of the tower and conformed in position to the mark at the highway crossing, the final derailment occurring just north of this point. Examination of the rear truck of UTLX tank car 31871 disclosed that the bottom arch bar on the left side of the truck was broken at the bend in front of the journal box and the top arch bar was bent downward. The forward column bolt was broken and the truck, while it remained in its position under the car, was in a badly-damaged condition. An inspection of the broken arch bar showed an old defect which began at the lower outside corner near the bend at the journal box and extended $1 \frac{5}{8}$ inches inward and 1 inch upward. Another old defect appeared near the center end on the bottom side of the arch bar, this defect extending $2 \frac{1}{2}$ inches across the bar and being $\frac{3}{8}$ inch deep.

This accident apparently was caused by the failure of an arch-bar truck under the eighth car in the train.

According to the statements of the members of the train crew, they had no knowledge of anything wrong until the train was derailed. An inspection of the track disclosed that something had been dragging, the first indication being a mark on a highway crossing on the outside of the left or west rail approximately 3 miles south of the point of accident. Another mark was found on the outside of the west rail of the crossover a short distance south of Perryman tower, followed by a mark on top of the main rail and then flange marks appeared on the ties. An examination of the rear truck of UTLX tank car 31871, the eighth car in the train, showed it to be in a badly-damaged condition. The lower arch bar on the left side was broken and the top bar was bent, a column bolt and the brake beams were also broken. Inspection of the broken arch bar revealed that it had been cracked for some time at the point of failure, and painted over subsequent to that time, thus preventing its detection when inspected by car inspectors.
