ACCIDENT ON THE
PENNSYLVANIA RAILROAD

PHILADELPHIA, PA.

INVESTIGATION NO. 2387

Inv. No. 2387
 Pennsylvania R.R.
 Philadelphia Pa.
 Oct. 13, 1939

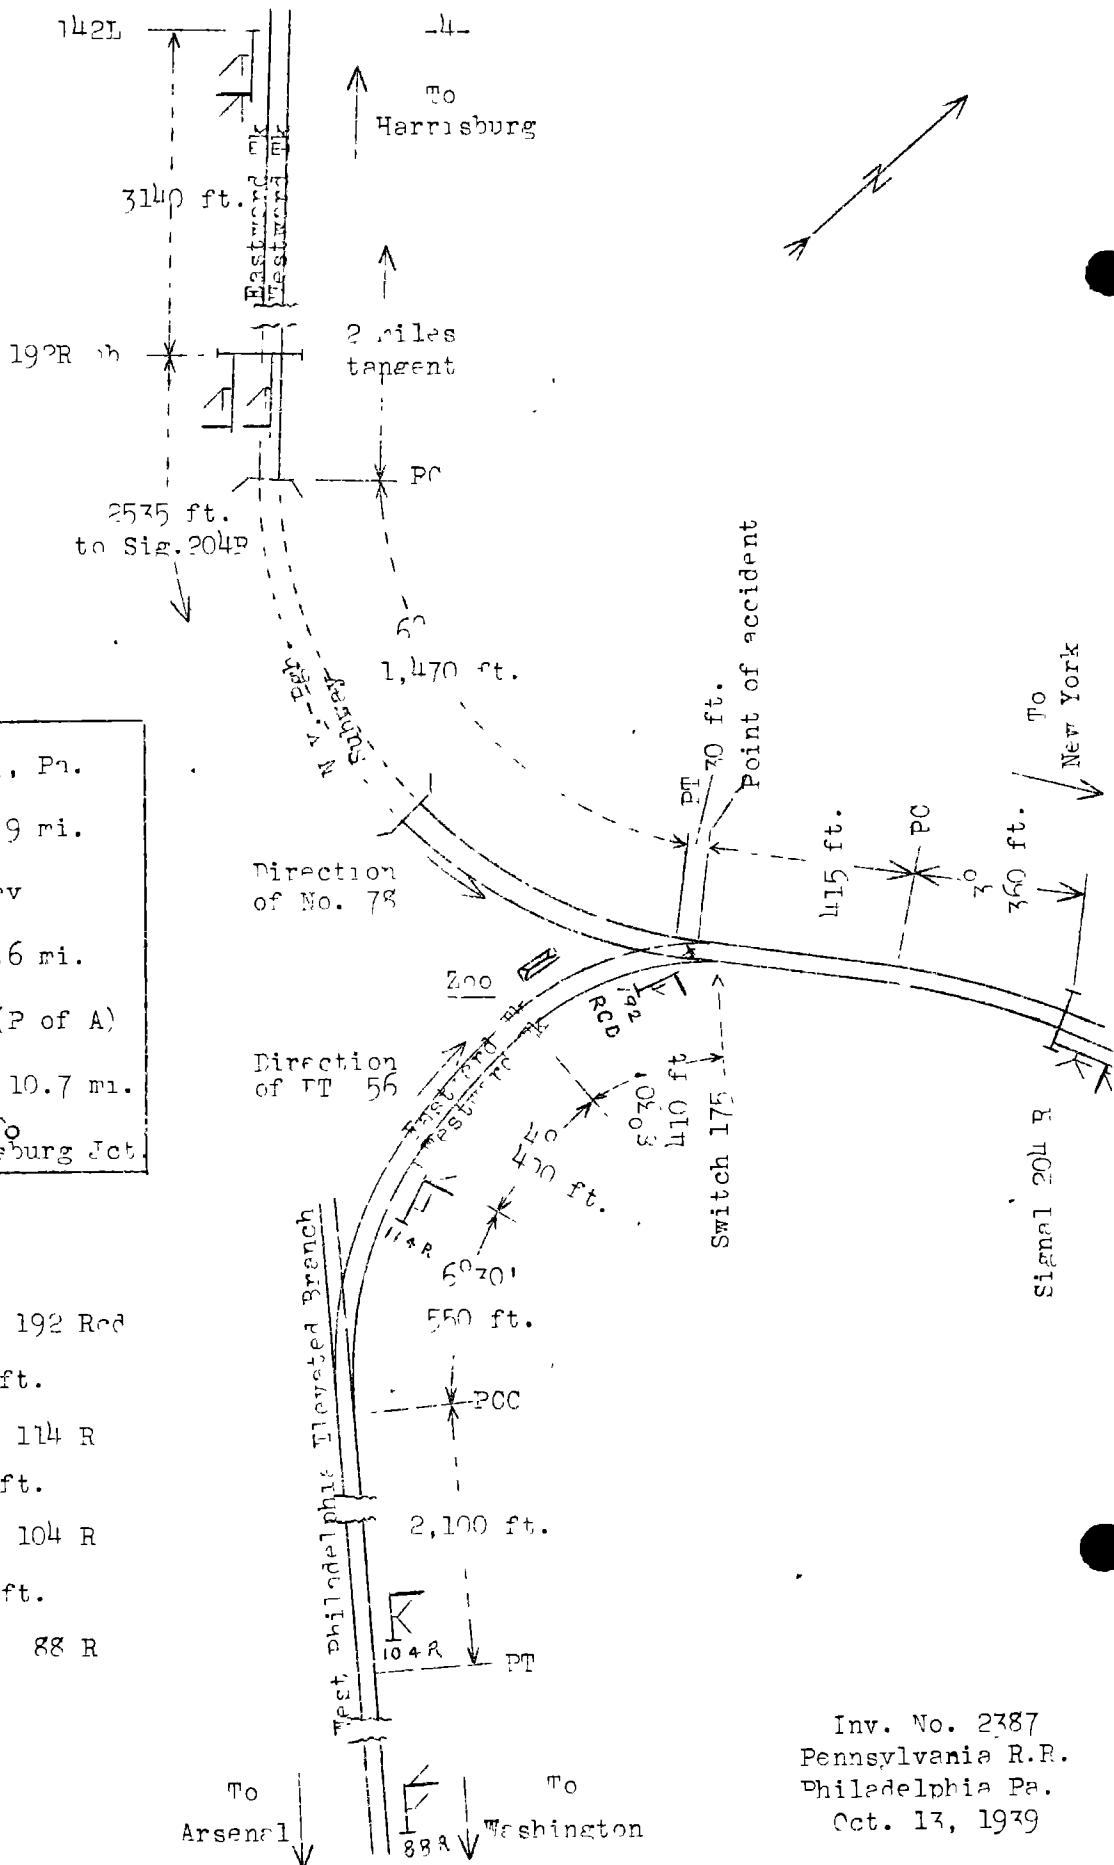
- Signal 192 Red
765 ft.
- Signal 114 R
1400 ft.
- Signal 104 R
1894 ft.
- Signal 88 R
