INVESTIGATION NO. 3048
THE PENNSYLVANIA RAILROAD COMPANY
REPORT IN RE ACCIDENT
AT PHILADELPHIA, PA., ON
DECEMBER 14, 1946

January 27, 1947

Accident at Philadelphia, Pa., on December 14, 1946, caused
by failure to operate No. 272 in accordance with an
interlocking signal indication.

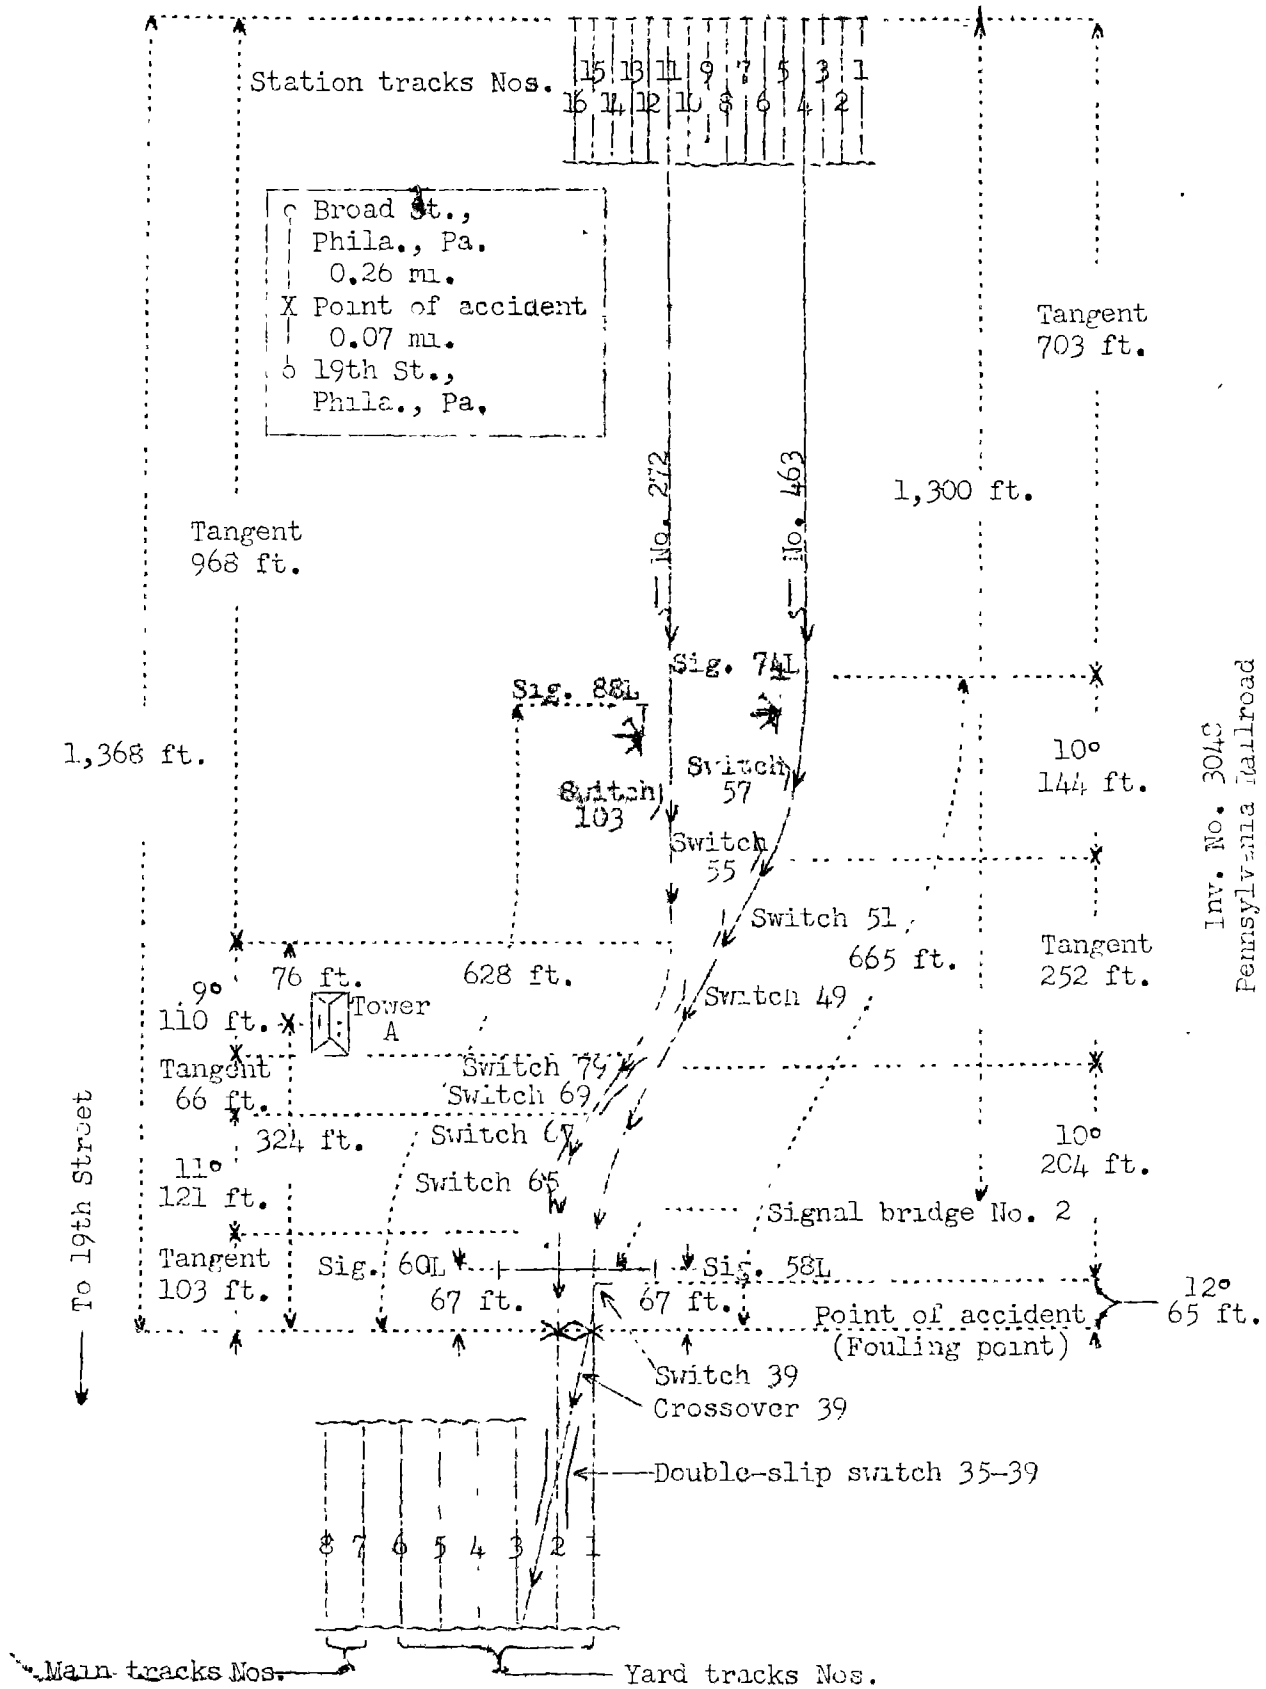
Inv. No. 304C
Pennsylvania Railroad
Philadelphia, Pa.
December 14, 1946

Interlocking signals 74L and 58L, governing west-bound movements from station track No. 4 through switch 39 to crossover 39, are, respectively, 665 feet and 67 feet east of the point of accident. Interlocking signals 88L and 60L, governing west-bound movements on station track No. 11, are, respectively, 628 feet and 67 feet east of the point of accident. These signals are of the two-unit, position-light type, and are continuously lighted. Signals 74L and 58L are mounted on masts, and signals 88L and 60L are mounted on signal bridge No. 2. The involved aspects and corresponding indications and names of these signals are as follows:

No. 463 entered crossover 39 at switch 39 and was moving at a speed of about 5 miles per hour when the right side of the tender of the engine was struck by No. 272 at the fouling point of station track No. 11 and crossover 39.
