ACCIDENT ON THE

PENNSYLVANIA RAILROAD

PRINCETON JUNCTION, N. J.

INVESTIGATION NO. 2108

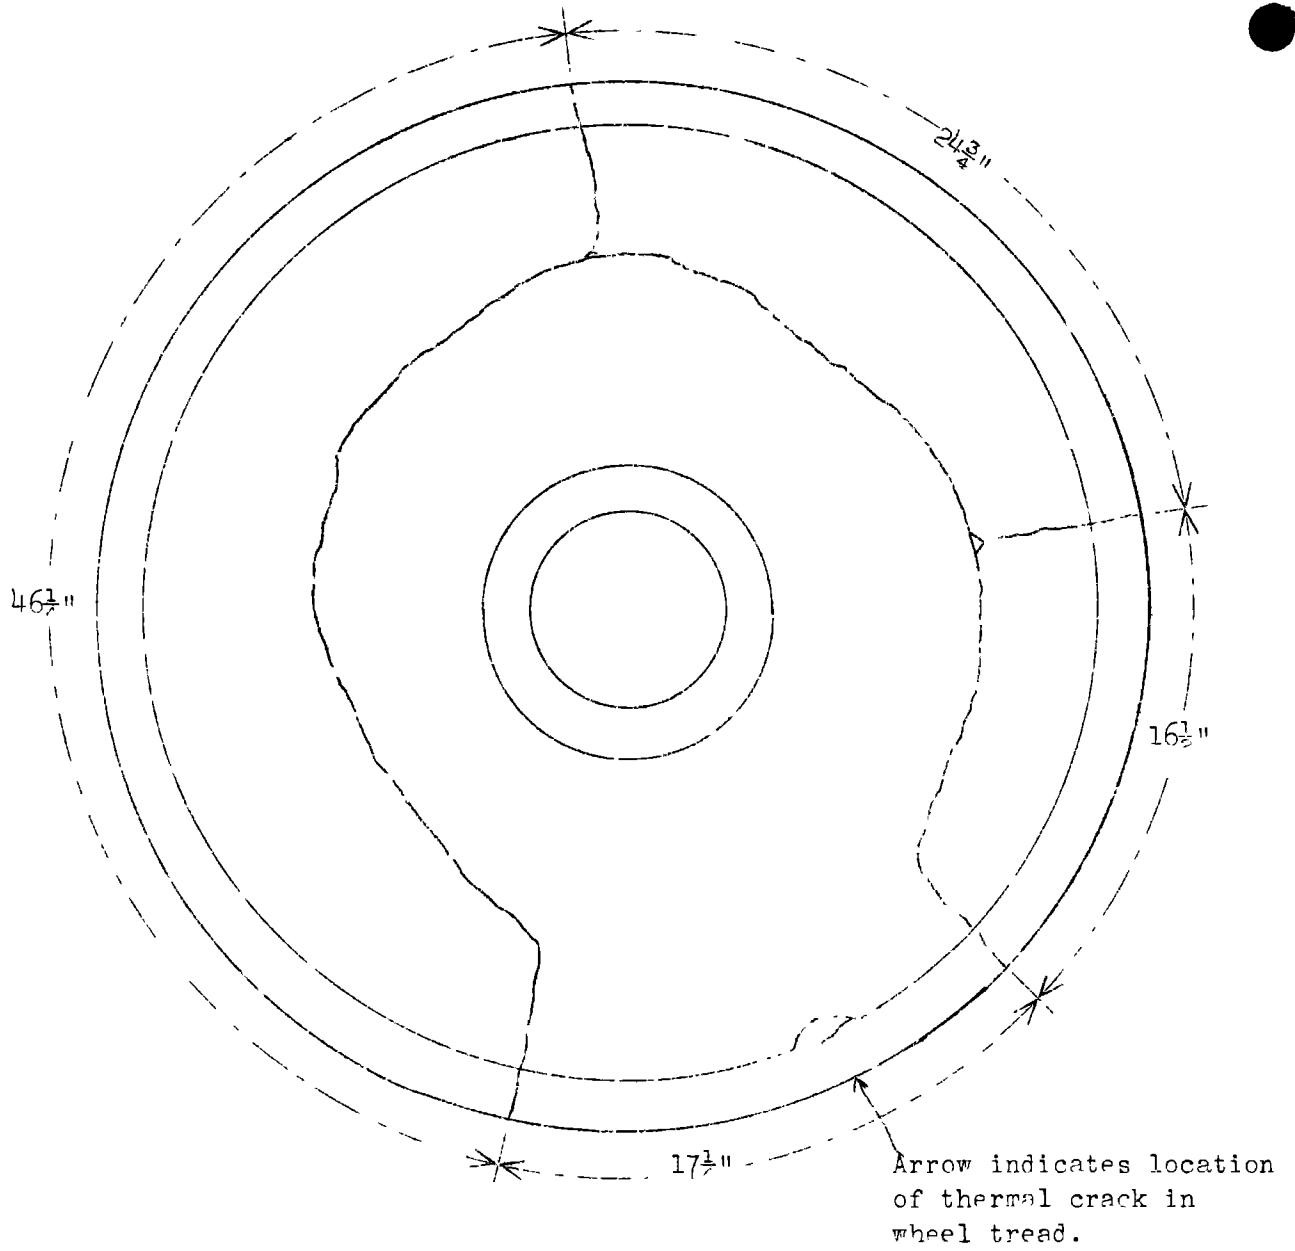
Examination of the broken wheel showed that the fracture extended practically at right angles through the rim section of the wheel and into the plate about halfway to the hub and then circumferentially around the plate section; approximately 18½ inches of the rim and flange remained on the wheel, the balance being broken off into three pieces. The flange and tread were found to have nearly a full contour, and no thermal checks, cracks or flaws were visible as a cause for the fracture, nor was there any discoloration or other indication that the wheel had been recently heated. The inside face of the cast steel truck frame and the journal box pedestal bore pronounced gouged marks and were newly scarred, plainly indicating that serious friction and blows had occurred at these points before the large segments had become free and separated from the wheel.

Sketch showing location of ruptures.

The crack in rim, opposite the abrasion on inside, was opened at the laboratory and a thermal crack, about 2 inches in length, was then disclosed, with a secondary crack extending through the thermal crack, which evidently resulted from the heavy impact on the inside of rim. No evidence of any such cracks could be found on any of the ruptures which resulted in the wreck, nor were any well defined thermal cracks found on any other portion of the wheel tread. Examination showed that the broken wheel was of proper contour and well above the established road limit; that the surface of tread on outer portion showed a slight heat discoloration from brake shoe application; that the few very small thermal checks found in the wheel tread were so small that they could not be detected under ordinary inspection.

In conclusion, the report states that all of the fractures through rim and web were entirely sudden with no evidence of an old defective condition. The tensile properties were normal with the exception of a slightly low limit of elasticity. The Brinell hardness was somewhat high and the steel was rather high in slag and oxide, and the type of fracture, in view of all these facts, leads to the conclusion that the bursting of this wheel was directly due to internal stresses, the presence of which cannot be determined without destroying the wheel. It was considered that the plate stresses were present in the wheel when new and the rim had sufficient band resistance to hold these locked up plate stresses, but when the rim thickness was reduced (the wheel having been turned to restore contour) the center zone of the rim, weakened by a high oxide and slag content, was reached, and this, together with the stresses set up by brake shoe heating, was evidently sufficient to permit the plate stresses to overcome the band resistance of the rim, resulting in the bursting rupture of the wheel.
