ACCIDENT ON THE
PENNSYLVANIA RAILROAD

RIEGELSVILLE, N. J.

OCTOBER 16, 1937

INVESTIGATION NO. 2208

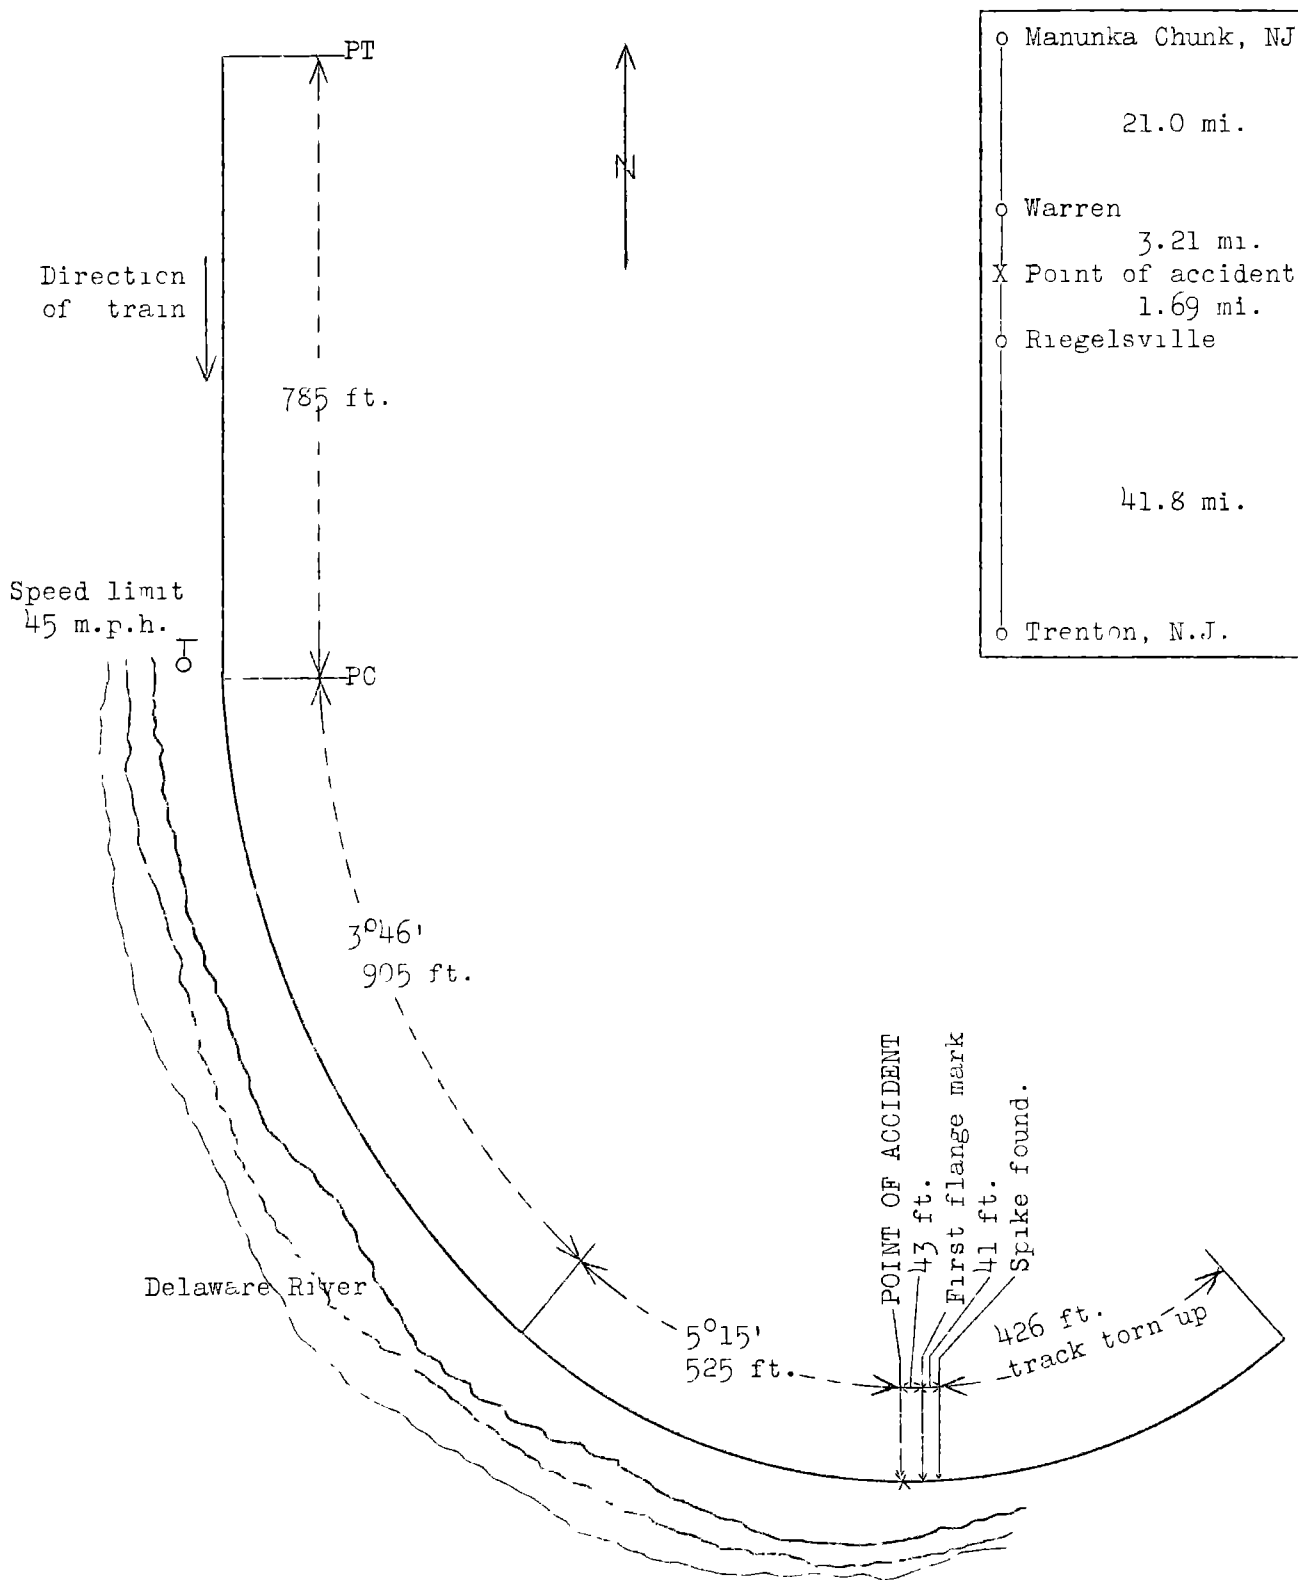
Inv. No. 2208
 Pennsylvania Railroad
 Riegelsville, N.J.
 Oct. 16, 1937

The bent track spike, which was found at a point 43 feet from flange mark on high rail and 12 feet to the west of the track, was a Pennsylvania Railroad Standard spike 7 inches in length and 5/8 inch by 5/8 inch in thickness. Placing this

spike on the rail against the tread of the engine-truck wheel of engine 1163, with the head of the spike against the gauge side of the rail, it appeared that the groove on top of the spike near the head was made by a flange striking it; the opposite side of the spike showed evidence of pressure and sliding. In addition, when this spike was placed on the high rail at the point of derailment it was found that it had been bent in such manner as to exactly fit the contour of the top of the high rail; all of the marks on the spike appeared to have been made recently. The broken rail mentioned above was examined and it appeared to have been caused by the derailment.

The nature of the marks found on the rail preceding the point of derailment, coupled with the manner in which the track spike was bent, indicate definitely that the spike was lying on top of the high rail with the head of the spike against the gauge side; the rail marks also indicate that the spike slid along the rail for some distance after being struck by the engine truck wheel but finally the wheel was lifted high enough to permit the flange to roll on top of the high rail.

This accident was caused by a track spike lying on top of the high rail of a curve.
