INTERSTATE COMMERCE COMMISSION

REPORT OF THE DIRECTOR OF THE BUREAU OF SAFETY CONCERNING AN
ACCIDENT ON THE PENNSYLVANIA RAILROAD NEAR SEANOR, PA.,
ON NOVEMBER 19, 1934.

Inv. No. 1945
 Pennsylvania R.R.
 Seanor, Pa.
 Nov. 19, 1934

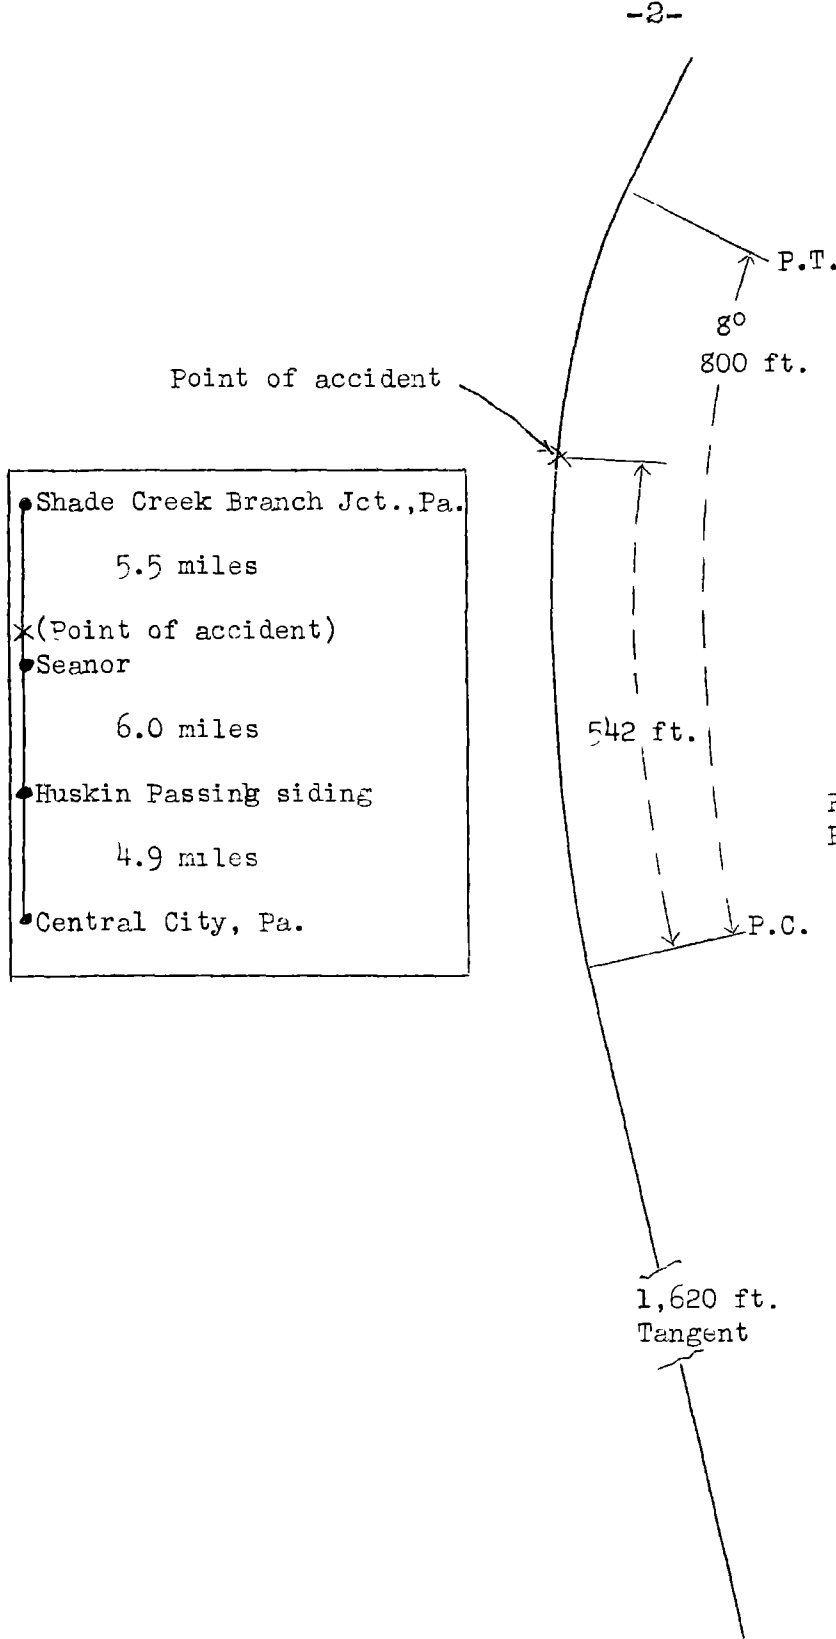
Receiving end of rail
 Piece $4 \frac{5}{8}$ " broken out
 and missing

Division Engineer Gillum arrived at the scene of the accident about 10:30 p.m. and inspected the track and equipment in an endeavor to ascertain the cause of the accident, but nothing could be found out until the following afternoon after the derailed equipment had been picked up. His examination of the leaving end of the adjacent rail south of the broken rail disclosed no marks on the end of that rail to indicate that the small piece was missing from the broken rail at the time the train passed over it on the south-bound trip, but in his opinion the small piece was broken during some very recent prior movement and then was held in place by the rail joint until kicked out by Extra 1544, thus precipitating the derailment.

A small piece had been broken out of the receiving end of the rail and there was another break 9 feet 2 inches from the leaving end. The latter break apparently was a result of the accident but the opinion was advanced that the small piece had been broken by some prior movement and then held in place by the rail joint until forced out by engine 1344. The question of when this break occurred, however, and the reason for its occurrence, were not definitely determined.
