INTERSTATE COMMERCE COMMISSION
WASHINGTON

INVESTIGATION NO. 2569
THE PENNSYLVANIA RAILROAD COMPANY
REPORT IN RE ACCIDENT
AT SEWARD, PA., ON
FEBRUARY 17, 1942

Accident at Seward, Pa., on February 17, 1942, caused by failure to comply with the provisions of a holding order, and by permitting a train to enter a block which was occupied by an opposing train.

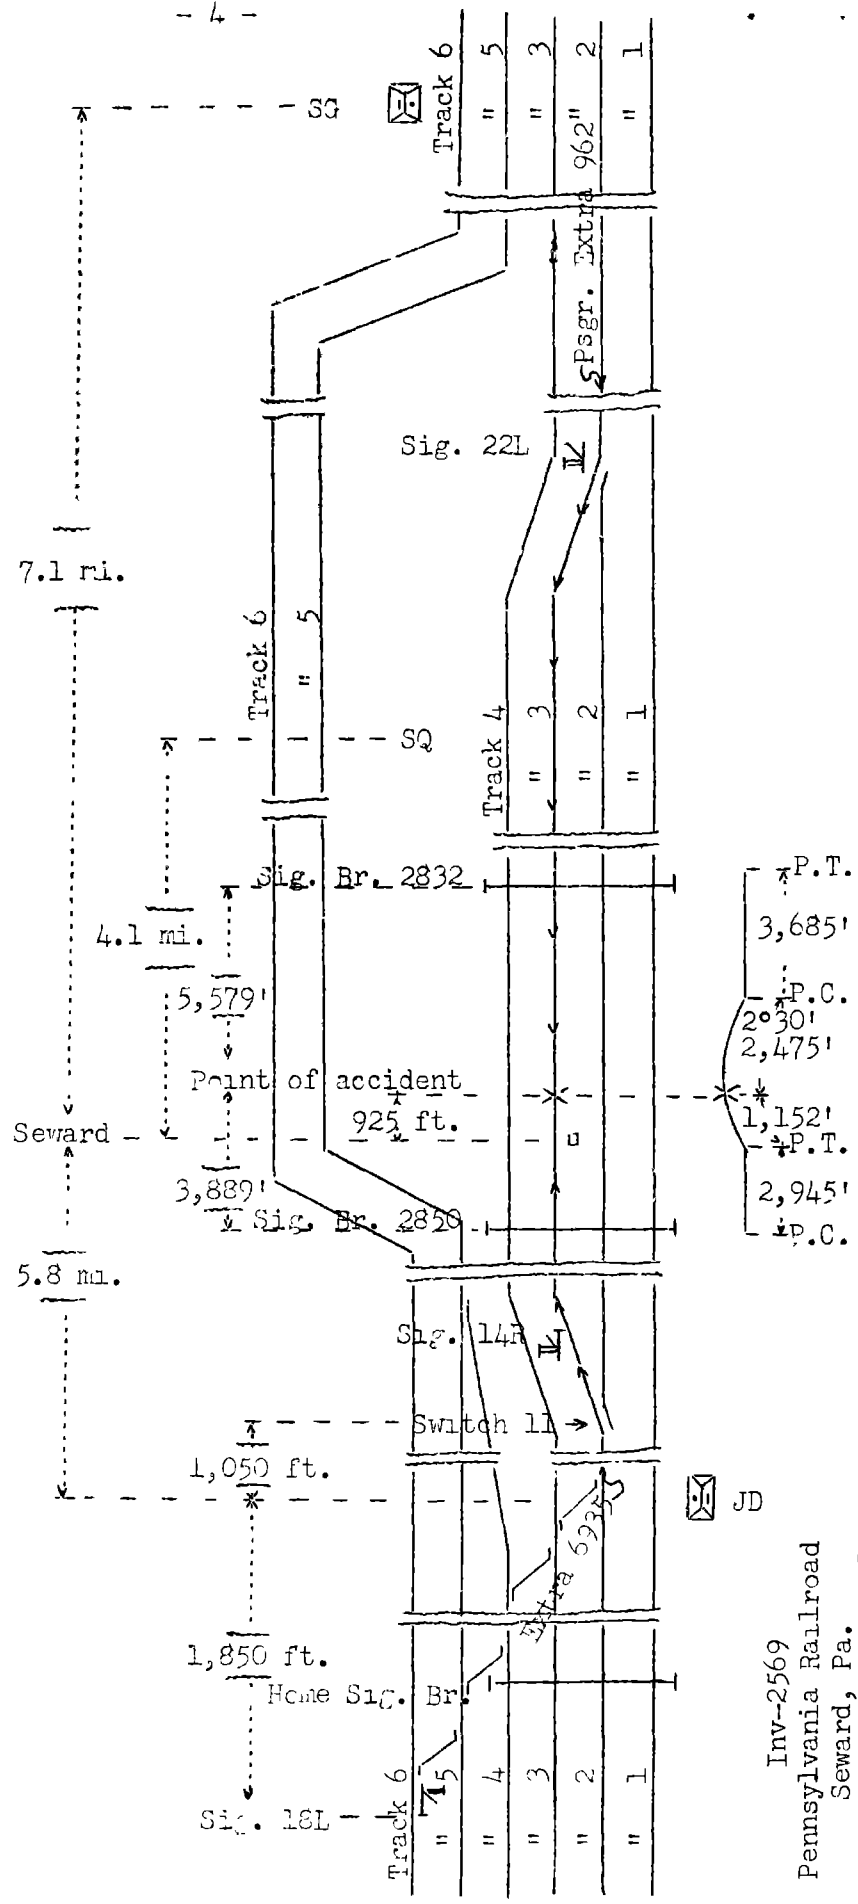
Inv-2569
 Pennsylvania Railroad
 Seward, Pa.
 February 17, 1944

Location of Accident and Method of Operation

This accident occurred on that part of the Pittsburgh Division which extends between EC block station, Altoona, and Pittsburgh, Pa., a distance of 112.9 miles. In the immediate vicinity of the point of accident this is a 6-track line. Tracks 1 to 4, inclusive, are laid on a hillside cut on the south side of the Conemaugh River. Tracks 5 and 6 are laid on the north side of the river. On tracks 1 to 4, inclusive, trains moving with the current of traffic are operated by an automatic block and cab-signal system, the indications of which supersede time-table superiority, and trains moving against the current of traffic are operated by train orders and a manual-block system. Between SQ and JD, located, respectively, 4.1 miles east and 5.8 miles west of Seward, the main tracks are numbered consecutively from south to north. Tracks 1 and 2 are eastward freight, track 3, eastward passenger, track 4, westward passenger, and tracks 5 and 6, westward freight. At SQ, tracks 2 and 3 converge, and track 2 is the eastward passenger track between SQ and SG, a distance of 3 miles. The accident occurred on track 3 at a point 925 feet east of the station at Seward. As the point of accident is approached from the east there is a tangent 3,685 feet in length, which is followed by a 2°30' curve to the left 2,475 feet to the point of accident and 1,152 feet beyond. As the point of accident is approached from the west there is a tangent 2,945 feet in length, which is followed by the curve on which the accident occurred. At the point of accident the grade is practically level.

Interlockings are located at SG, SQ and JD. The interlocking at SQ is controlled by the signalman at SG. Westward home signal 22L at SQ, which governs west-bound movements on track 2 and diverging west-bound movements on track 3, is located at the converging point of tracks 2 and 3. This signal is a 2-indication, position-light, dwarf signal. The indications displayed by this signal and their corresponding names are as follows:

Signal bridges 2832 and 2850 are located, respectively, 5,579 feet east and 3,889 feet west of the point of accident. The automatic signals on these bridges are of the position-light type and are approach-lighted. Eastward home signal 18L at JD, which governs east-bound movements entering the interlocking on track 6, is located 1,850 feet west of the tower. Switch 11, which is located 1,050 feet east of the tower at JD, is facing-point for east-bound movements and its normal position is for movement from track 2 to track 3.

Because of the track curvature and an embankment on the south side of the track, the view of an approaching train from an engine moving in either direction is restricted to a distance of about 1,000 feet.
