INVESTIGATION NO. 2726
THE PENNSYLVANIA RAILROAD COMPANY
REPORT IN RE ACCIDENT
AT SHORE, PA., ON
SEPTEMBER 6, 1943

Railroad: Pennsylvania
Date: September 6, 1943
Location: Shore, Pa.
Kind of accident: Derailment
Train involved: Passenger
Train number: Passenger Extra 4930 East
Engine number: 4930
Consist: 16 cars
Speed: 56 m. p. h.
Operation: Interlocking
Track: Four; tangent; 0.61 percent
descending grade eastward
Weather: Clear
Time: 6:06 p. m.
Casualties: 79 killed; 129 injured
Cause: Broken journal

Accident at Shore, Pa., on September 6, 1943, caused by a
broken journal.

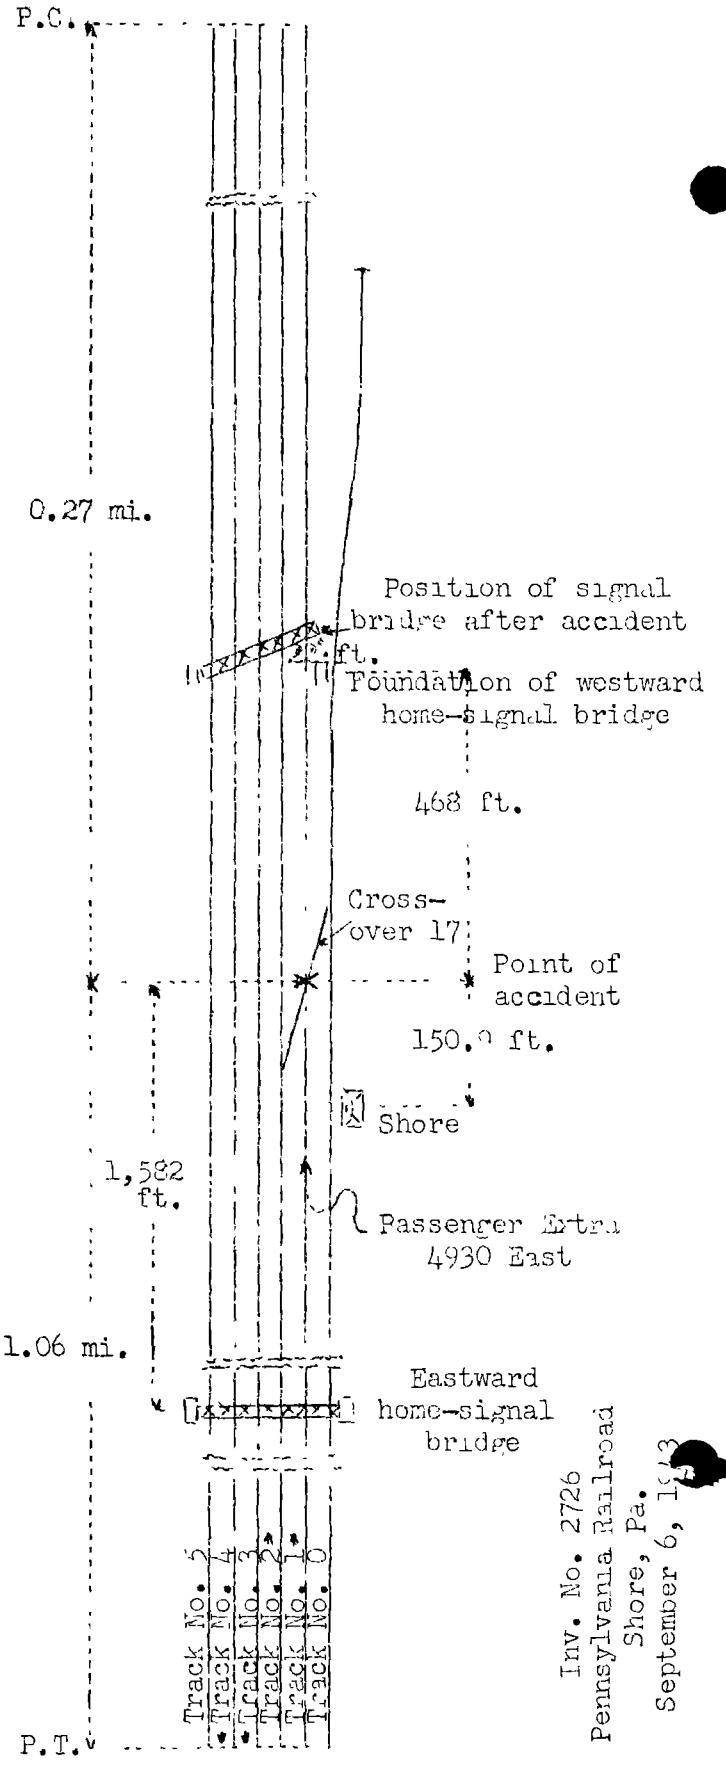
Inv. No. 2726
 Pennsylvania Railroad
 Shore, Pa.
 September 6, 1913

Broken journal
5-1/2" by 10"

After the accident it was found that the left front journal of the front truck of P. R. R. 1860, the seventh car, was broken off. Beginning at the heel of the west frog of the movable-point crossing and extending eastward 23 feet 4-1/4 inches, an angular flange-mark appeared on top of the head of the north rail. Extending from the east end of this mark a distance of 48 feet 8-1/4 inches to the heel block of the east movable point of the crossing, the ties bore wheel marks outside the north rail and inside the south rail. Immediately east of the heel block the track was torn up a distance of 480 feet, and from this point eastward it was damaged 1,056 feet.
