INVESTIGATION NO. 2727
THE PENNSYLVANIA RAILROAD COMPANY
REPORT IN RE ACCIDENT
NEAR SLOPE, PA., ON
SEPTEMBER 10, 1943

INVESTIGATION NO. 2727

Accident near Slope, Pa., on September 10, 1945, caused
by insufficient number of cars of Extra 3641 West
equipped with adequate power brakes to control safely
movement of the train.

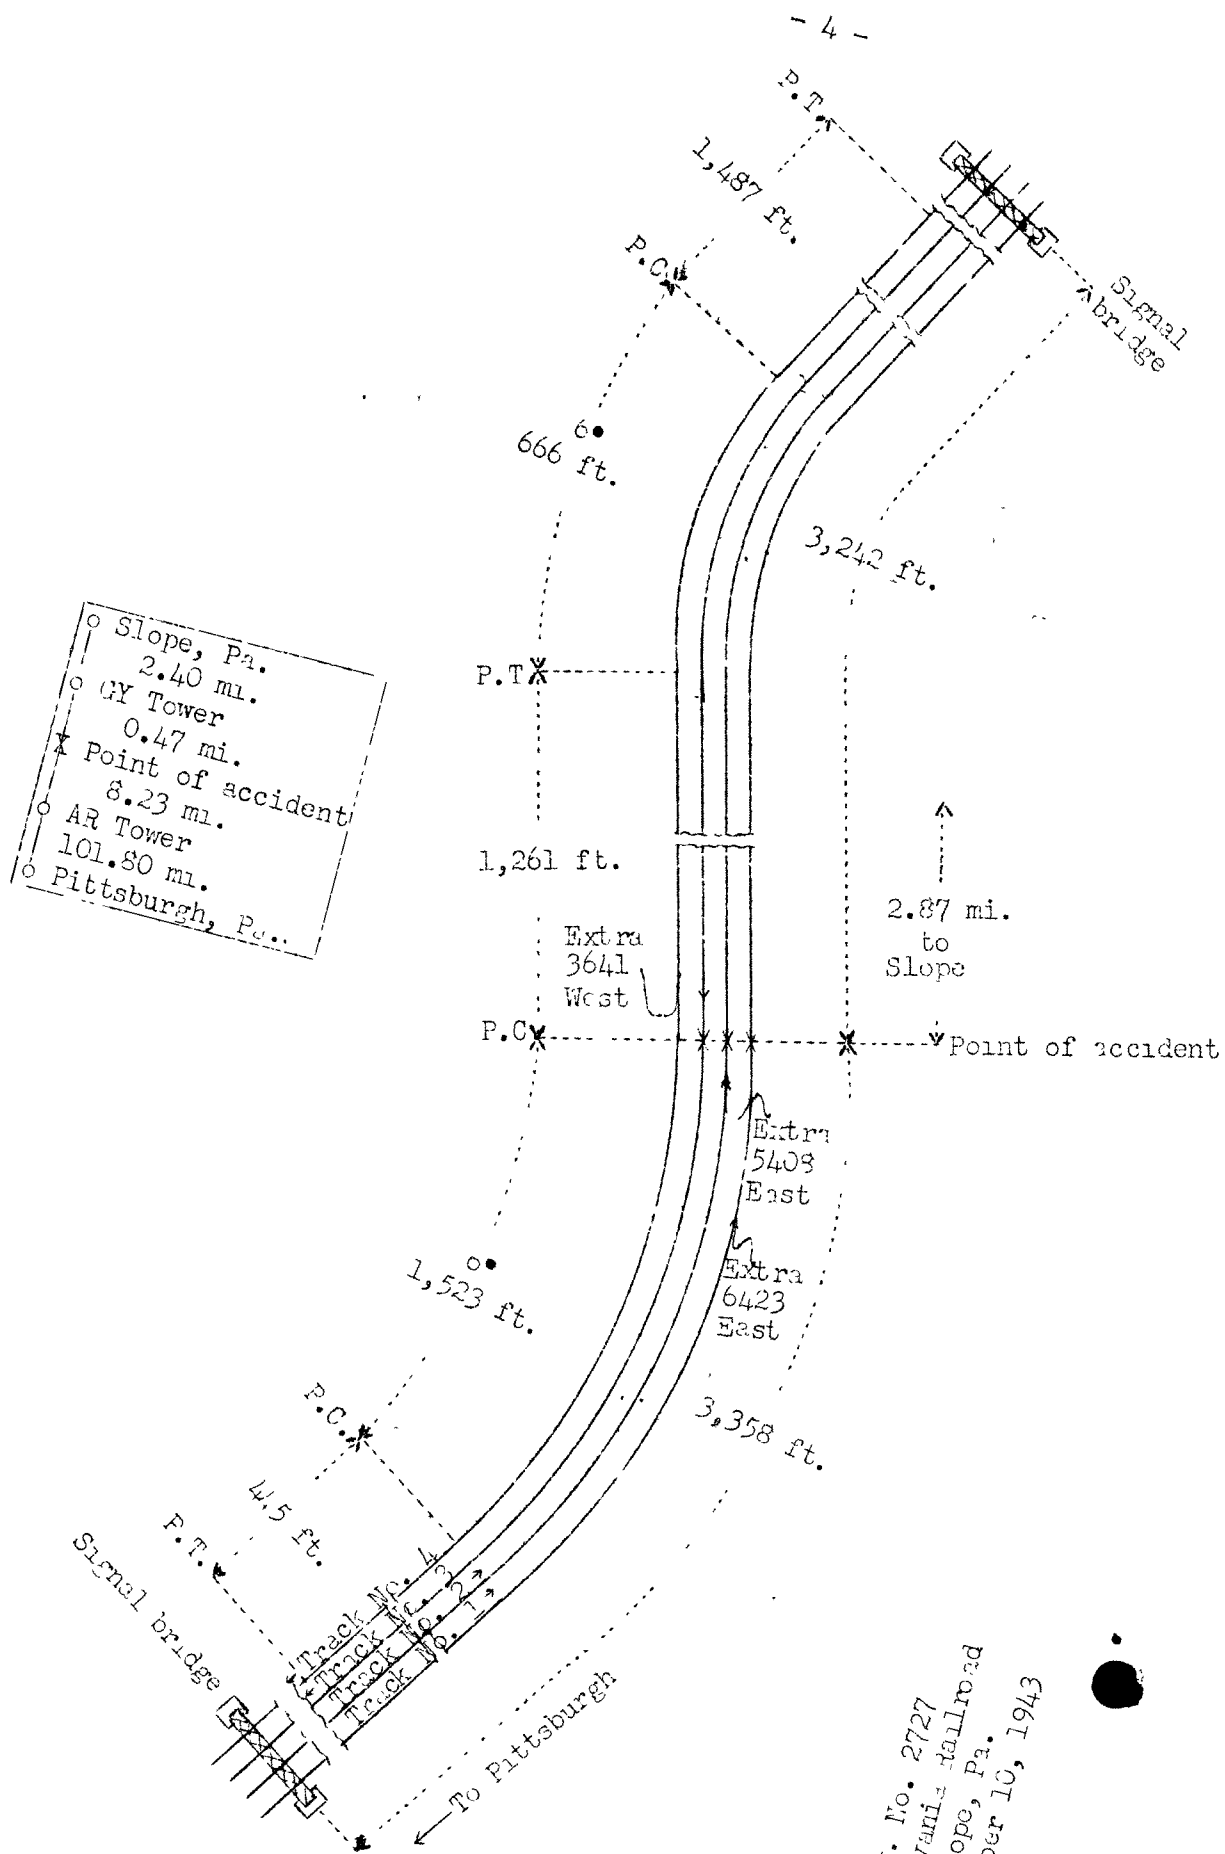
Inv. No. 2727
 Pennsylvania Railroad
 Slope, Pa.
 September 10, 1943

Location of Accident and Method of Operation
