REPORT OF THE DIRECTOR

PENNSYLVANIA RAILROAD

SPRINGDALE, PA.

INVESTIGATION NO. 2124

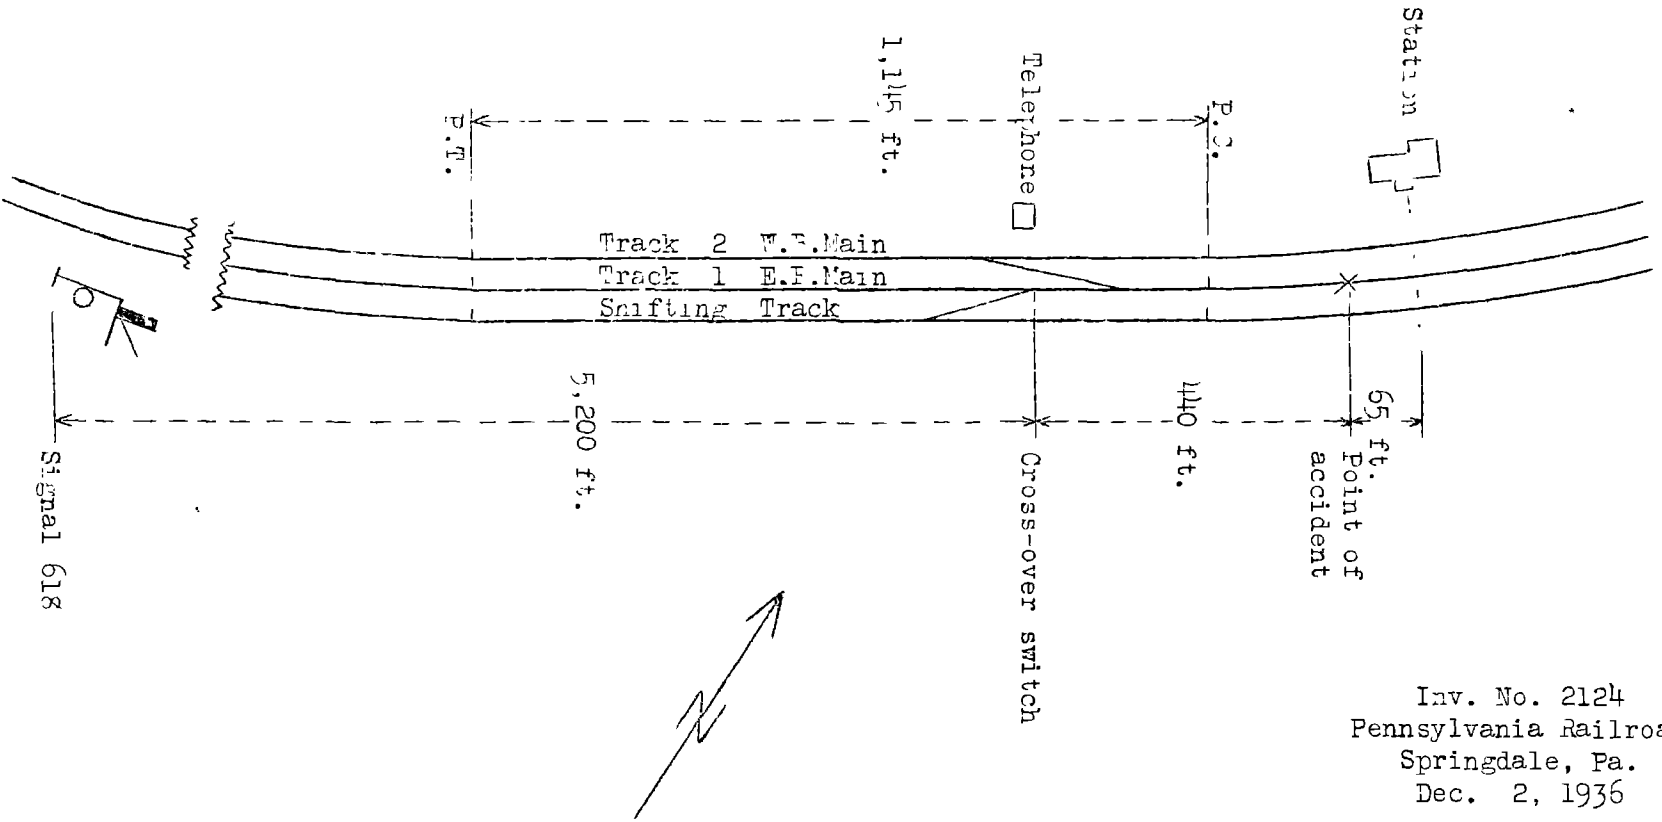
Inv. No. 2124
 Pennsylvania Railroad
 Springdale, Pa.
 Dec. 2, 1936

At Springdale a shifting track, locally known as the glue track, parallels the main tracks on the south; the shifting track connects with the east-bound main track through a cross-over about 135 feet in length, the east or main track switch thereof being a trailing-point switch located 505 feet west of the station. A second trailing-point cross-over, about 200 feet in length, connects the two main tracks, the east switch of which is located 374 feet west of the station. The latter cross-over has a mechanical center-locking device operated from the ground and connected to the signal circuit on both main tracks; the cross-over between the shifting track and the east-bound main track is not equipped with such a locking device. All of the switches are hand-operated and so arranged that any movement of the switch levers from normal position, or a movement of the center locking device of the main track cross-overs, shunts the track circuit and causes east-bound automatic block signal 618 to assume stop position. This signal is located 5,200 feet west of the east switch of the shifting track.
