INTERSTATE COMMERCE COMMISSION

REPORT OF THE DIRECTOR OF THE BUREAU OF SAFETY IN RE INVESTIGATION OF AN ACCIDENT WHICH OCCURRED ON THE PENNSYLVANIA RAILROAD NEAR SPRUCE CREEK, PA, ON APRIL 17, 1931

JUNE 8, 1931

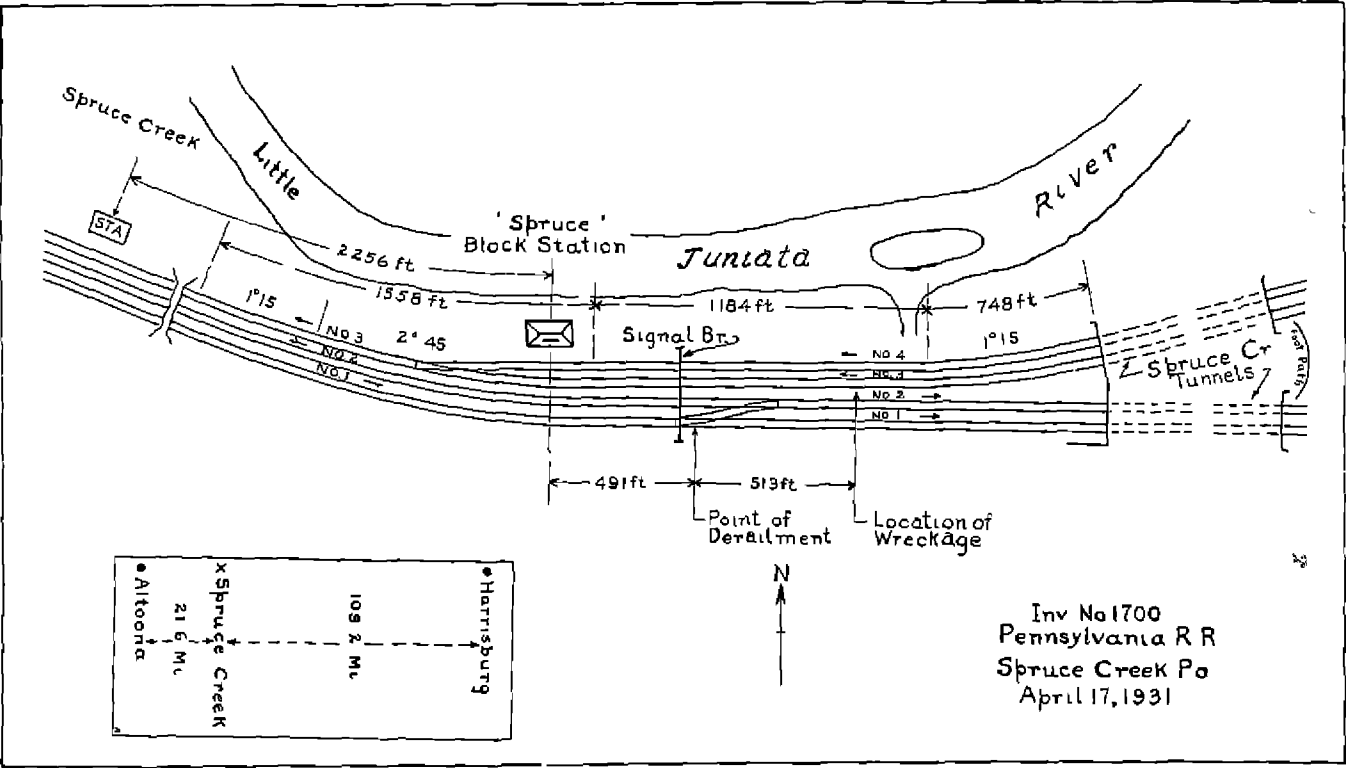
FIGURE 1—Track layout in vicinity of point of accident

The first mark on the track was at a point 234 feet west of Spruce Block Station, or 708 feet west of the crossover, and indicated that something had been dragging, a nut on the south side of the south rail had been broken off, and numerous bolts on the following joints, as well as spikes, were damaged or broken. At a point 54 feet east of the first mark there was a mark on a tie about 10 inches south of the south rail, and another tie 10 feet beyond was similarly marked, from this point eastward various ties, spikes, bolts, and all splices bore evidence of having been struck by some dragging part of the equipment. Approximately 725 feet east of the first dragging mark there were flange marks on the north side of track 1, indicating that the wheels were first derailed at that point, flange marks were also found on the base of the left-hand switch point, between the switch point and the stock rail, there was a mark on the heel block and the heel had been forced out of position, the next mark was a deep flange mark on the receiving end of the rail immediately east of the heel of the switch point. Flange marks were then found on the ties and at the base of the gage side of the south rail of track 2, marks indicating a dragging truck frame were on the ties on the gage side of the north rail of track 1, these marks continuing to the point where the derailed cars finally came to rest, 513 feet beyond, or 1,238 feet east of the first mark of dragging equipment.

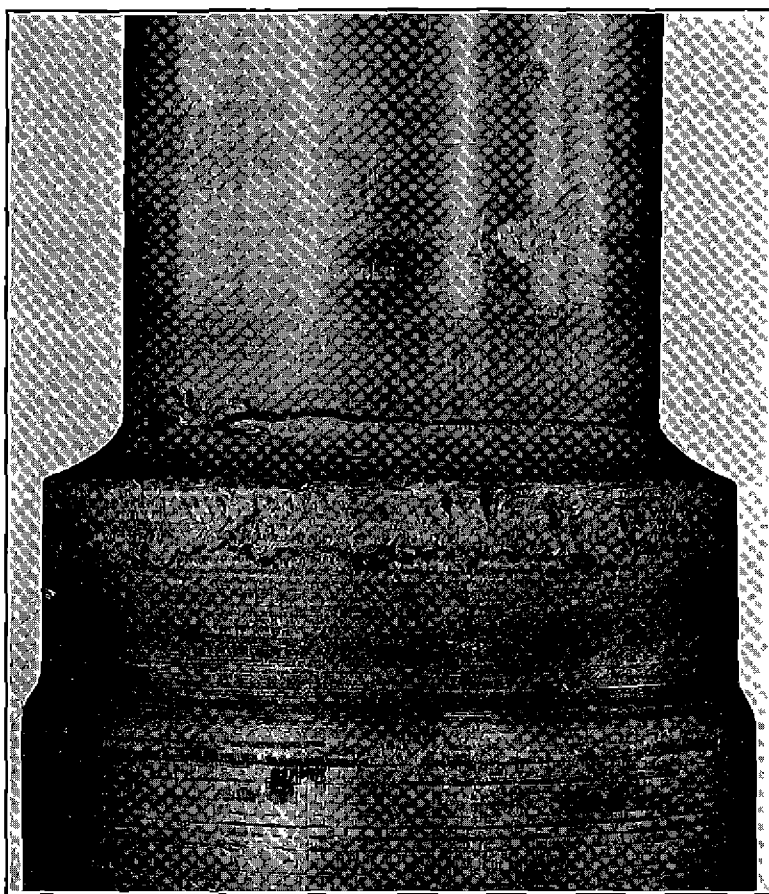
FIGURE 2—Appearance of surface of welded fillet after etching with 10 per cent nitric acid

Macroscopical examination at the location of the fracture showed that this axle had been welded in the fillet location as indicated by the dark areas shown on photograph T-23496 (magnified 2 diameters), pointed out by arrow. The rough tool marks which have cut below the bearing area of the journal were evidently produced at the time of smoothing out the welded fillet which also points out that this welding was done after this axle had been in service for

some time, and was probably used to restore the worn journals to their original nominal length

The origin of the detail fracture with ragged areas around the entire circumference is typical of failures resulting from welding of axles, and the failure was solely due to this welding

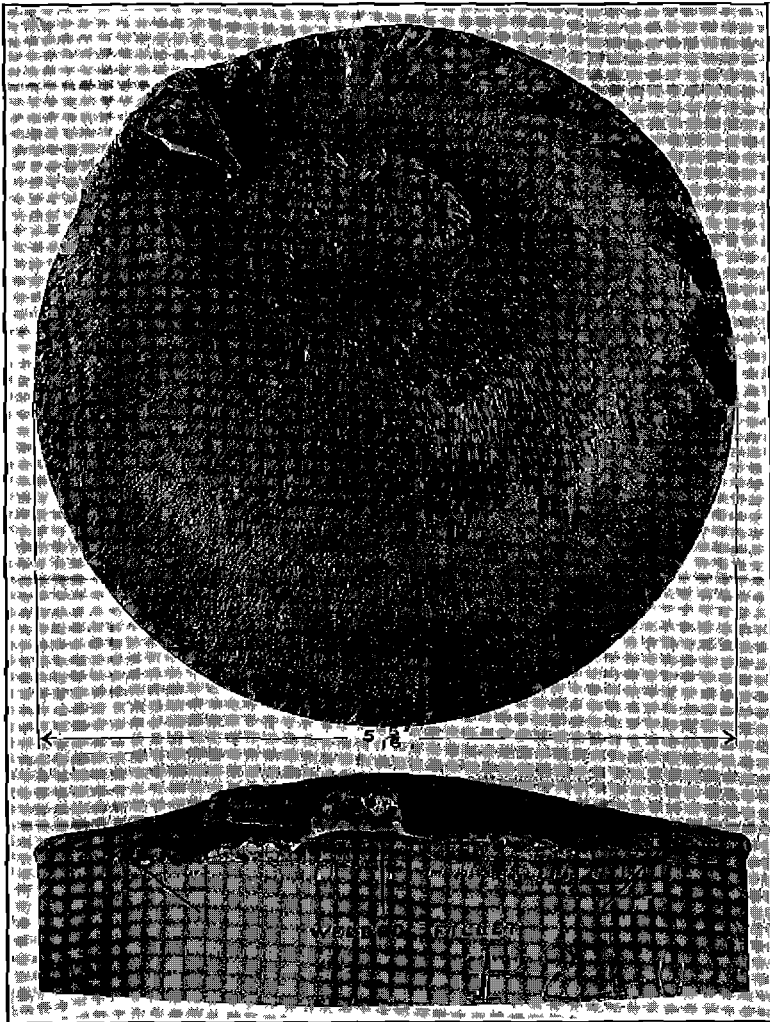
FIGURE 3—Appearance of fracture which caused accident (Referred to as photograph T-23495)

The back collars on the axle were turned very narrow, three eighths of an inch wide, and are badly rusted. No identification as to the manufacturer could be found on this account. The markings available are insufficient to identify the axle with any manufacturer. The fracture of the axle remaining in the wheel was badly burned, caused by friction subsequent to the accident. The original failure, as represented on photograph T-23495, showed a 90 per cent detail fracture evidently started from the entire periphery. The view below this fracture shows rough turning marks in the fillet portion. This condition of rough turning existed on both journals on this axle.

This accident was caused by the failure of a fusion-welded axle on the front truck of the forty-seventh car in extra 6944.

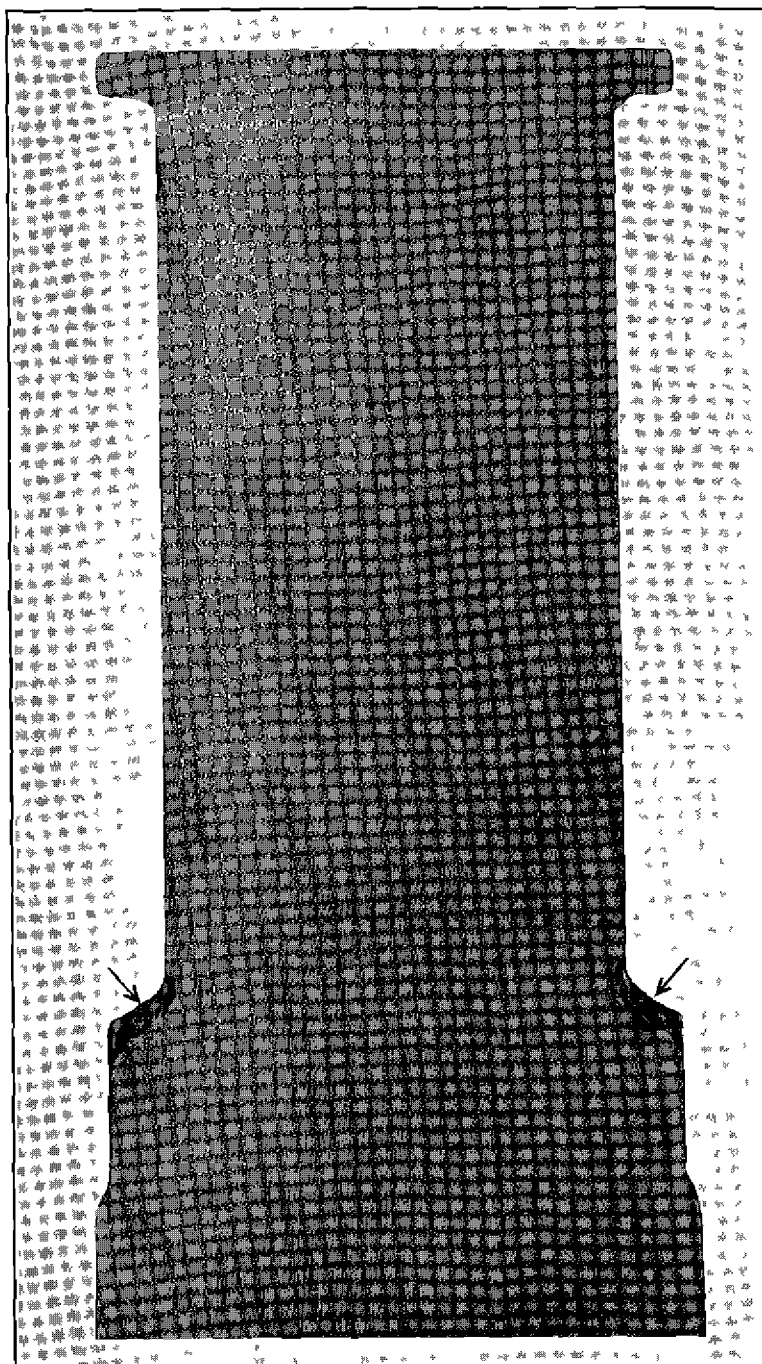
FIGURE 5—Longitudinal etching through journal at opposite end of broken axle
(Referred to as photograph T-23497)

Longitudinal etching through the entire length of the opposite journal including part of the wheel seat is shown on photograph T-23497. This side of the axle also shows that the fillet adjacent to the wheel seat had been built up by electric welding.
