## INTERSTATE COMMERCE COMMISSION

REPORT OF THE DIRECTOR OF THE BUREAU OF SAFETY CONCERNING AN  
ACCIDENT ON THE PENNSYLVANIA RAILROAD AT TYRONE, Pa.,  
ON DECEMBER 24, 1932.

February 11, 1933

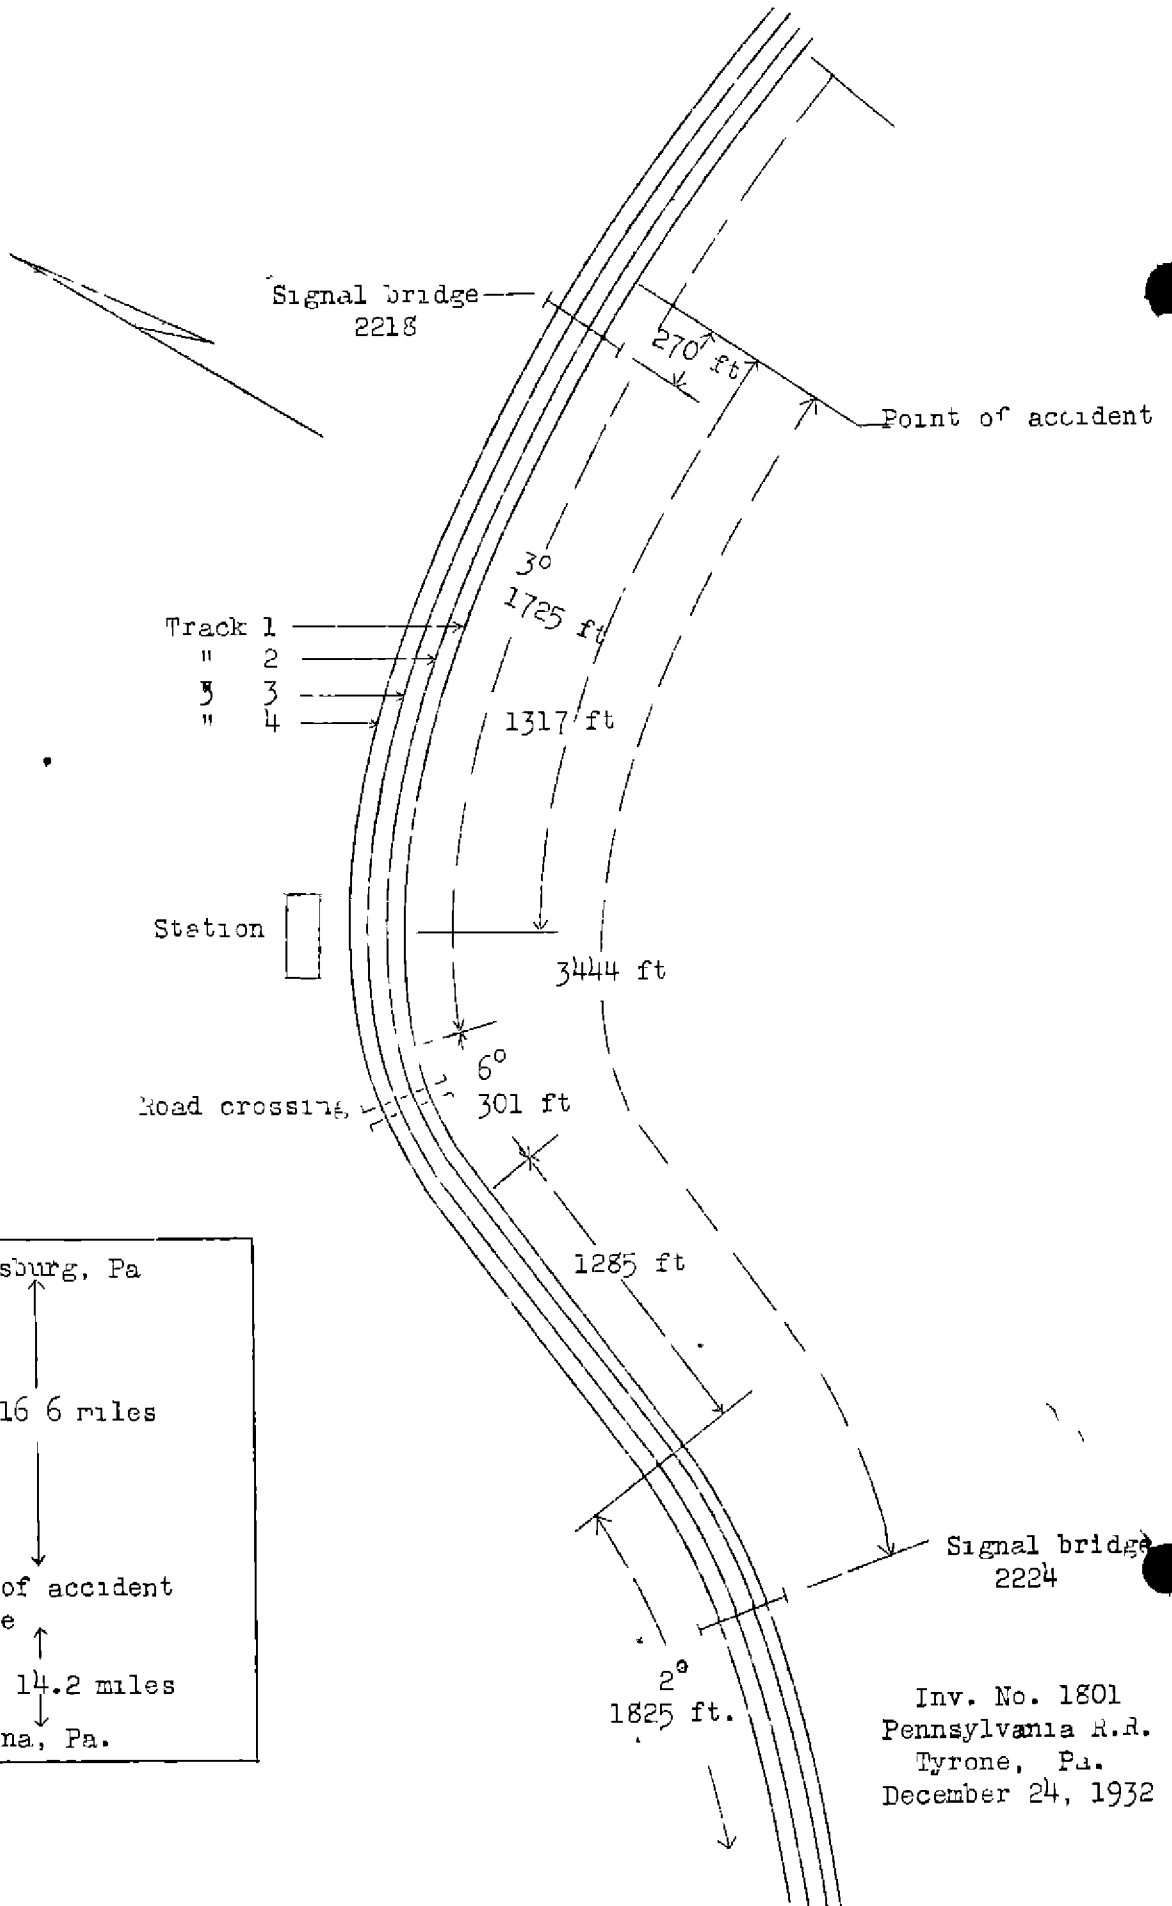
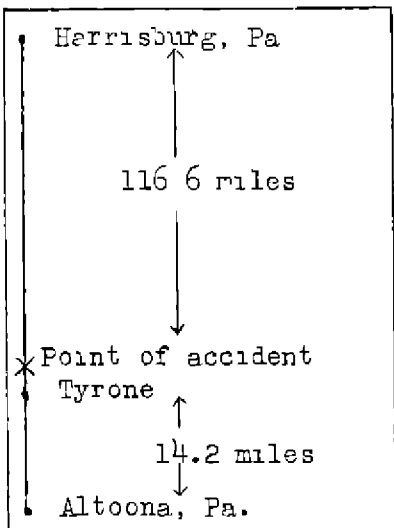
Inv. No. 1801  
 Pennsylvania R.R.  
 Tyrone, Pa.  
 December 24, 1932

The caboose and four rear cars in extra 6906 were derailed and badly damaged, the caboose being demolished. Engine 6919 stopped in line with track 1 in an upright position, partially derailed to the south, the front end of the engine was badly damaged. Excepting the thirty-third car in extra 6919, none of the remaining equipment in either train was derailed or damaged. The employee injured was the fireman of extra 6919.
