REPORT OF THE DIRECTOR

ACCIDENT ON THE

PENNSYLVANIA RAILROAD

INVESTIGATION NO. 2035

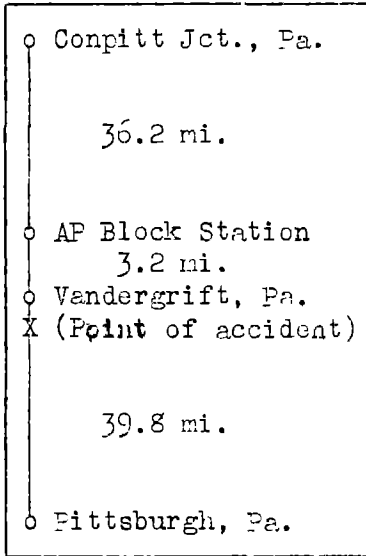
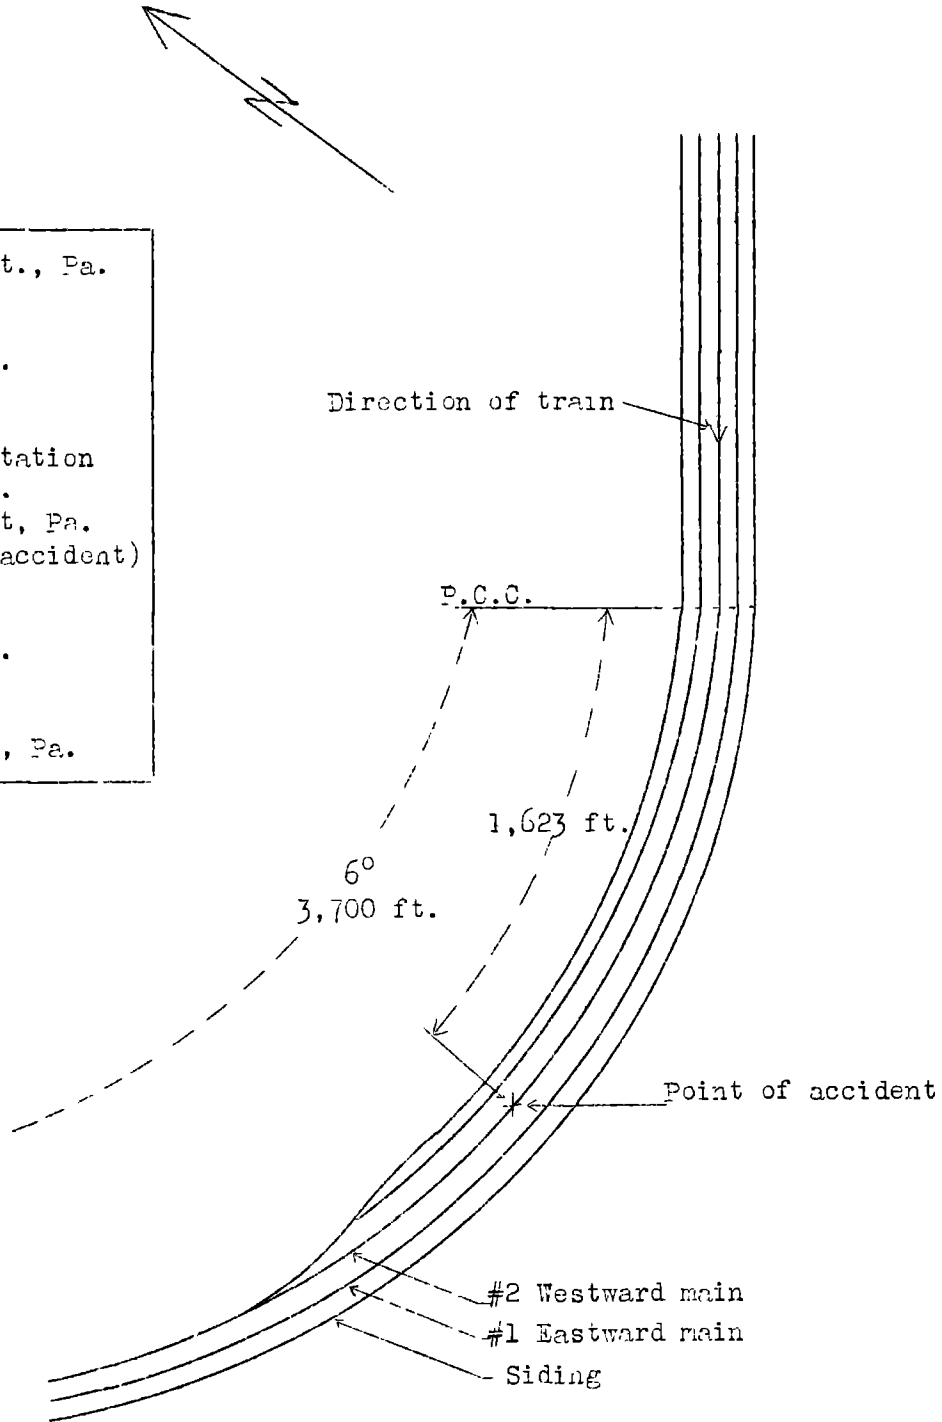
Inv. No. 2085
Pennsylvania Railroad
Vandergrift, Pa.
July 21, 1936

After the accident he saw several young people in the vicinity. He looked for evidence as to the cause of the accident and found that the engine truck wheels had run off the high rail of the curve and he noticed a small piece of iron lying right at the point of derailment which bore a bright mark, indicating that it had been run over. He left the iron in its original position, where it was afterwards found by Superintendent Sixsmith and party. It was the opinion of Assistant Train Master Dixon that this piece of iron caused the accident.

The investigation developed that a piece of strap iron, found on the ties on the outside of the high rail of the curve, measuring $8\frac{1}{2}$ " x $1\text{-}7/8$ " x $\frac{1}{2}$ ", had been placed on top of the rail by a 12-year old boy who was arrested and confessed to having placed the iron on the track.

This accident was caused by a piece of iron having been placed on the track by a 12-year old boy.
