INTERSTATE COMMERCE COMMISSION

REPORT OF THE DIRECTOR OF THE BUREAU OF SAFETY CONCERNING AN
ACCIDENT ON THE PENNSYLVANIA RAILROAD NEAR WASHINGTON,
D. C., ON AUGUST 24, 1933.

November 8, 1933.

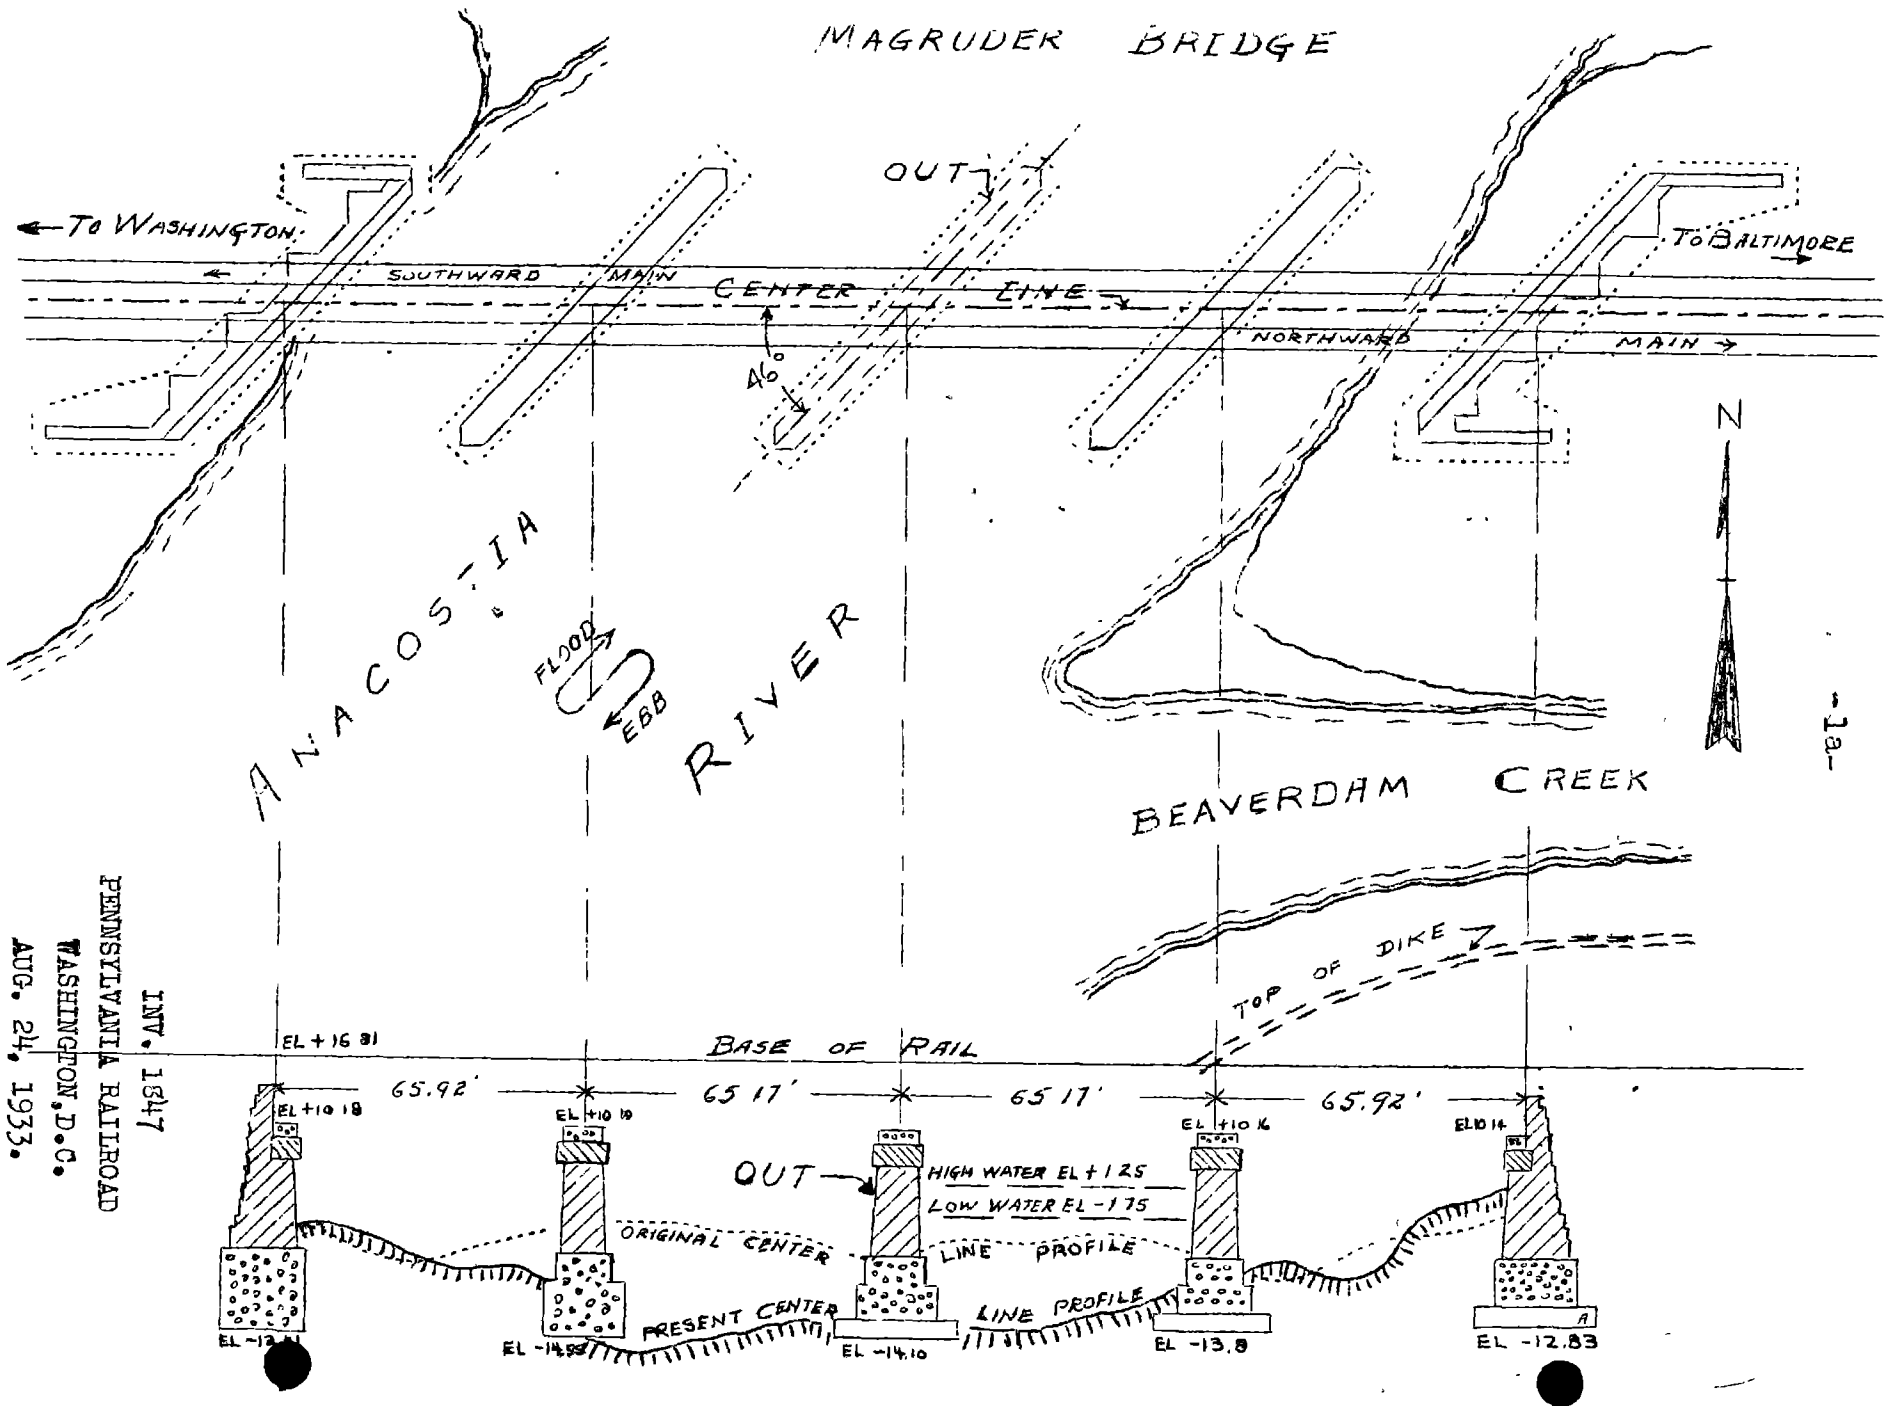
MAGRUDER BRIDGE

Observations of conditions at the bridge a few hours after the occurrence of the accident showed that the center pier had been broken in two about midway its length and that the downstream half, which the conductor said was in place for about an hour after the accident, had entirely disappeared while the upstream half was tipped downward at its upstream end with the result that that end had disappeared from view while the opposite end was still visible, although settled considerably, and it was still supporting the girders under the south-bound track; these girders were sagging where they rested on this settled section of the pier and also had moved sidewise toward the upstream side of the bridge. The two girder spans which had been under the north-bound track on either side of the center pier were in the water, the most northerly of these two spans having entirely disappeared from view while the other was supported at its southern end by the south pier, with the north end in the water, downstream from the bridge location at an angle of about 45°. The south pier had broken off on the upstream end just outside of the bridge seat, the broken-off portion tipping toward the upstream side and also northward toward the middle of the stream. The north pier was in place as well as both abutments and the end spans, although considerable damage had been done to the south abutment by derailed equipment. C. E. Heineman, a diver, made an examination of that portion of the south pier which remained in place and it was found that the bottom of this pier, which was 9 feet in width, was undermined on its north side to within 20 feet of its downstream end. This undermining became progressively deeper toward the upstream end, reaching a maximum of 3 feet 6 inches at the point where the pier had fractured and extending in under the pier for a distance of 6 feet at the fractured end.

This accident was caused by the undermining of the center pier of bridge 2.95.

mean low water or sufficiently to undermine the center pier to a depth of at least 3 feet. Investigation by a diver developed the fact that the south pier also had been partly undermined. It was apparent that the settlement of the center pier under the train precipitated the derailment.

Inspections and soundings to discover evidence of undermining should be made immediately after the occurrence of flood conditions, before the waters have had a chance to fill in the scouring which may have been created; there had been previous heavy rains in the territory drained by this river which might well have resulted in scourings, and careful inspection and the taking of soundings immediately following such flood conditions might have developed a necessity for action which would have prevented the occurrence of this accident and it is recommended that such inspections and soundings be made in the future, for without them it will be difficult if not impossible to detect the existence of scour or the tendency of a stream to shift its channel and create conditions which may lead to a dangerous situation. The American Railway Engineering Association rules for the inspection of bridges, trestles and culverts provide in part as follows:
