REPORT OF THE DIRECTOR

ACCIDENT ON THE

PENNSYLVANIA RAILROAD

INVESTIGATION NO. 2164

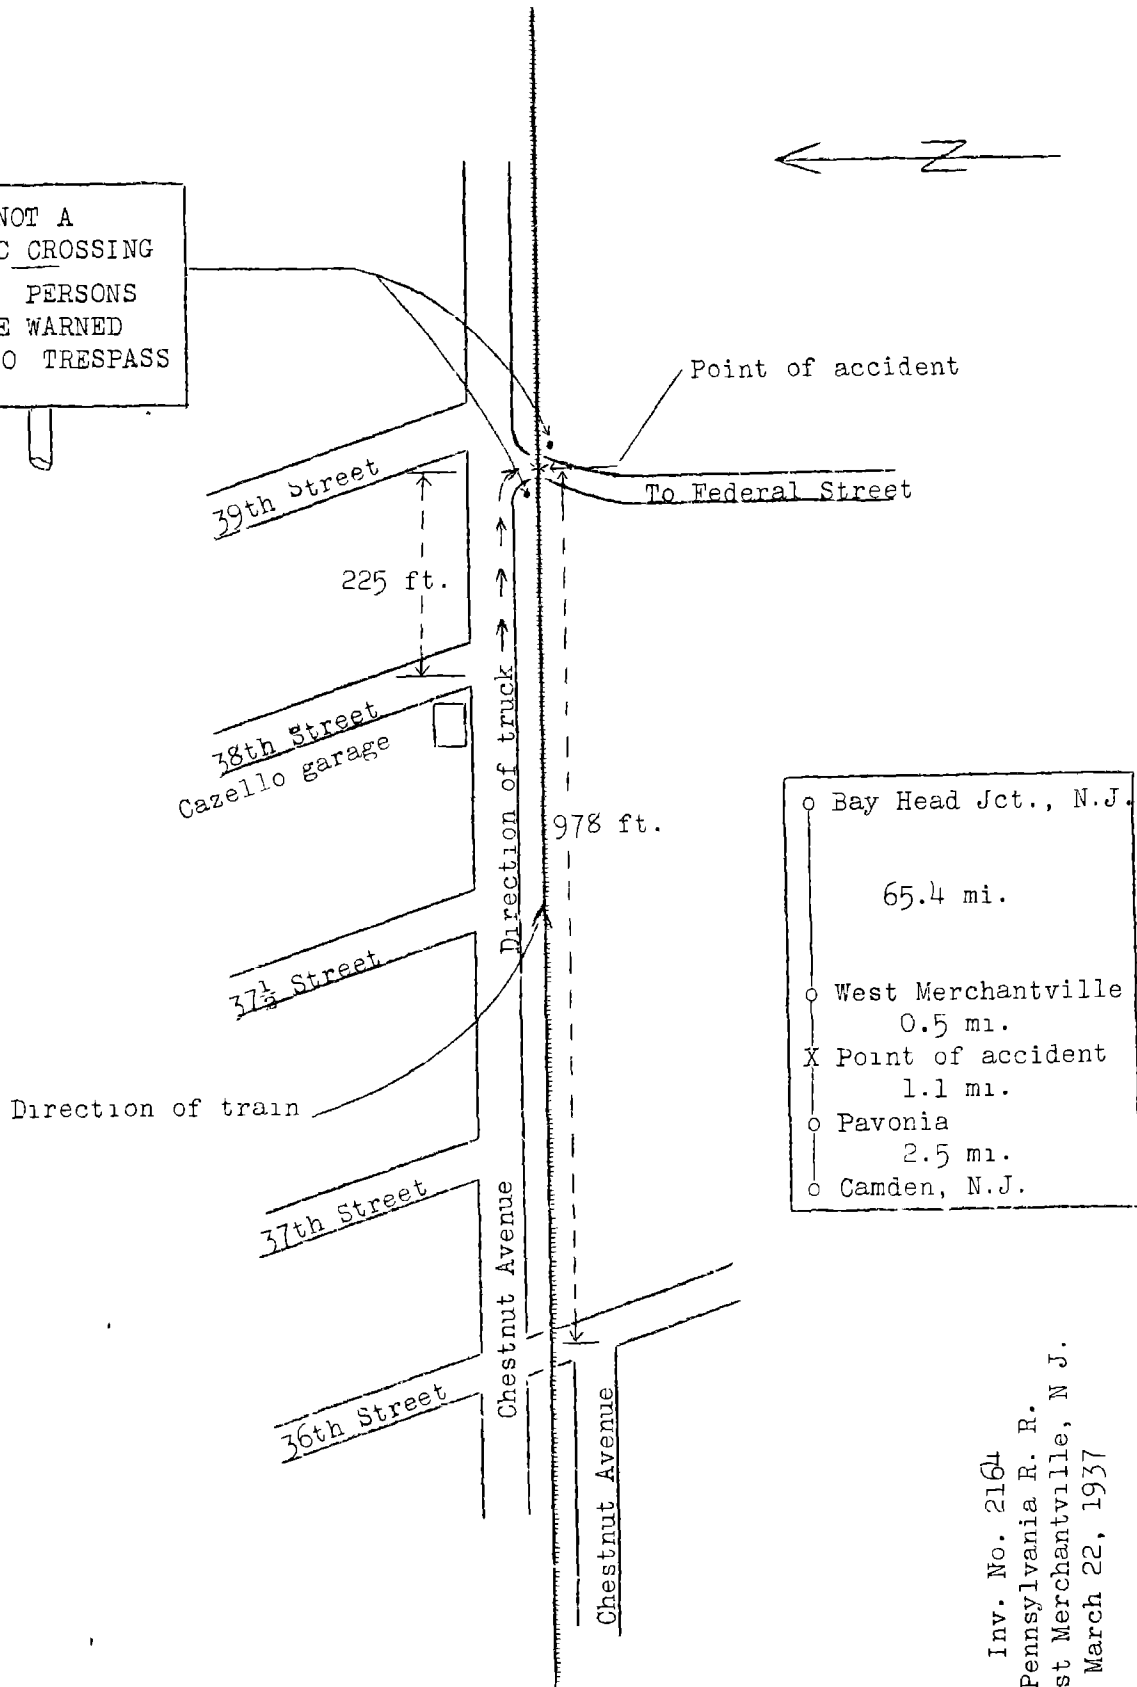
Inv. No. 2164  
Pennsylvania R. R.  
West Merchantville, N. J.  
March 22, 1937

From 36th to 40th Street, Chestnut Avenue runs parallel to the track with its south edge 25 feet north of the north rail, and none of these intersecting streets, except 36th Street, extends to the railroad. The private crossing involved is located 50 feet west of the end of 39th Street, and provides entry to an unimproved dirt road leading to the South. The crossing, which is 12 feet in width, is constructed of macadam and dirt, and is level with the rails, but there is a slight ascent to the track level from either side. There was a warning sign on each side of the crossing, bearing the words, "NOT A PUBLIC CROSSING. ALL PERSONS ARE WARNED NOT TO TRESPASS." The view of the track from Chestnut Avenue is unobstructed and a clear view of an approaching east-bound train could be had by the driver of a motor vehicle for a distance of 2,152 feet, when at the private crossing and 15 feet from the track.

Track Supervisor Walker stated that negotiations are underway to convert this private crossing into a public highway and although the change has not been authorized a construction company has started to widen the crossing. In the course of this work and without the knowledge or sanction of the railroad company, the warning sign on the north side of the track had been removed and after the accident was found lying east of the crossing. Warning signs are placed at the crossing and maintained by the railroad company, and this warning sign was in its proper position, 15 feet west of the

center line of the crossing and 15 feet north of the north rail, when a check was made by the engineering department about two weeks prior to the occurrence of the accident. During the construction work a saw horse plank barrier bearing the words "STREET CLOSED" has been used to prevent entry to the crossing but this sign was standing at right angles to the track and west of the crossing at the time of the accident. He was on the train at the time of the accident and heard the whistle sounded at 36th Street.
