INTERSTATE COMMERCE COMMISSION

REPORT OF THE DIRECTOR OF THE BUREAU OF SAFETY IN RE
INVESTIGATION OF AN ACCIDENT WHICH OCCURRED ON
THE PENNSYLVANIA RAILROAD NEAR WILKES-BARRE, PA ,
ON JANUARY 28, 1932.

INV. NO. 1748
 PENNSYLVANIA R. R.
 WILKES-BARRE, PA.
 JAN. 28, 1932.

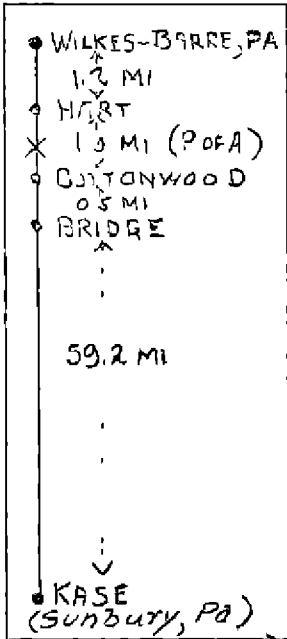
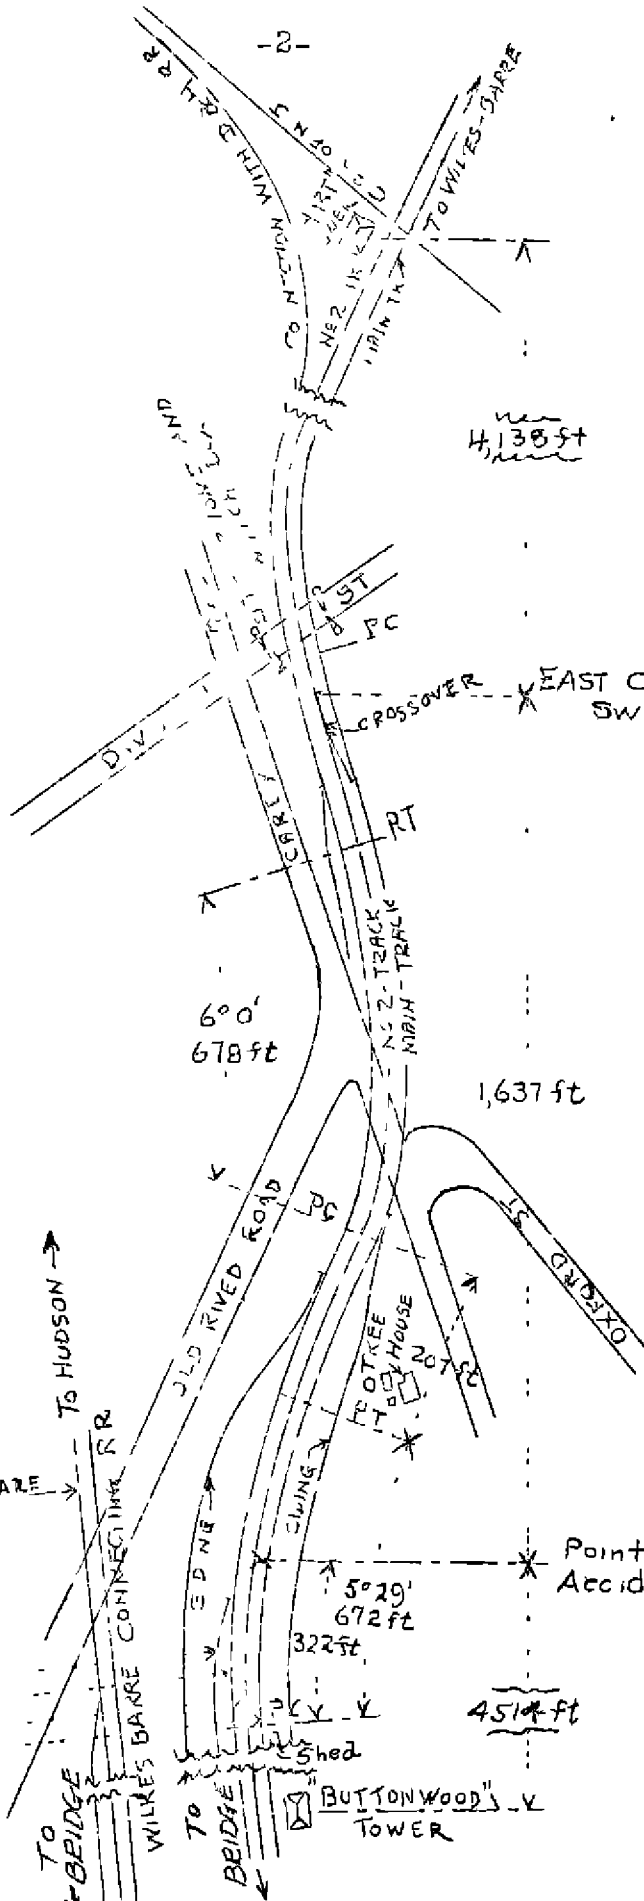
The view is obscured by buildings and sheds located south of the main track and on each end of the curve on which the accident occurred, and an embankment on the inside of the curve which varies in height from 3 feet to $6\frac{1}{2}$ feet above the rails. At the time of the accident a freight train was standing on yard track 2, with its rear end about 10 car-lengths west of the point of accident.
