REPORT NO. 3691  
THE PENNSYLVANIA RAILROAD COMPANY  
IN RE ACCIDENT  
AT ATWATER, OHIO, ON  
MAY 28, 1956

Accident at Atwater, Ohio, on May 28, 1956, caused by failure to stop a motor-truck short of a train moving over a rail-highway grade crossing.

Report No. 3691  
 Pennsylvania Railroad  
 Atwater, Ohio  
 May 28, 1956

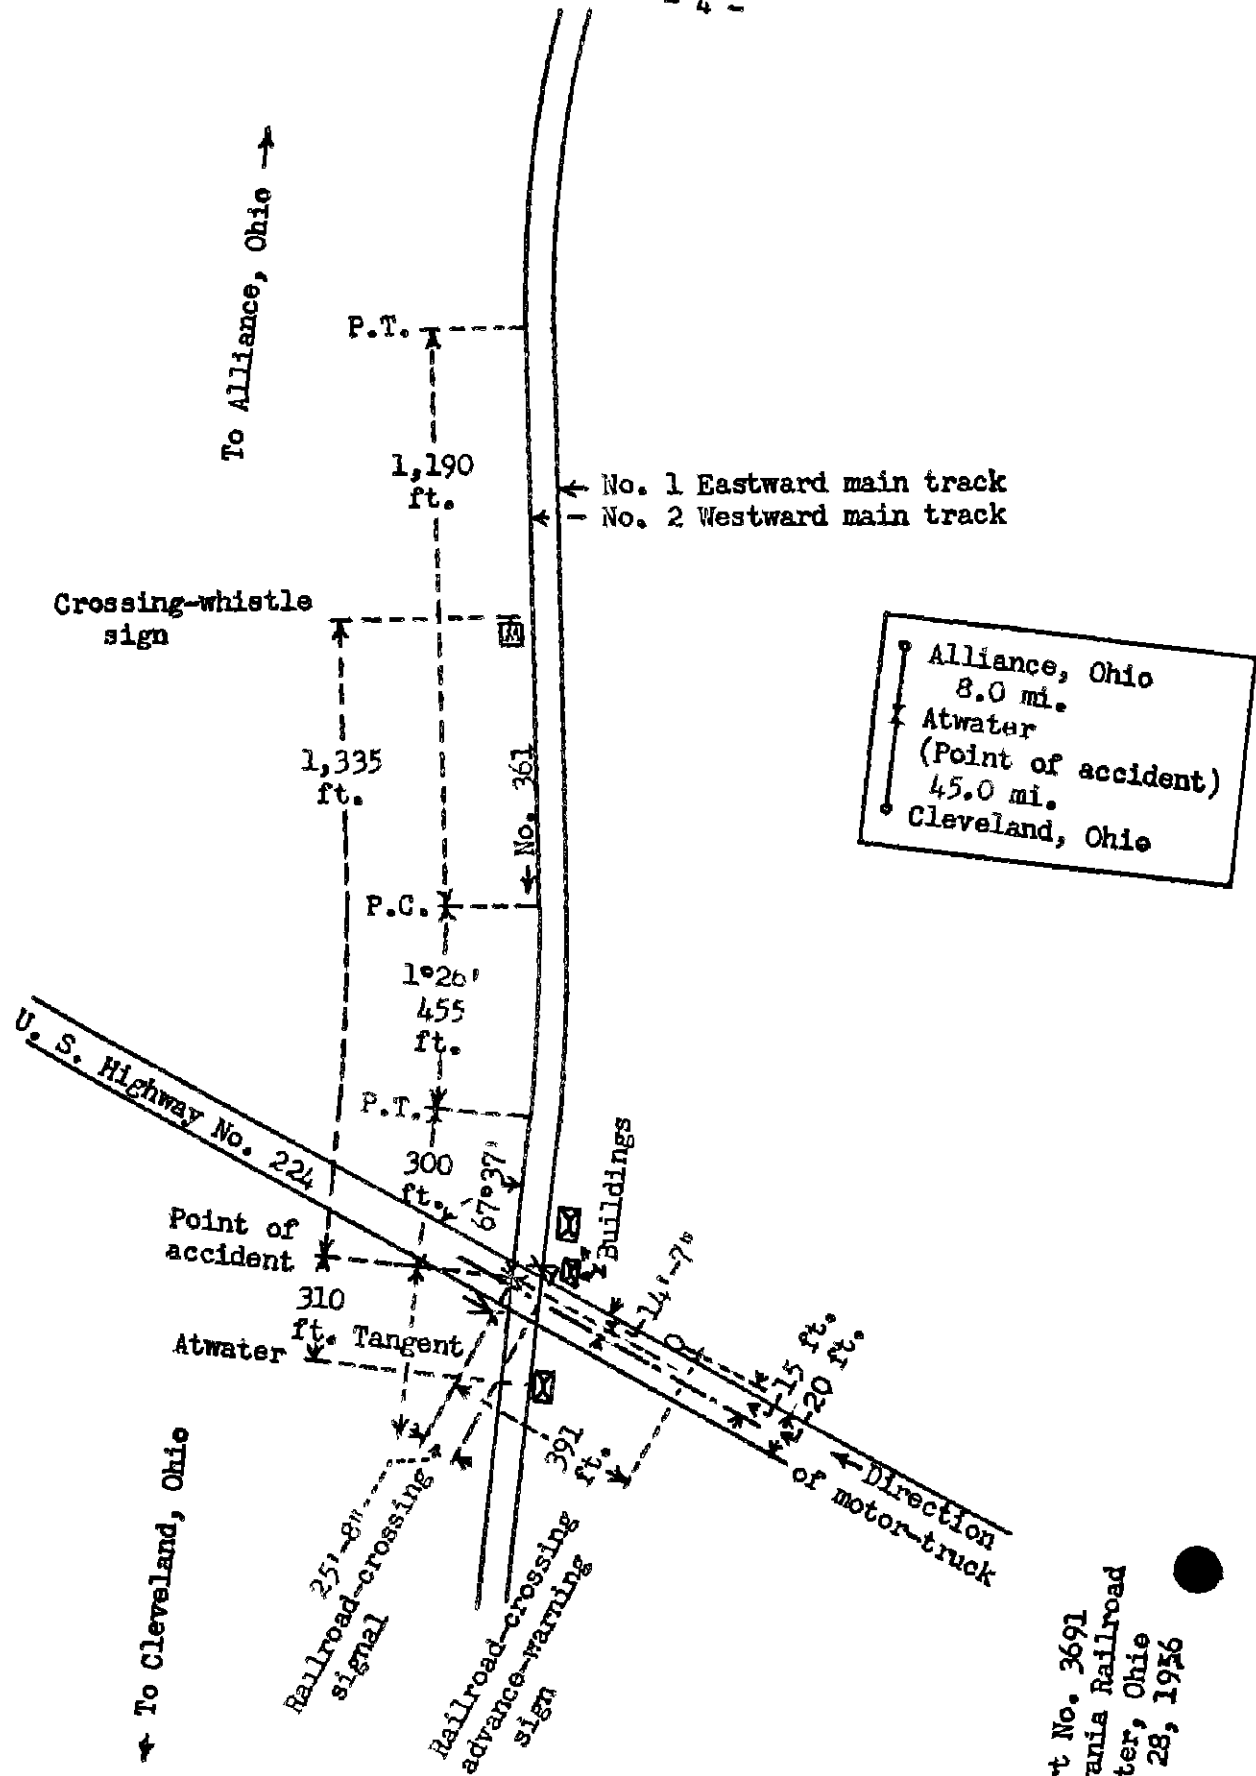
Alliance, Ohio  
 8.0 mi.  
 Atwater  
 (Point of accident)  
 45.0 mi.  
 Cleveland, Ohio
