REPORT NO. 3555
THE PENNSYLVANIA RAILROAD COMPANY
IN RE ACCIDENT
AT BROADWAY STATION,
CAMDEN, N. J., ON
JANUARY 15, 1954

Accident at Broadway Station, Camden, N. J., on January
15, 1954, caused by failure to operate the following
train in accordance with a signal indication.

Report No. 3555
The Pennsylvania Railroad
Broadway Station, Carden, N.J.
January 15, 1954

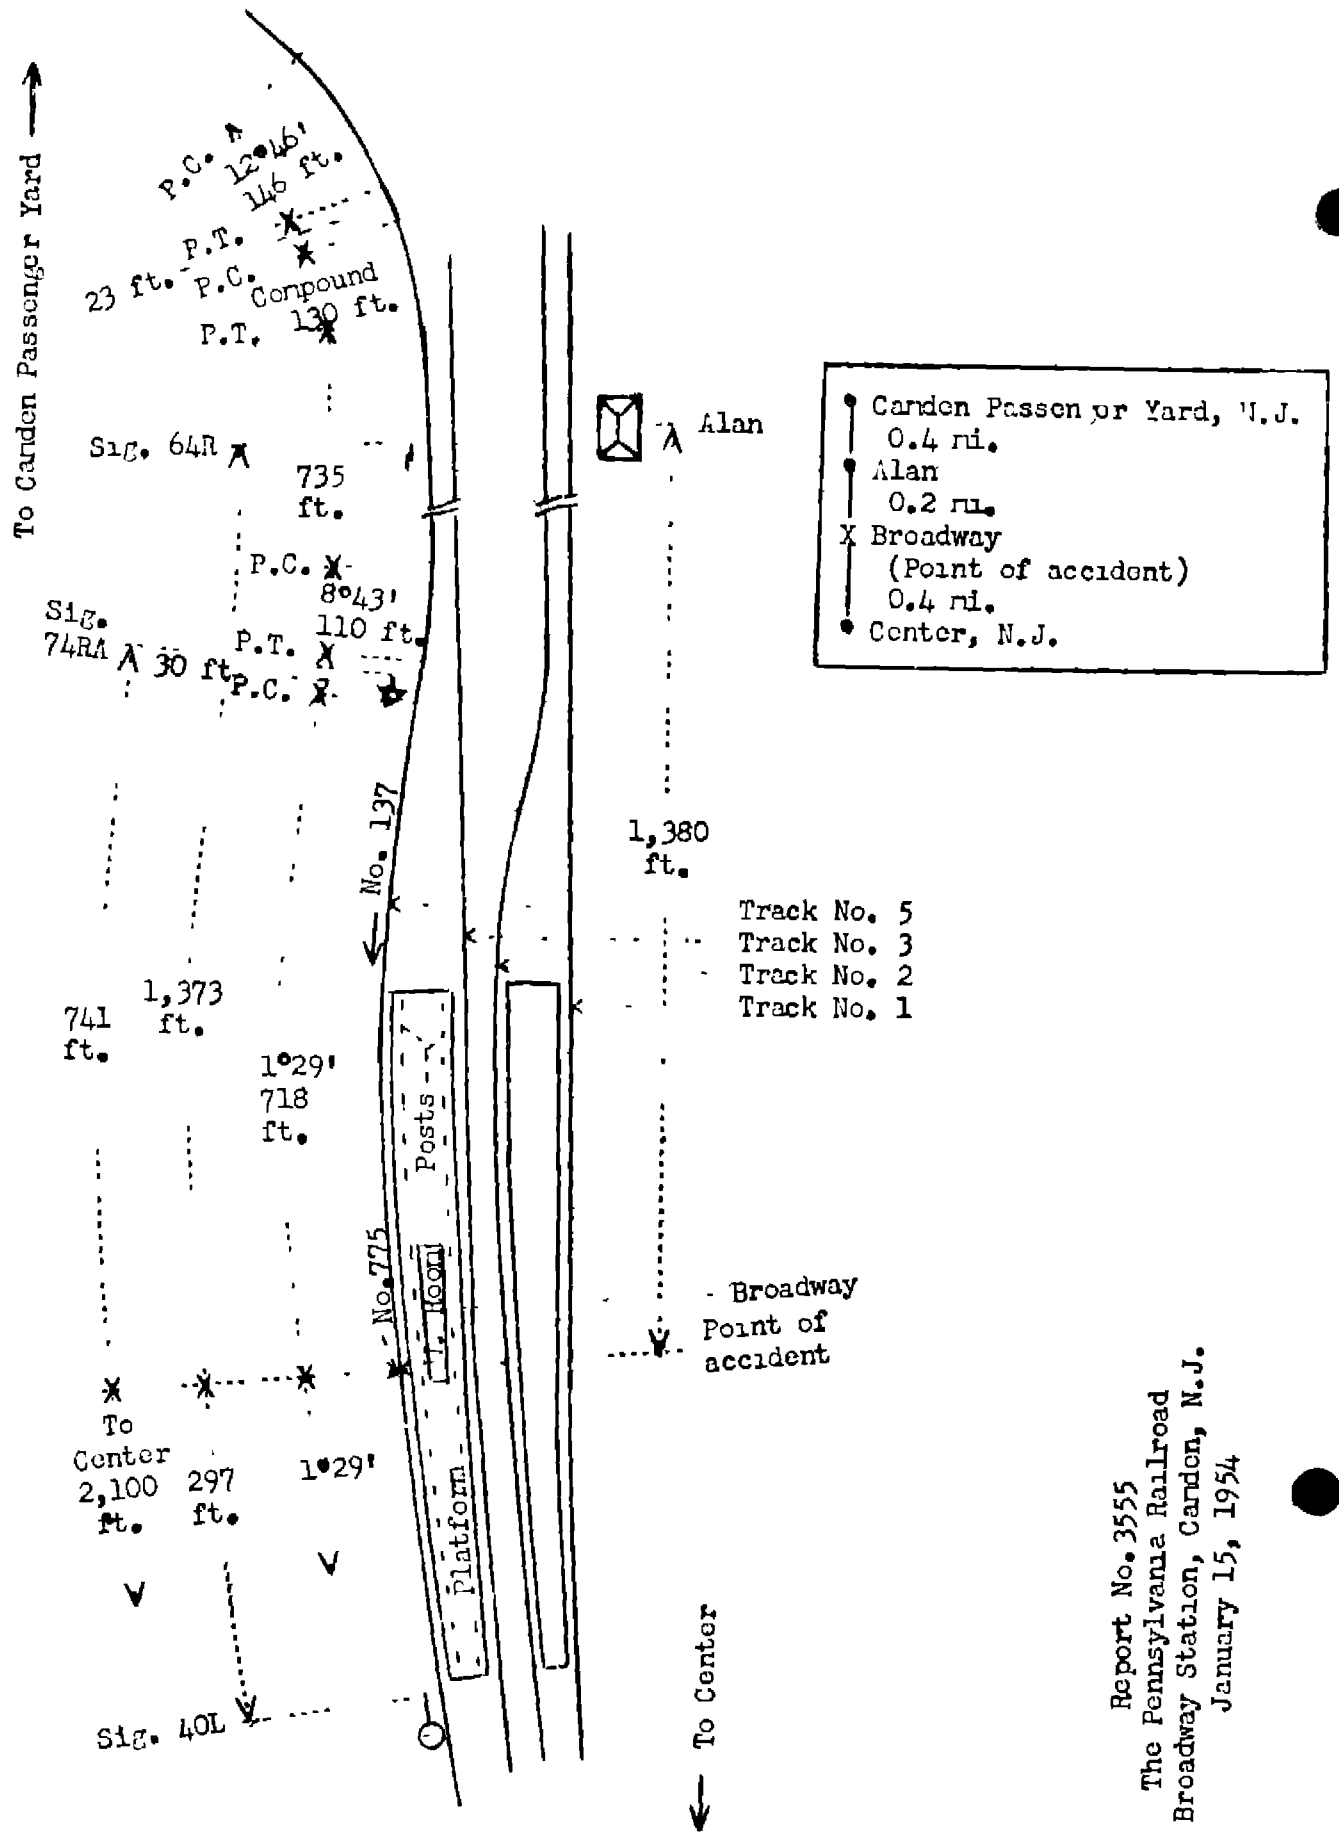
This accident occurred on that part of the Atlantic Division extending between Camden Passenger Yard and Center Interlocking Station, Camden, N. J., 1 mile. Trains of the Pennsylvania-Reading Seashore Lines are regularly operated over this portion of the Pennsylvania Railroad. In the vicinity of the point of accident this is a four-track line, over which trains are operated by signal indications. From east to west the main tracks are designated as No. 1, northward passenger, No. 2, northward passenger, No. 3, southward passenger, and No. 5, northward and southward passenger. At Broadway Station, approximately 3,200 feet south of Camden Passenger Yard, platforms for passenger traffic are located between tracks Nos. 1 and 2 and between tracks Nos. 3 and 5. A roof is provided on each platform. Reflector type electric lights are mounted on the under side of each roof. The platform adjacent to track No. 5 is approximately 720 feet in length. An enclosed waiting room for passengers is provided. The north end of this enclosure is about 265 feet south of the north end of the platform. The accident occurred on track No. 5 at a point approximately 400 feet south of the north end of the Broadway Station platform. From the north on track No. 5 there are in succession, a 12'46" curve to the right 165 feet in length, a tangent 23 feet, a compound curve to the right, having a maximum curvature of 11°28', 130 feet, a tangent 735 feet, an 8°43' curve to the right 110 feet, a tangent 30 feet, and a 1°29' curve to the left 718 feet to the point of accident and several hundred feet southward. The grade is 0.74 percent ascending southward at the point of accident.

Semi-automatic signals 64P, 74Ra, and 40L governing south-bound movements on track No. 5, are located, respectively, 1,323 feet north, 741 feet north, and 297 feet south of the point of accident. Signals 64R and 74Ra are of the dwarf position-light type and each displays four aspects. They are continuously lighted. Aspects applicable to this investigation and the corresponding indications and names are as follows:
