**RAILROAD ACCIDENT INVESTIGATION**

**Report No 3850**

THE PENNSYLVANIA RAILROAD COMPANY

DILLE, OHIO

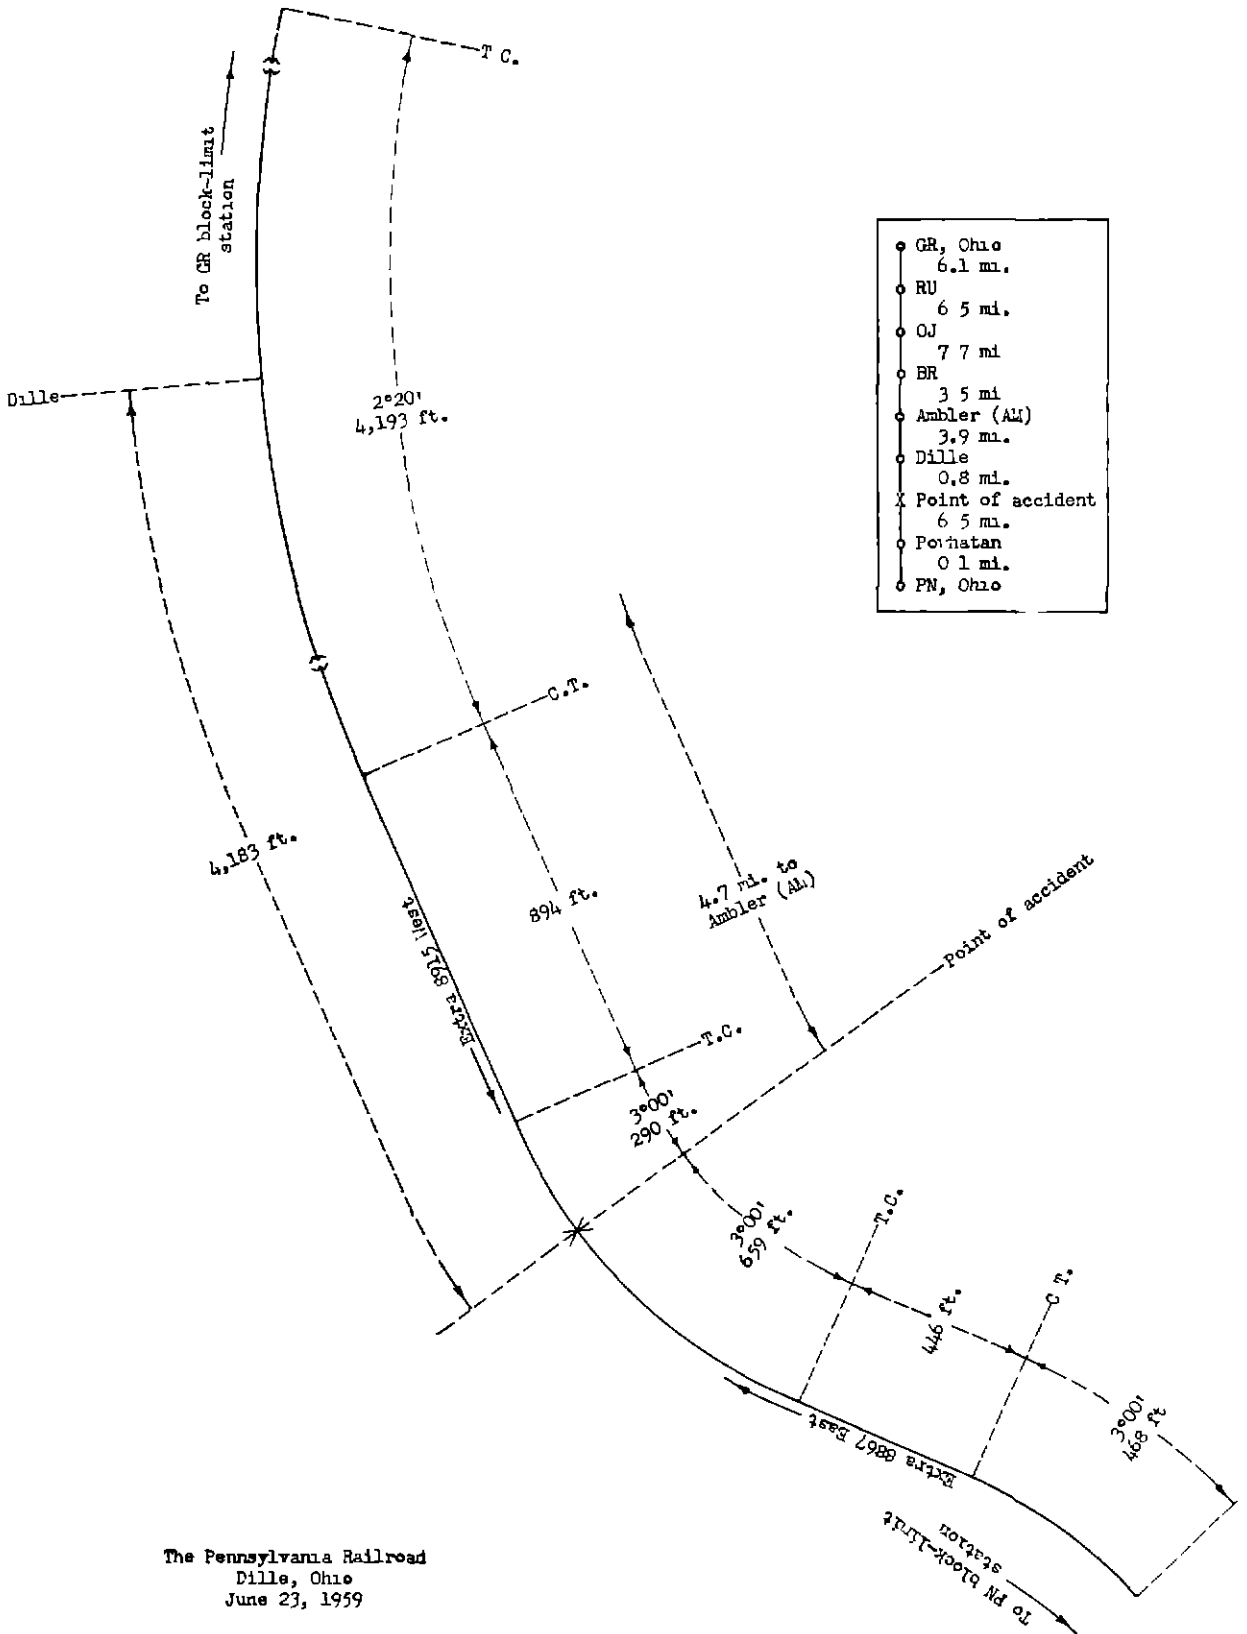
The Pennsylvania Railroad  
 Dille, Ohio  
 June 23, 1959

The locomotive and the 1st car of Extra 8915 West, and the locomotive, the caboose, the 1st car and the 2nd car of Extra 8867 East were derailed. The derailed equipment of both trains stopped in positions as shown in PLATE I. The diesel-electric units of both trains were considerably damaged. The caboose of Extra 8867 East was destroyed, and the 1st car was considerably damaged.
