REPORT NO. 3591
THE PENNSYLVANIA RAILROAD COMPANY
IN RE ACCIDENT
AT EBENSBURG JCT., PA., ON
AUGUST 6, 1954

Accident at Ebensburg Jct., Pa., on August 6, 1954, caused by unauthorized use by the track motor-car of the track involved, and by failure properly to control the speed of a train in accordance with rules for movement on a secondary track.

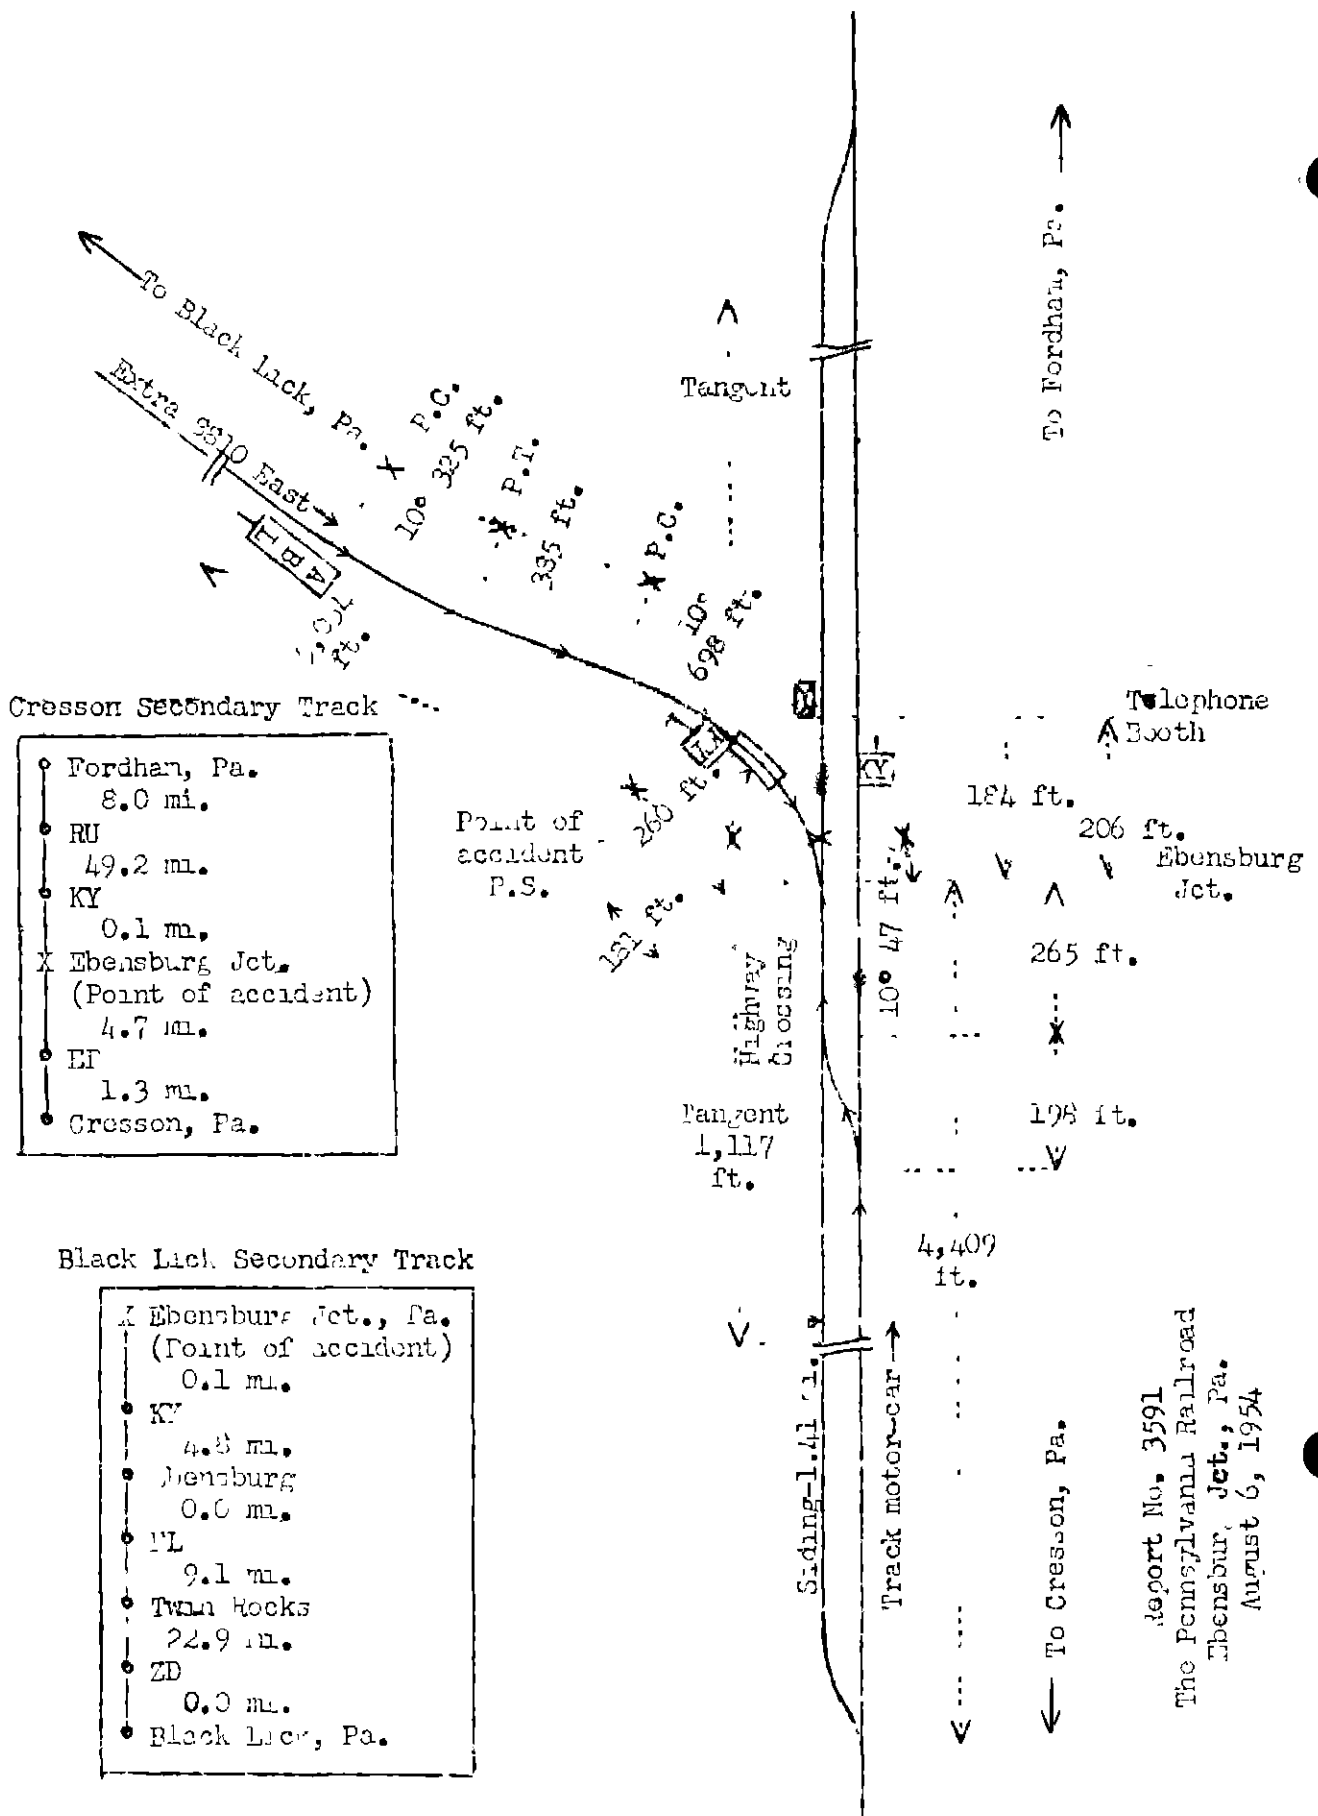
Report No. 3591
The Pennsylvania Railroad
Ebensburg Jct., Pa.
August 6, 1954

This accident occurred on that part of the Pittsburgh Division designated as the Cresson secondary track, which extends between Cresson and Fordham, Pa., 63.3 miles. In the vicinity of the point of accident this is a single-track line, over which trains are operated by operating rules and a manual-block system. At Ebensburg Jct., 6.0 miles north of Cresson, a siding 1.41 miles in length parallels the main track on the west. A spring switch, normally lined for movements on the Cresson line, is located at the south end of the siding. At a junction switch located in the siding, 4,409 feet north of the south siding-switch, a line converges from the west. This line is designated as the Black Lick secondary track and extends between Black Lick, Pa., and Ebensburg Jct., 36.9 miles. It is a single-track line, over which trains are operated by operating rules and a manual-block system. Timetable directions on the Cresson line are north and south, and on the Black Lick line are east and west. A crossover 198 feet in length, which is facing-point for north-bound movements on the Cresson line, connects the Cresson secondary track and the siding at Ebensburg Jct. The north switch of this crossover is located in the siding at a point 265 feet south of the switch at the junction with the Black Lick line. The junction switch is facing-point for north-bound movements on the siding. In normal position it is lined for movements to or from the Black Lick line. The accident occurred 47 feet north of the point-of-switch at the junction. The track of the Cresson line and the siding are tangent throughout a distance of 1,117 feet immediately south of the point of accident and a considerable distance northward. From the west on the Black Lick line there are, in succession, a 10° curve to the left 325 feet, a tangent 385 feet, and a 10° curve to the right 698 feet to the point of accident and 47 feet eastward. The grade is approximately 0.70 percent descending northward at the point of accident.

Track Car Extra 4816 North, a north-bound track motor-car, occupied by a track foreman and two trackmen, departed from EP block station, the last open office, at 11 38 a. m. The block signal at EP indicated Proceed for this movement. The track motor-car proceeded to Ebensburg Jct., entered the siding at the crossover immediately south of the junction with the Black Lick line, then moved northward on the siding and stopped 47 feet north of the point of the junction switch. A few seconds later it was struck by Extra 8810 East.

Extra 8810 East, an east-bound freight train, consisted of Diesel-electric units 8810 and 8812, coupled in multiple-unit control, 20 cars, and a caboose. This train departed from Twin Rocks, on the Black Lick line, 14 miles west of the point of accident, at 11 16 a. m., according to the block record maintained at EP, proceeded eastward with clear-block authority through intervening blocks to KY block-limit station, passed the block-limit station at KY, and while moving at an estimated speed of 10 miles per hour it struck Track Car Extra 4816 North.

The track motor-car was moved southward on the siding a distance of approximately 200 feet to the point at which the front end of Extra 8810 East stopped. It was destroyed. The front end of the locomotive of Extra 8810 East was slightly damaged.

Because of the conditions disclosed by this investigation, the carrier should promptly take necessary steps to clarify the rules and instructions governing operation in this territory.
