RAILROAD ACCIDENT INVESTIGATION

Report No 3846

THE PENNSYLVANIA RAILROAD COMPANY

FRAZER, PA

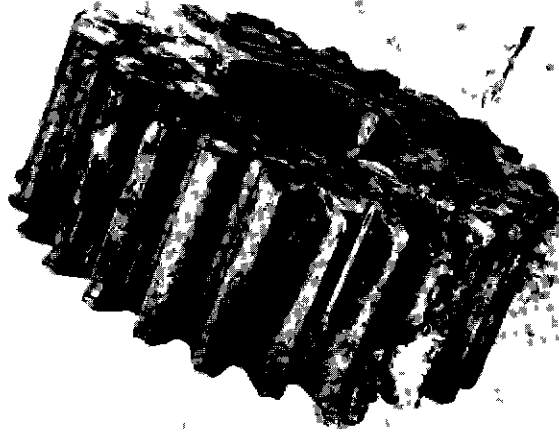
PLATE 1

No 3 Traction motor pinion, electric unit 4774

The No. 4 traction motor pinion was loosened to the extent that it could be removed from the armature shaft by hand. There was no other evidence of damage to the No. 4 traction motor.

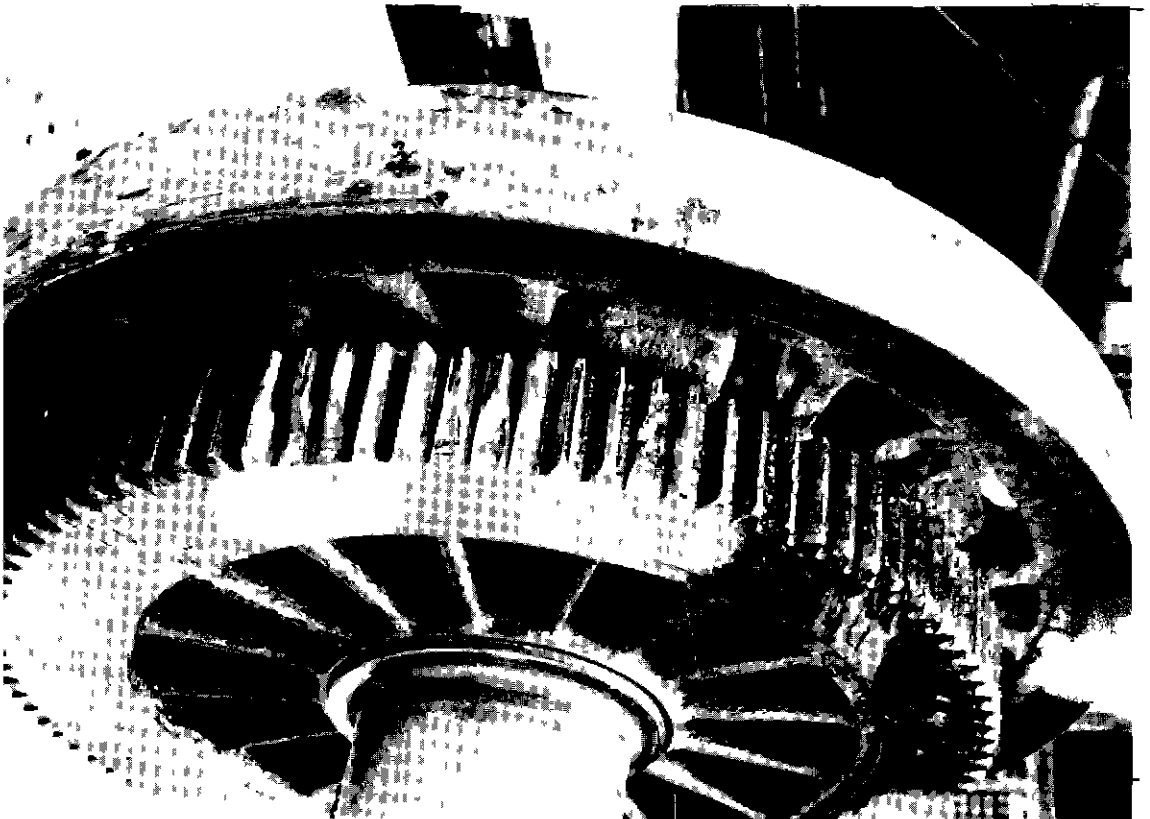
PLATE 2

No 2 Driving wheel ring gear, electric unit 4774

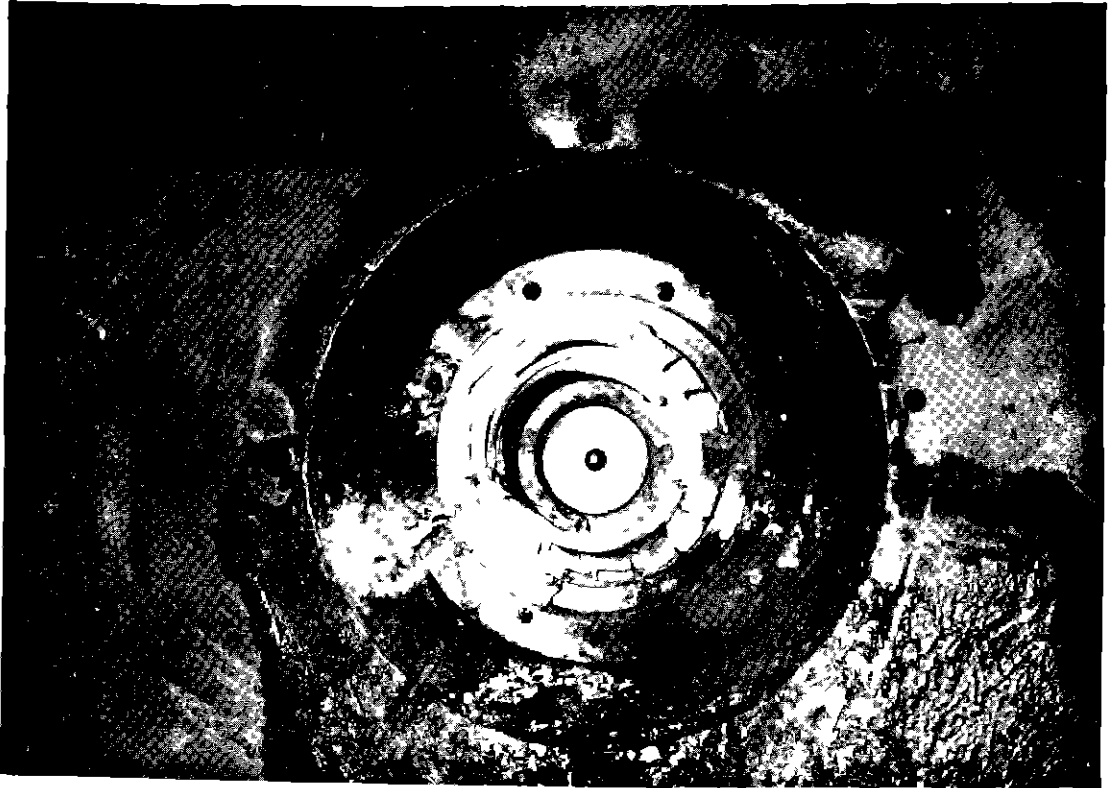
PLATE 3

Pinion end of No. 3 traction motor, electric unit 4774

Inspection of the No 3 traction motor after it was removed from electric unit 4774 disclosed that the armature shaft had seized as a result of the failure of the pinion end bearing. Both the pinion end and the commutator end armature shaft bearings had failed, and the armature and field coils were damaged as a result of the armature striking the stator. The pinion was extensively worn, indicating that it had been rotating under an abnormal load for a considerable distance before the armature shaft seized, and the ring gear had a total of seven broken teeth at four locations. The commutator and brushes were intact, indicating that much of the damage occurred after electric power was removed from the motor.

Examination of the armature shaft bearings disclosed that the pinion end bearing was damaged to the extent that the cause of its failure could not be determined. It was evident from the appearance of the bearing, however, that it had lubricant prior to the failure and that the lubricant had been burned by the intense heat which destroyed the bearing. The commutator end bearing was considerably damaged and it was evident that this damage was caused by armature shaft misalignment, resulting from the pinion end bearing failure.

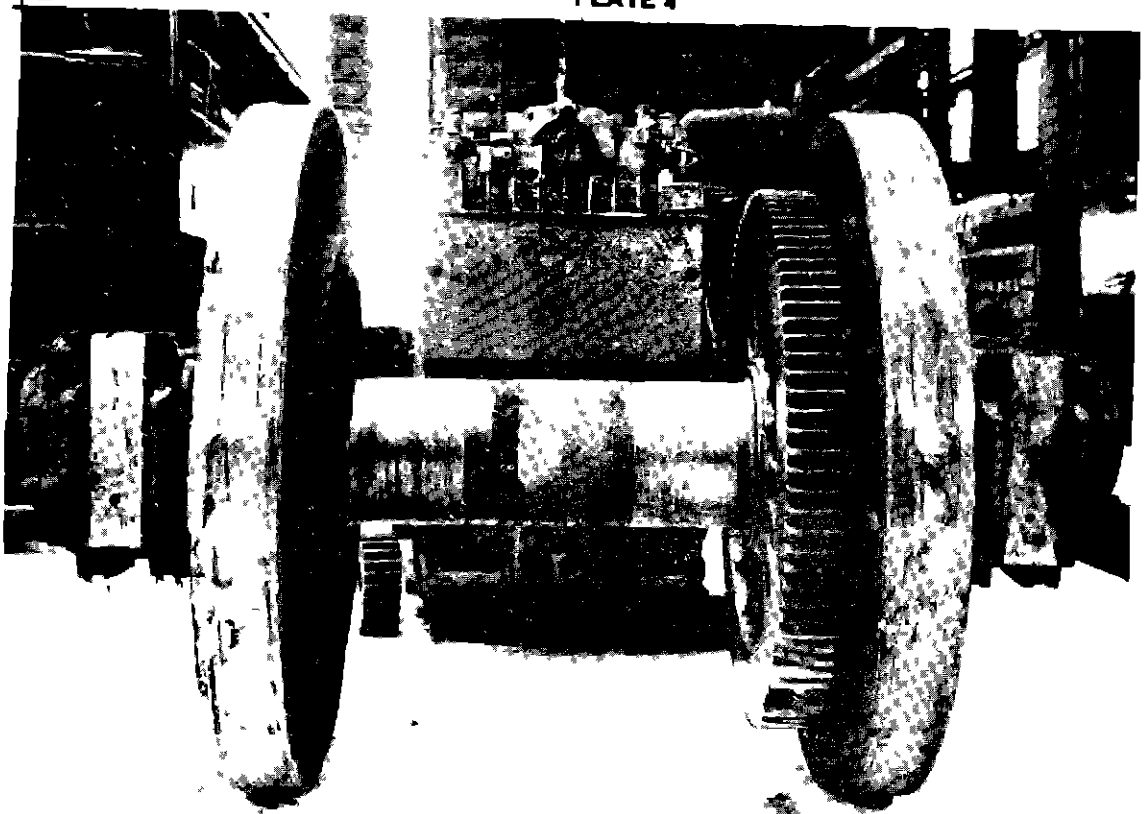
PLATE 4

No. 2 Driving wheels electric unit 4774

As a result of the No. 3 traction-motor armature shaft seizure, the tires of the No. 2 driving wheels were extensively damaged by sliding contact with the rails. There was a flat spot on the right tire 11 3/4 inches long, 3 3/4 inches wide, and 5/8 inch deep. At the same relative location on the left tire, there was a flat spot 11 inches long, 3 1/2 inches wide, and 5/8 inch deep. In addition, each tire had a flat spot 4 inches long, 3 inches wide, and 1/16 inch deep, and several smaller flat spots of various dimensions.
