RAILROAD ACCIDENT INVESTIGATION

Report No 4002

THE PENNSYLVANIA RAILROAD COMPANY

JULY 24, 1963

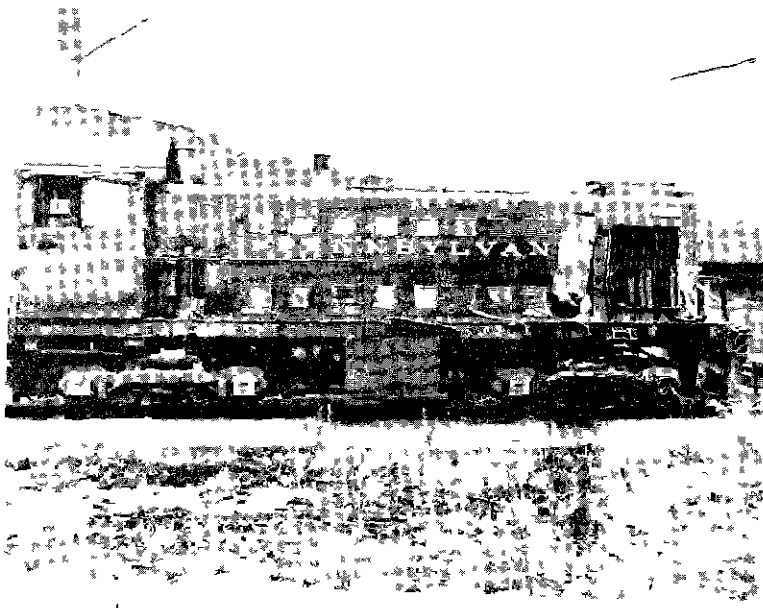
Locomotive 9240 with damaged front end showing at right

Locomotive 9240 with the cut to which it was coupled was moved six feet westward by the impact. None of this equipment was derailed. None of the members of the crew was injured. Both enginemen were looking westward at the time of the collision and were unaware of anything wrong until the collision occurred.

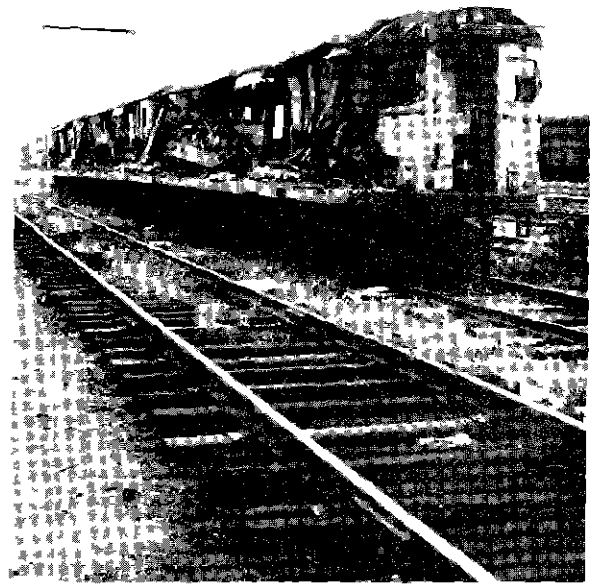
Damage to first three cars of No. 3319

No. 3319 stopped on track No. 4 with the front end 148 feet west of the point of accident. There were no separations. The rear wheels of the front truck of the first unit were derailed. The north side of the superstructure of the first three units was torn out as a result of contact with the right side of the front end of locomotive 9240. Two passengers were killed. The conductor, a ticket collector, and 25 passengers were injured.

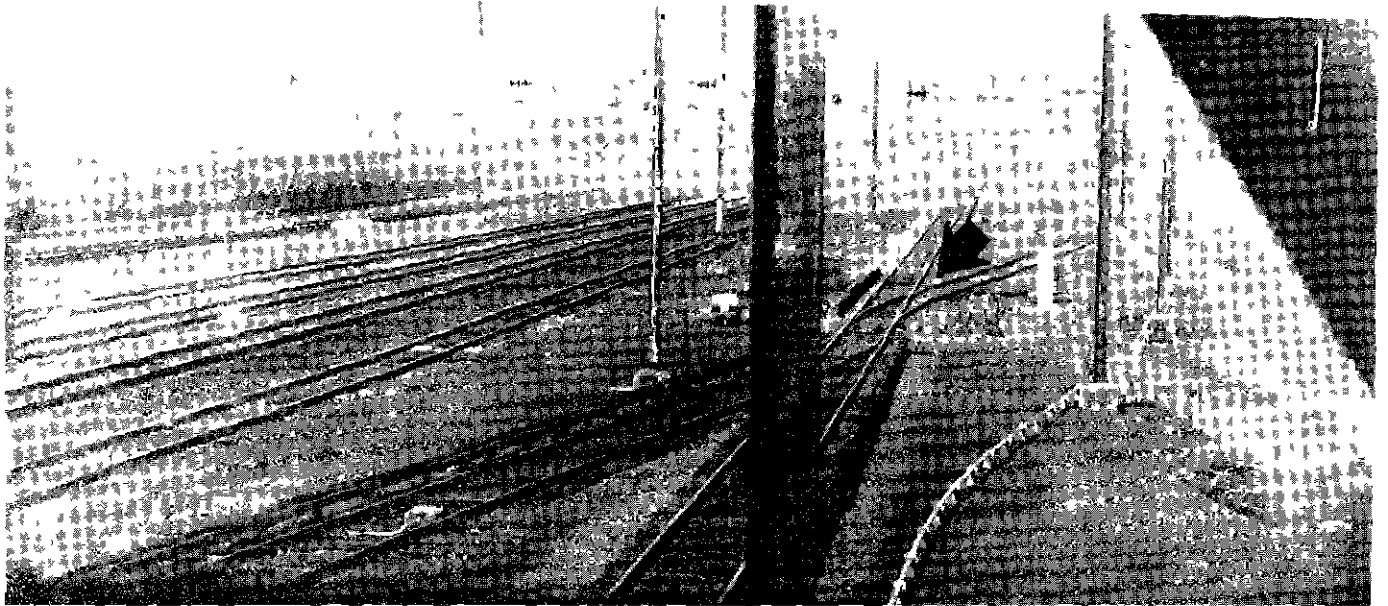
View westward from operator's station at Hudson interlocking. Point of accident marked by arrow at fouling point of tracks No. 4 and No. 8 at right

About 12 02 a m, locomotive 9240 shoved the cut of seven cars westward on track No 8 toward a coupling with the cut of three passenger units. The first attempt to make this coupling was unsuccessful, and the locomotive was moved a few feet eastward with the seven cars to enable the conductor and the brakeman to adjust the couplers involved. The locomotive then shoved the cut of seven cars and coupled it to the three units, at which time it stopped on the east end of track No 8 with its front end fouling track No 4. The brakeman began coupling the air hose in preparation for movement of the locomotive and the combined cut westward on track No 8 to a point west of signal 74Rb and clear of track No 4. While the brakeman was coupling air hose, the conductor observed westbound passenger train No 3319 closely approaching on track No 4 and realized it would collide with the locomotive. He promptly pulled the brakeman from between the cars. About the same time, No 3319 struck locomotive 9240, at the fouling point of track No 4 and the east end of track No 8.
