RAILROAD ACCIDENT INVESTIGATION

Report No. 4008

THE PENNSYLVANIA RAILROAD COMPANY

MARCH 1, 1964

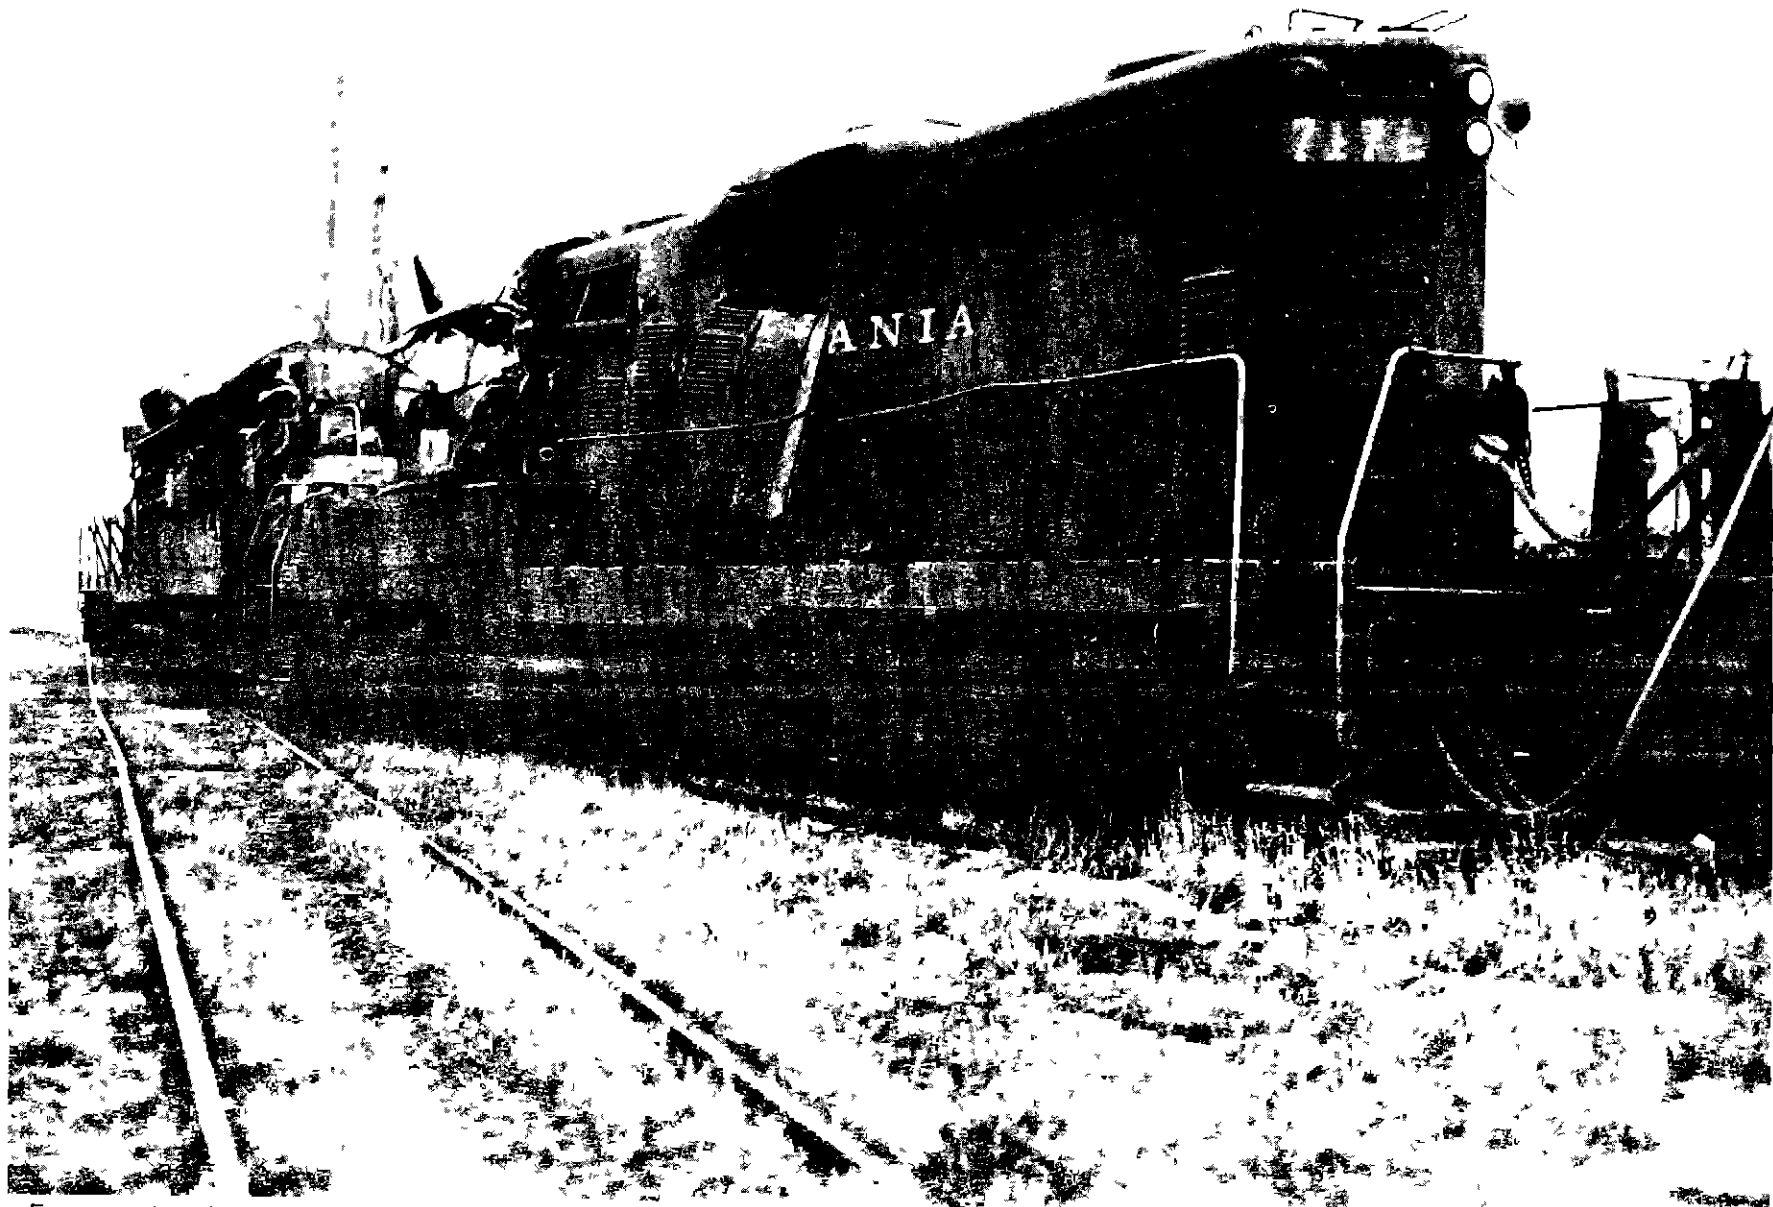
First two diesel-electric units of Extra 7190 East Leading unit 7190 at left

None of the equipment of Extra 7190 East was derailed. The protruding hatch cover struck the diesel-electric units of this train on the north side at a height of 10 to 12 feet above the rails as shown in a photograph at the front of this report. It then struck the north sides of the first 16 cars. The north side of the superstructures of the first and second diesel-electric units was heavily damaged, and the control compartment of the second unit was destroyed. The third unit, which was not equipped with a control compartment was slightly damaged. The first 16 cars were also slightly damaged.

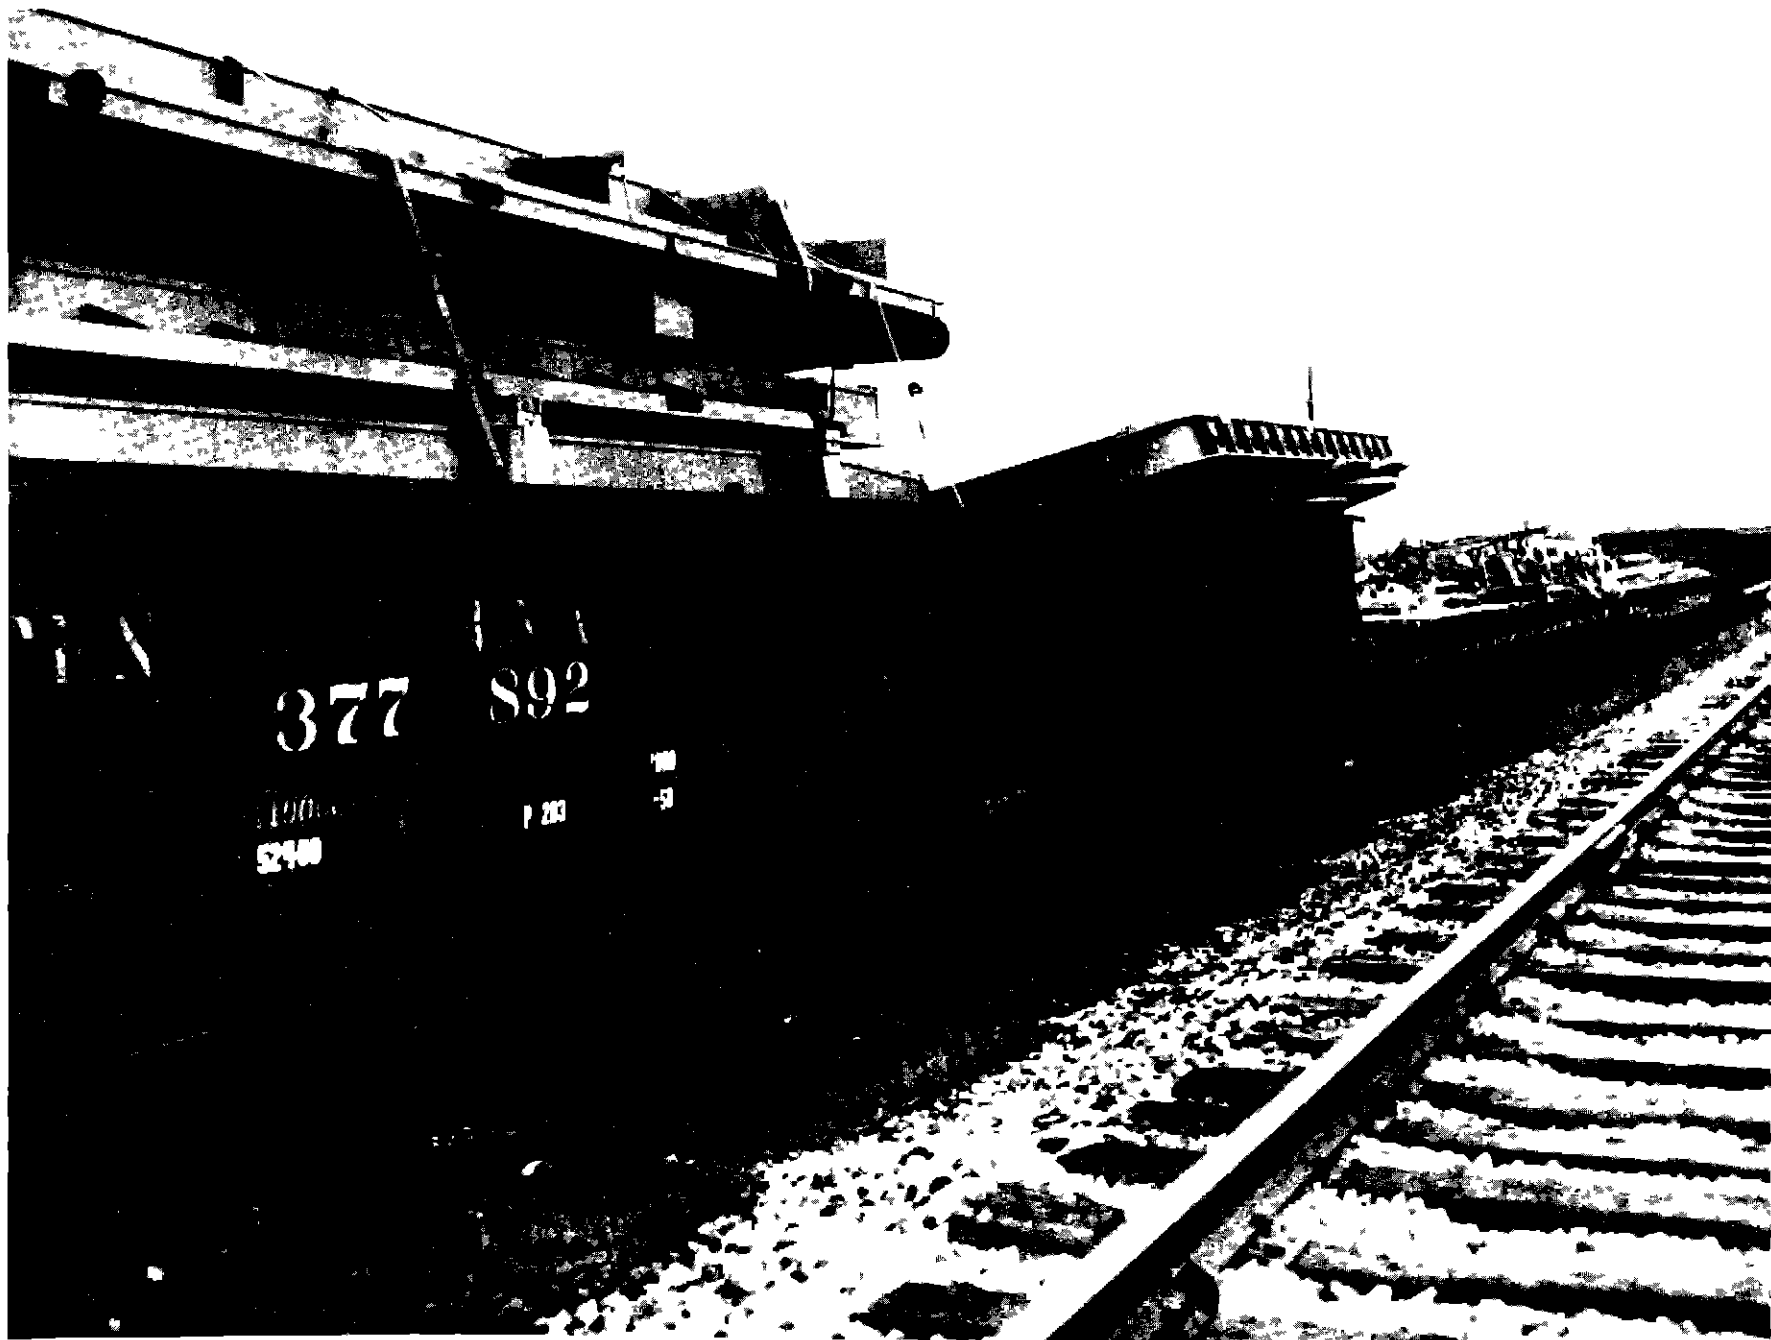
PRR 377892 Load of collapsible hatch covers shown at left The one-piece hatch cover remaining in car is shown at right over collapsed A frames The two flat cars that were loaded with farm implements are to the rear

After the accident, the cargo of the two flat cars to the rear of PRR 377892 was found strewn along the track structure west of the collision point. The east end-gate of PRR 377892 and one of the one-piece hatch covers were lying on the ground to the north of the track structure near the collision point. The other one-piece hatch cover had fallen from its original upright position in the gondola car and was found in a horizontal position in this car. One of its sides protruded about 36 inches over the top of the south side of the gondola car as shown in a photograph at the front of this report. The four A frames provided for securing the two one-piece hatch covers in their original upright positions had collapsed. Broken pieces of these frames were under the one-piece hatch cover remaining in the car. One of the three steel bands used to secure the one-piece hatch covers to the A frames was pulled out of the locking clip. The other two bands were broken.

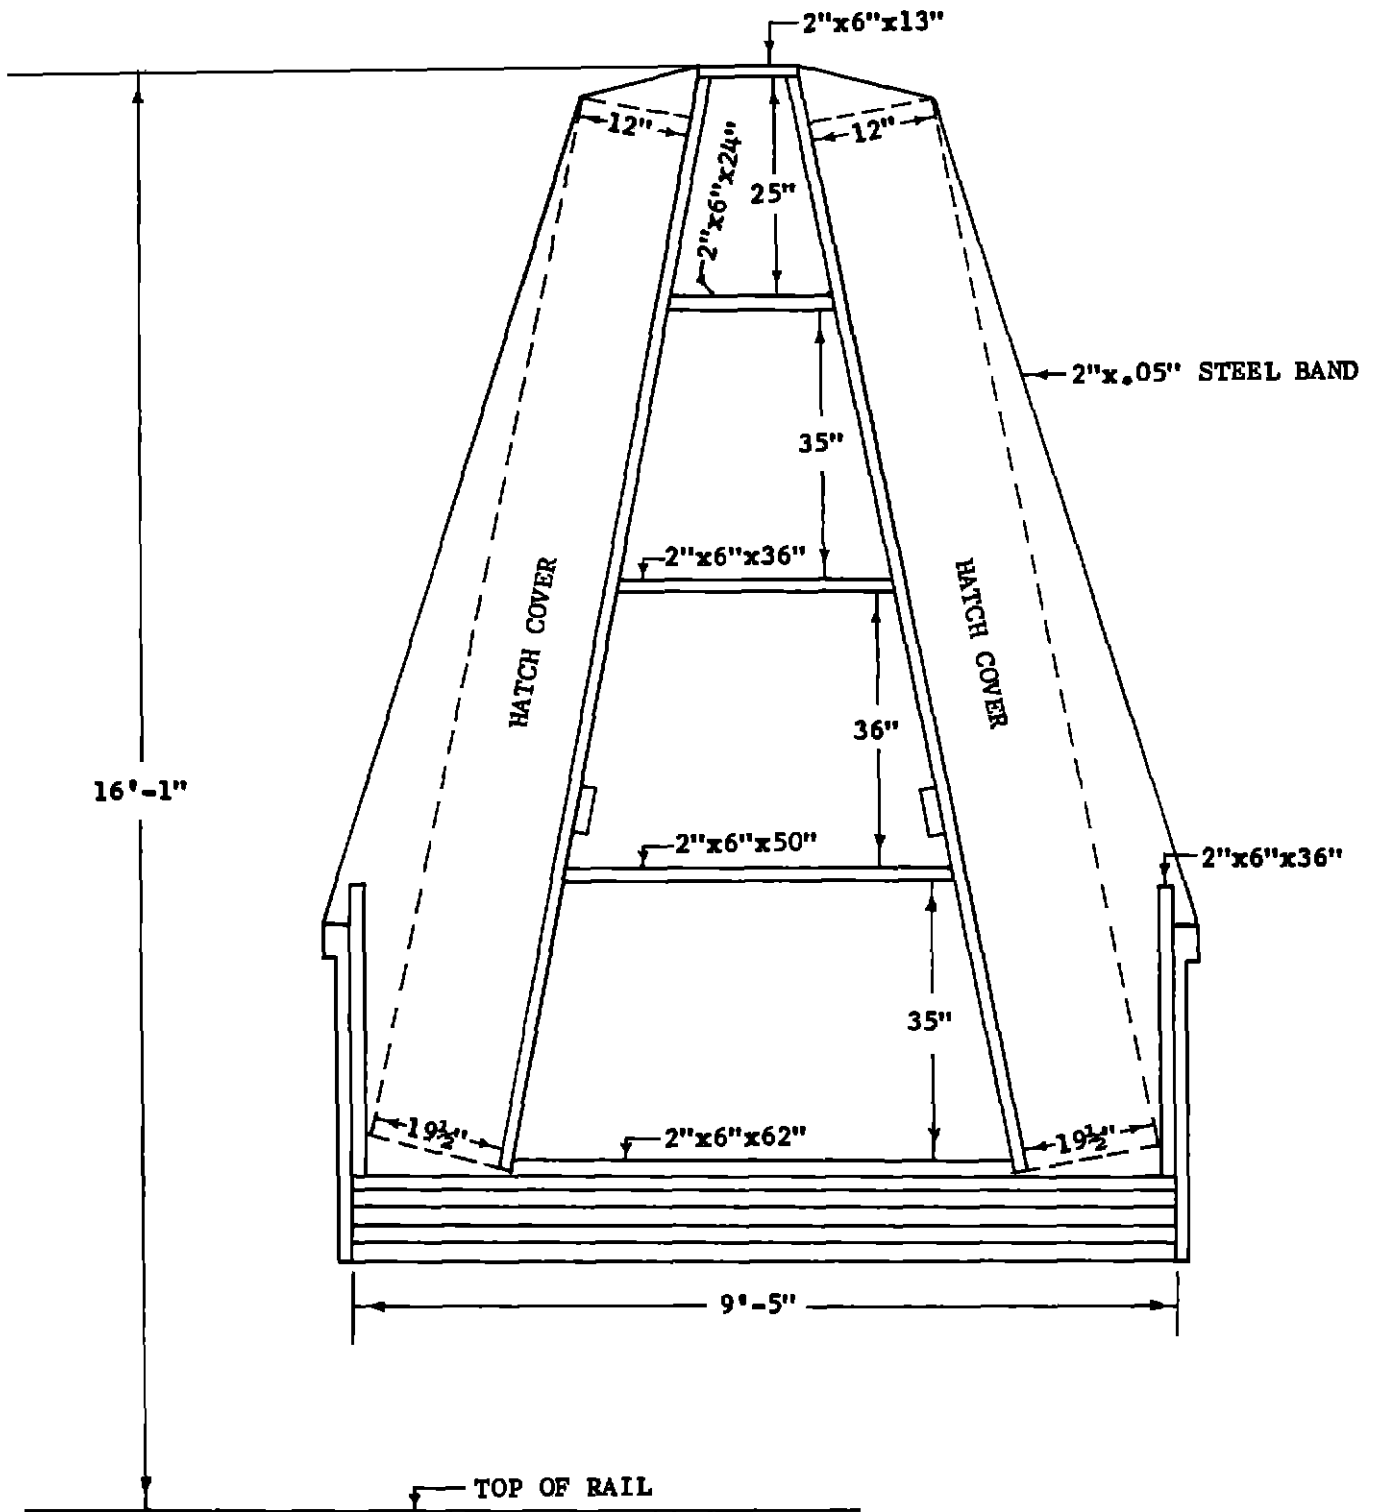
END VIEW

Details of A frame and blocking used to secure the two one-piece hatch covers in PRR 377892

Inspection of the method used to secure the lading of PRR 377892 revealed that although long free spans existed between points where the three steel bands contacted the car and the one-piece hatch covers, no dampening arrangement had been provided to prevent excessive vibrations of the bands as prescribed by Association of American Railroads general loading rules. The material used for bearing pieces, blocking, and construction of the A frames consisted of soft and hard wood pieces of inferior quality and did not conform to A A R General Rules. Vacant spaces between the load of three-piece hatch covers and the load of two-piece hatch covers, and between ends of these loads and the ends of the car, exceeded 18 inches. However, nothing was found to indicate blocking had been provided to prevent longitudinal movement of either load of hatch covers.

Four bearing pieces were constructed and attached crosswise on the floor of the gondola car. Each consisted of five pieces of 2-inch by 6-inch by 113-inch lumber lying flat, one on top of the other, and secured together by nails. An A frame of 2-inch by 6-inch lumber was built on each bearing piece. The four A frames extended to a height of 12 feet 4 inches above the car floor. Five spreaders separated the two legs of each A frame at various heights above the car floor and varied in length from 13 to 62 inches as indicated in a sketch at the front of this report. The four A frames were connected by two pieces of 2-inch by 6-inch lumber nailed to the inside surface of the legs of each frame about 50 inches above the car floor. At each end of the four bearing pieces, a 2-inch by 6-inch by 36-inch piece of lumber was nailed vertically against the side of the car to block the bottom of the hatch cover against lateral movement.

Three 2-inch high tension bands crossed the top of the one-piece hatch covers at equally spaced intervals and were secured to the car sides by the use of 2-inch locking clips. These bands were machine tightened and were double-crimped. No dampeners were provided to prevent vibration of the bands.

It is recommended that the Pennsylvania Railroad Company take such action as may be necessary to insure adequate inspection and proper enforcement of the rules governing the loading of open-top cars prior to acceptance for transit.
