RAILROAD ACCIDENT INVESTIGATION

Report No 3847

THE PENNSYLVANIA RAILROAD COMPANY

JUNE 13, 1959

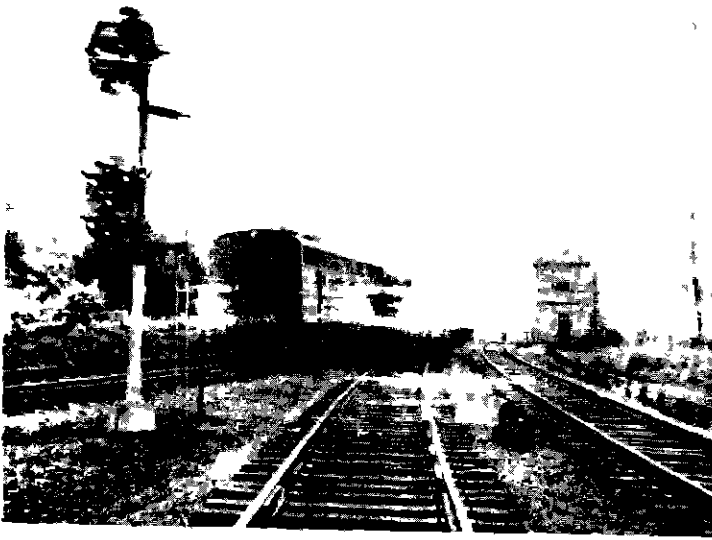
PLATE 1

Westward view from point on auxiliary track Linden Branch
to signal 8L are to the left of picture Signal 8LC is to the right

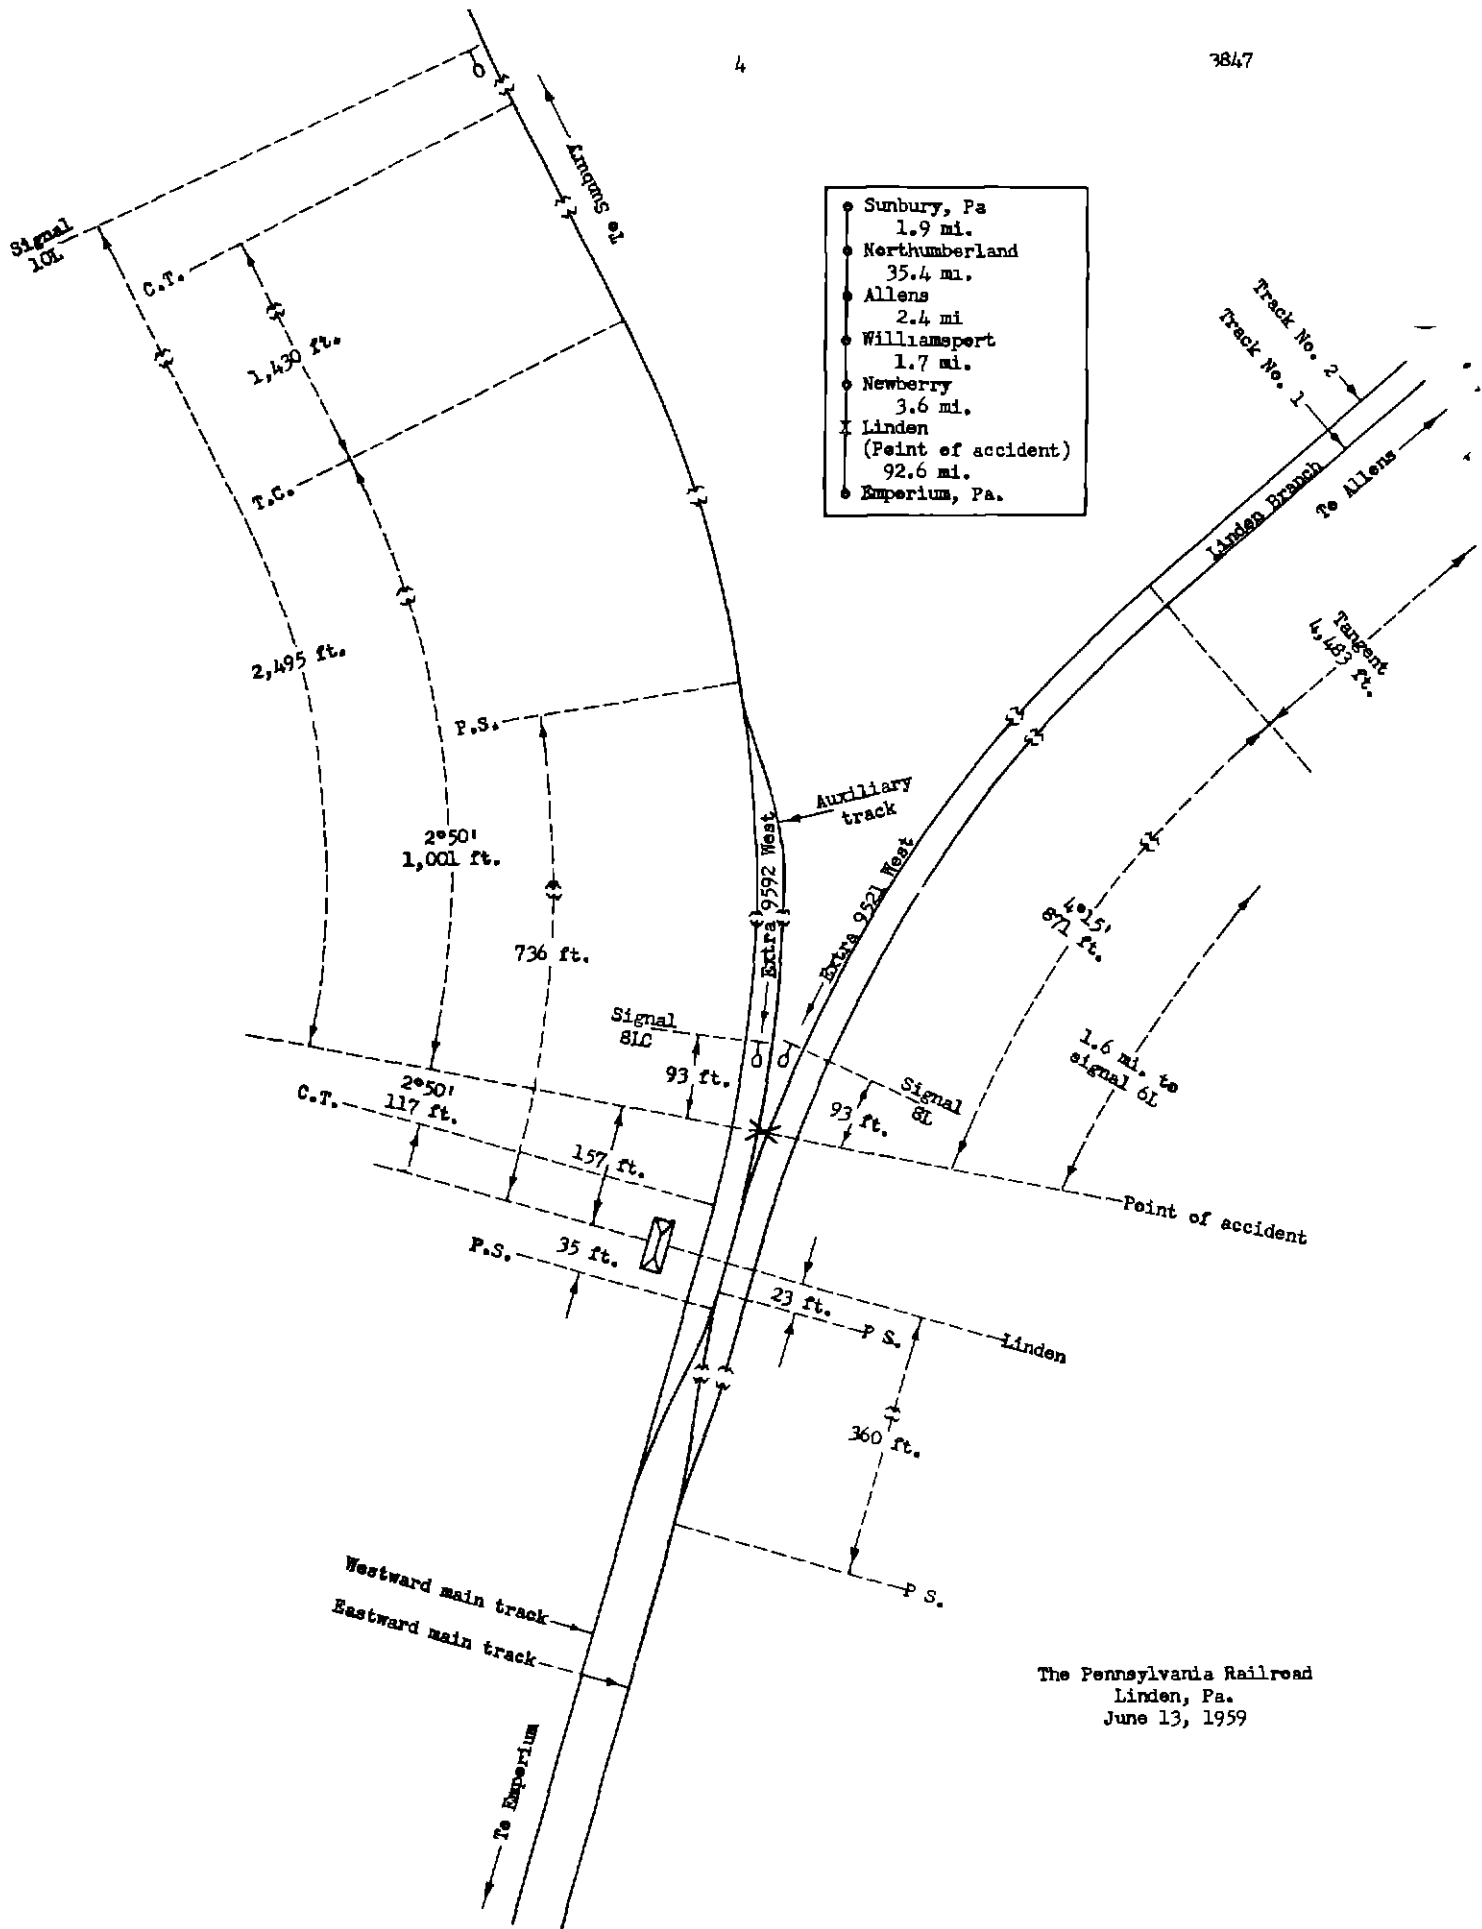
The Pennsylvania Railroad
Linden, Pa.
June 13, 1959

The accident occurred 157 feet east of the interlocking station at Linden, at the fouling point of the auxiliary track and track No. 2 of the Linden Branch.
