RAILROAD ACCIDENT INVESTIGATION

Report No 3841

THE PENNSYLVANIA RAILROAD COMPANY

MACE, OHIO

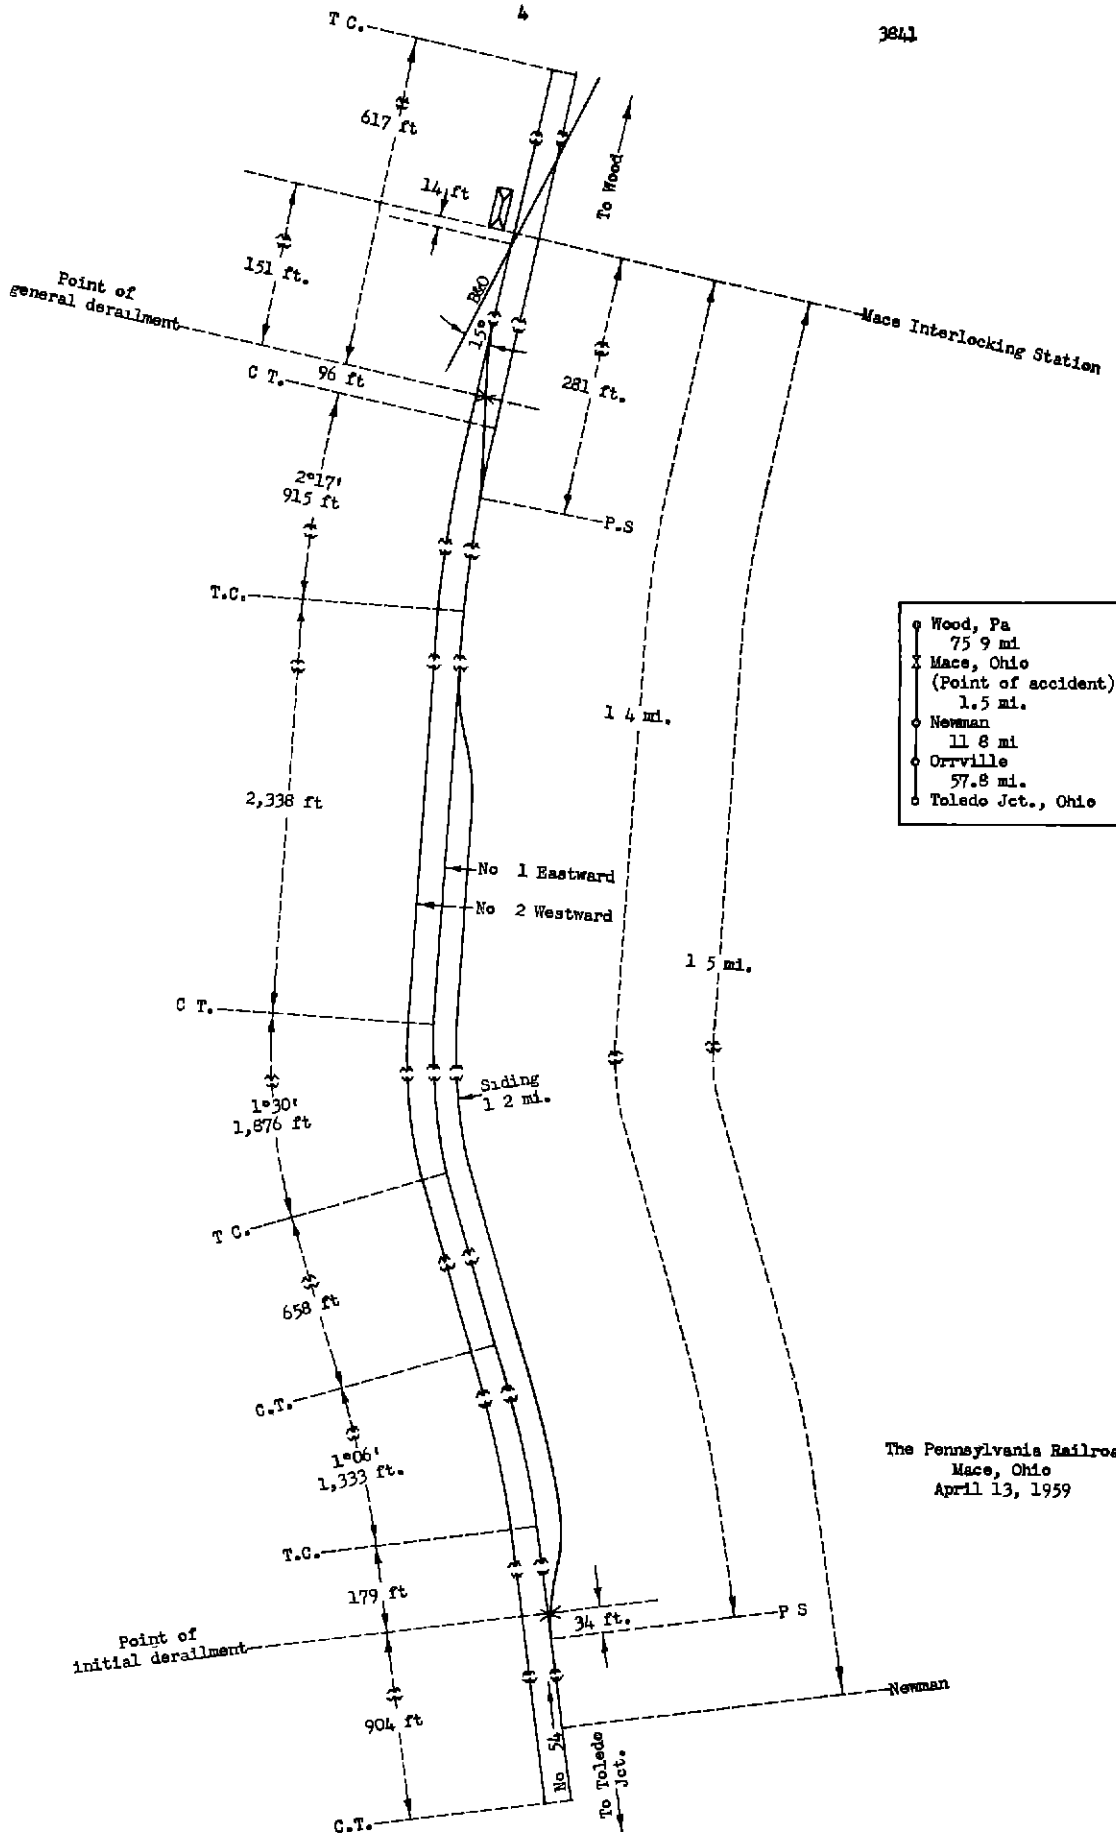
The Pennsylvania Railroad
 Mace, Ohio
 April 13, 1959

No separations occurred between units of the train. The train stopped with the locomotive 1,368 feet east of the point of general derailment. The derailed cars stopped in various positions as shown in the sketch. The 8th car was somewhat damaged. The other derailed cars were slightly damaged.
