RAILROAD ACCIDENT INVESTIGATION

Report No 3833

THE PENNSYLVANIA RAILROAD COMPANY

FEBRUARY 12, 1959

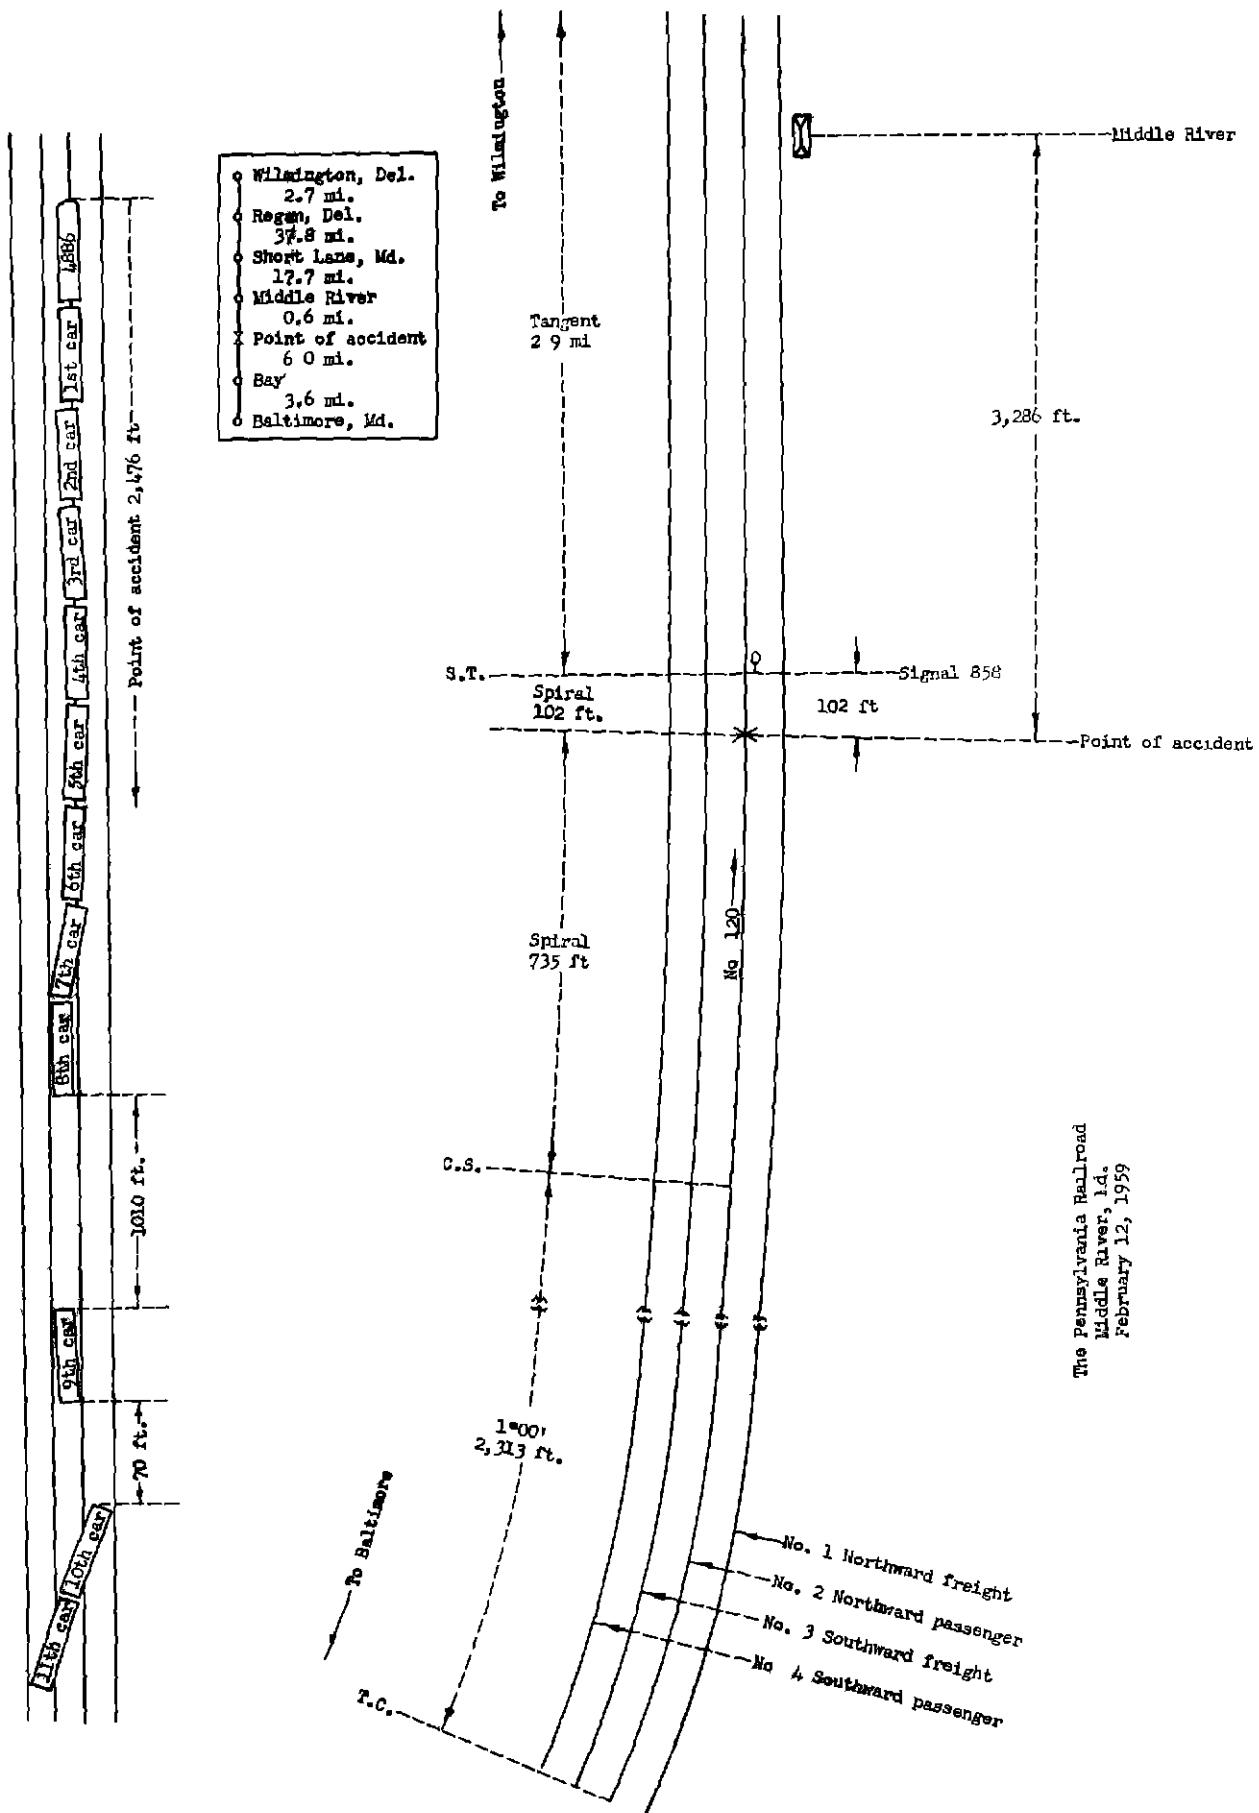
The Pennsylvania Railroad
 Middle River, Md.
 February 12, 1959

Separations occurred at both ends of the 9th car. The locomotive and cars stopped upright and in various positions as shown in the sketch. The locomotive was somewhat damaged and the derailed cars were slightly damaged.
