RAILROAD ACCIDENT INVESTIGATION

Report No 4013

THE PENNSYLVANIA RAILROAD COMPANY

ORLEANS, N Y

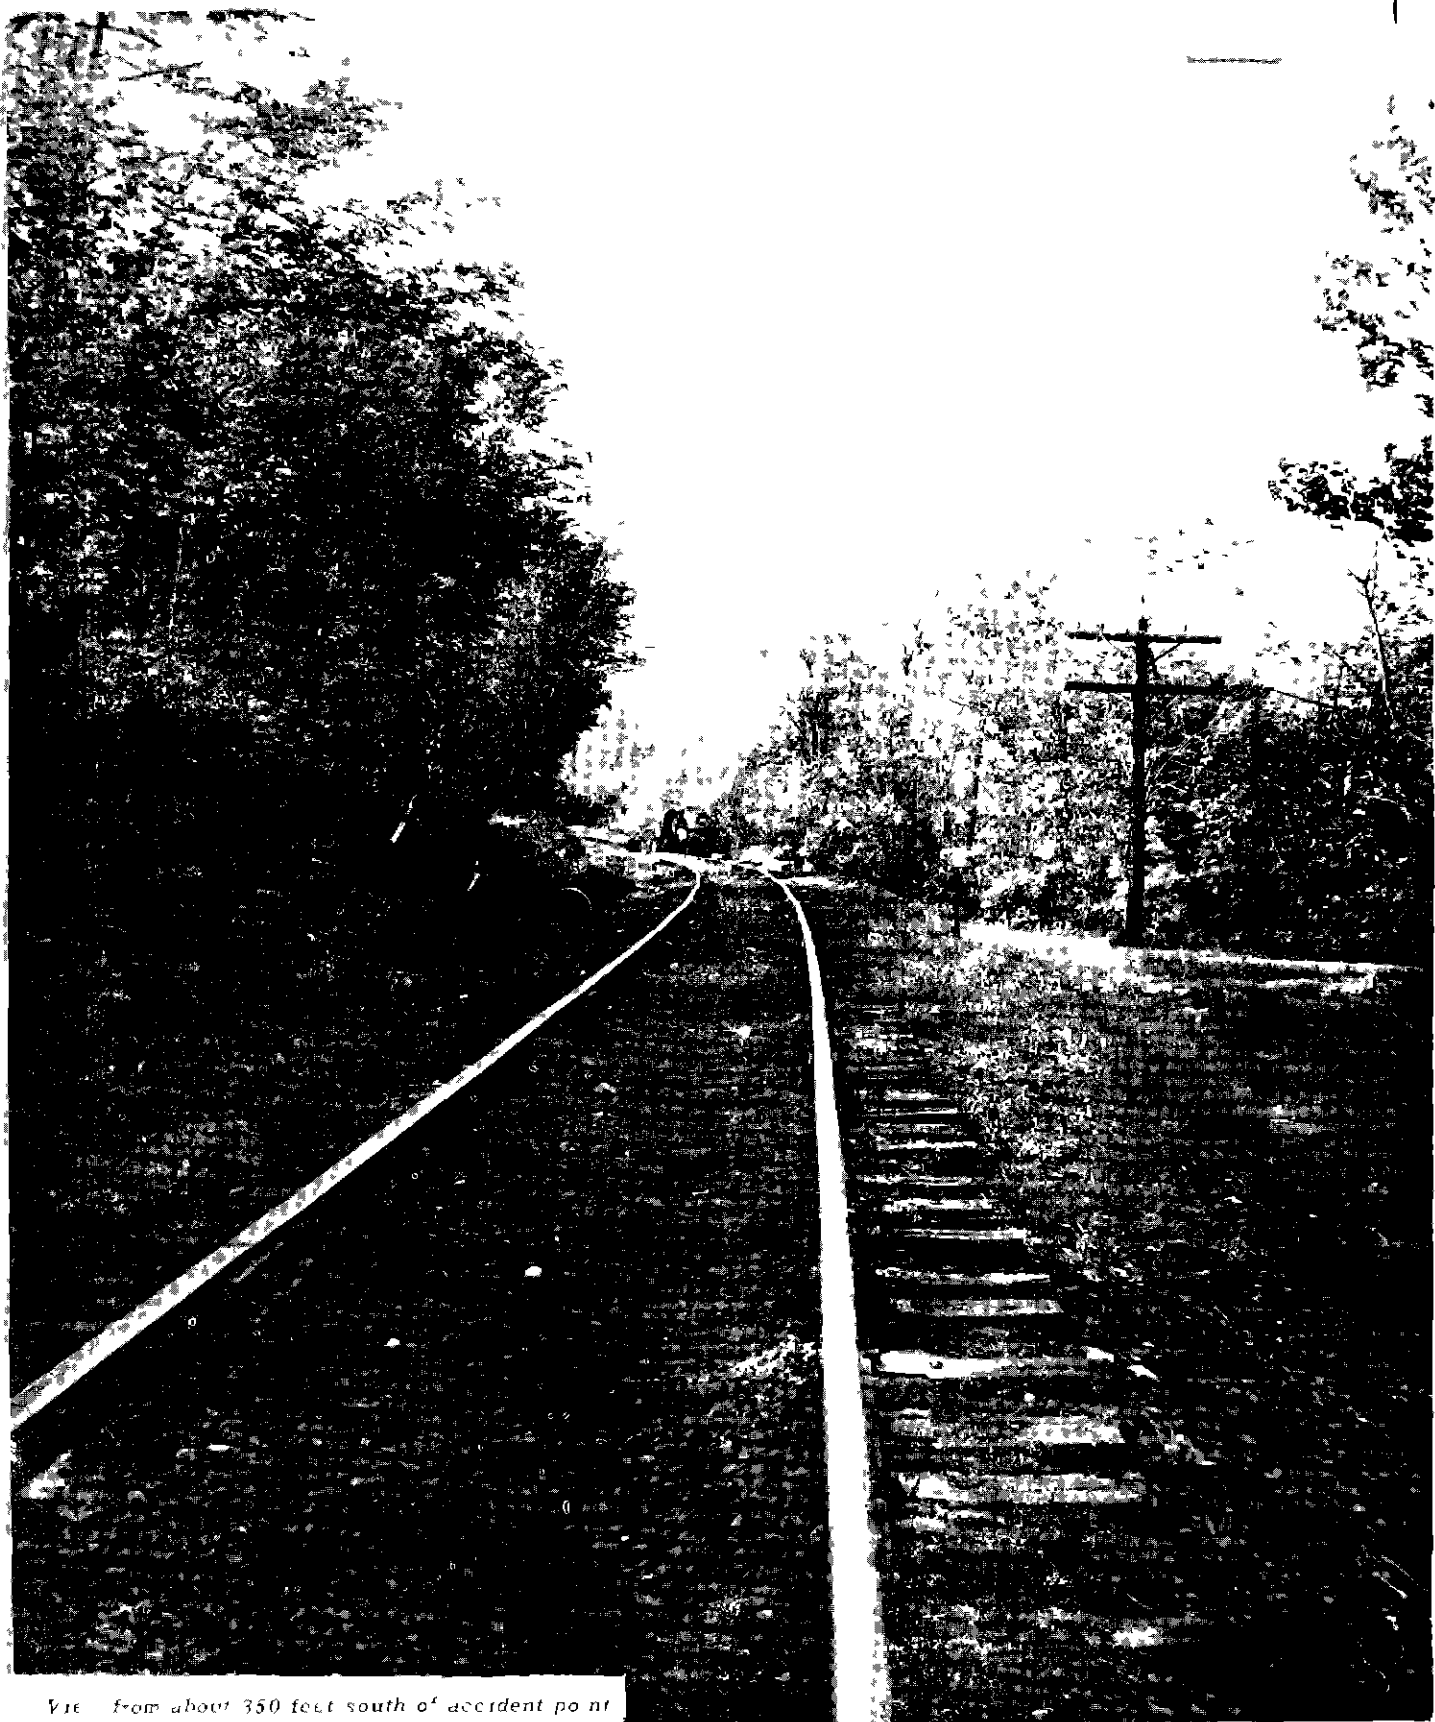
View from about 350 feet south of accident point

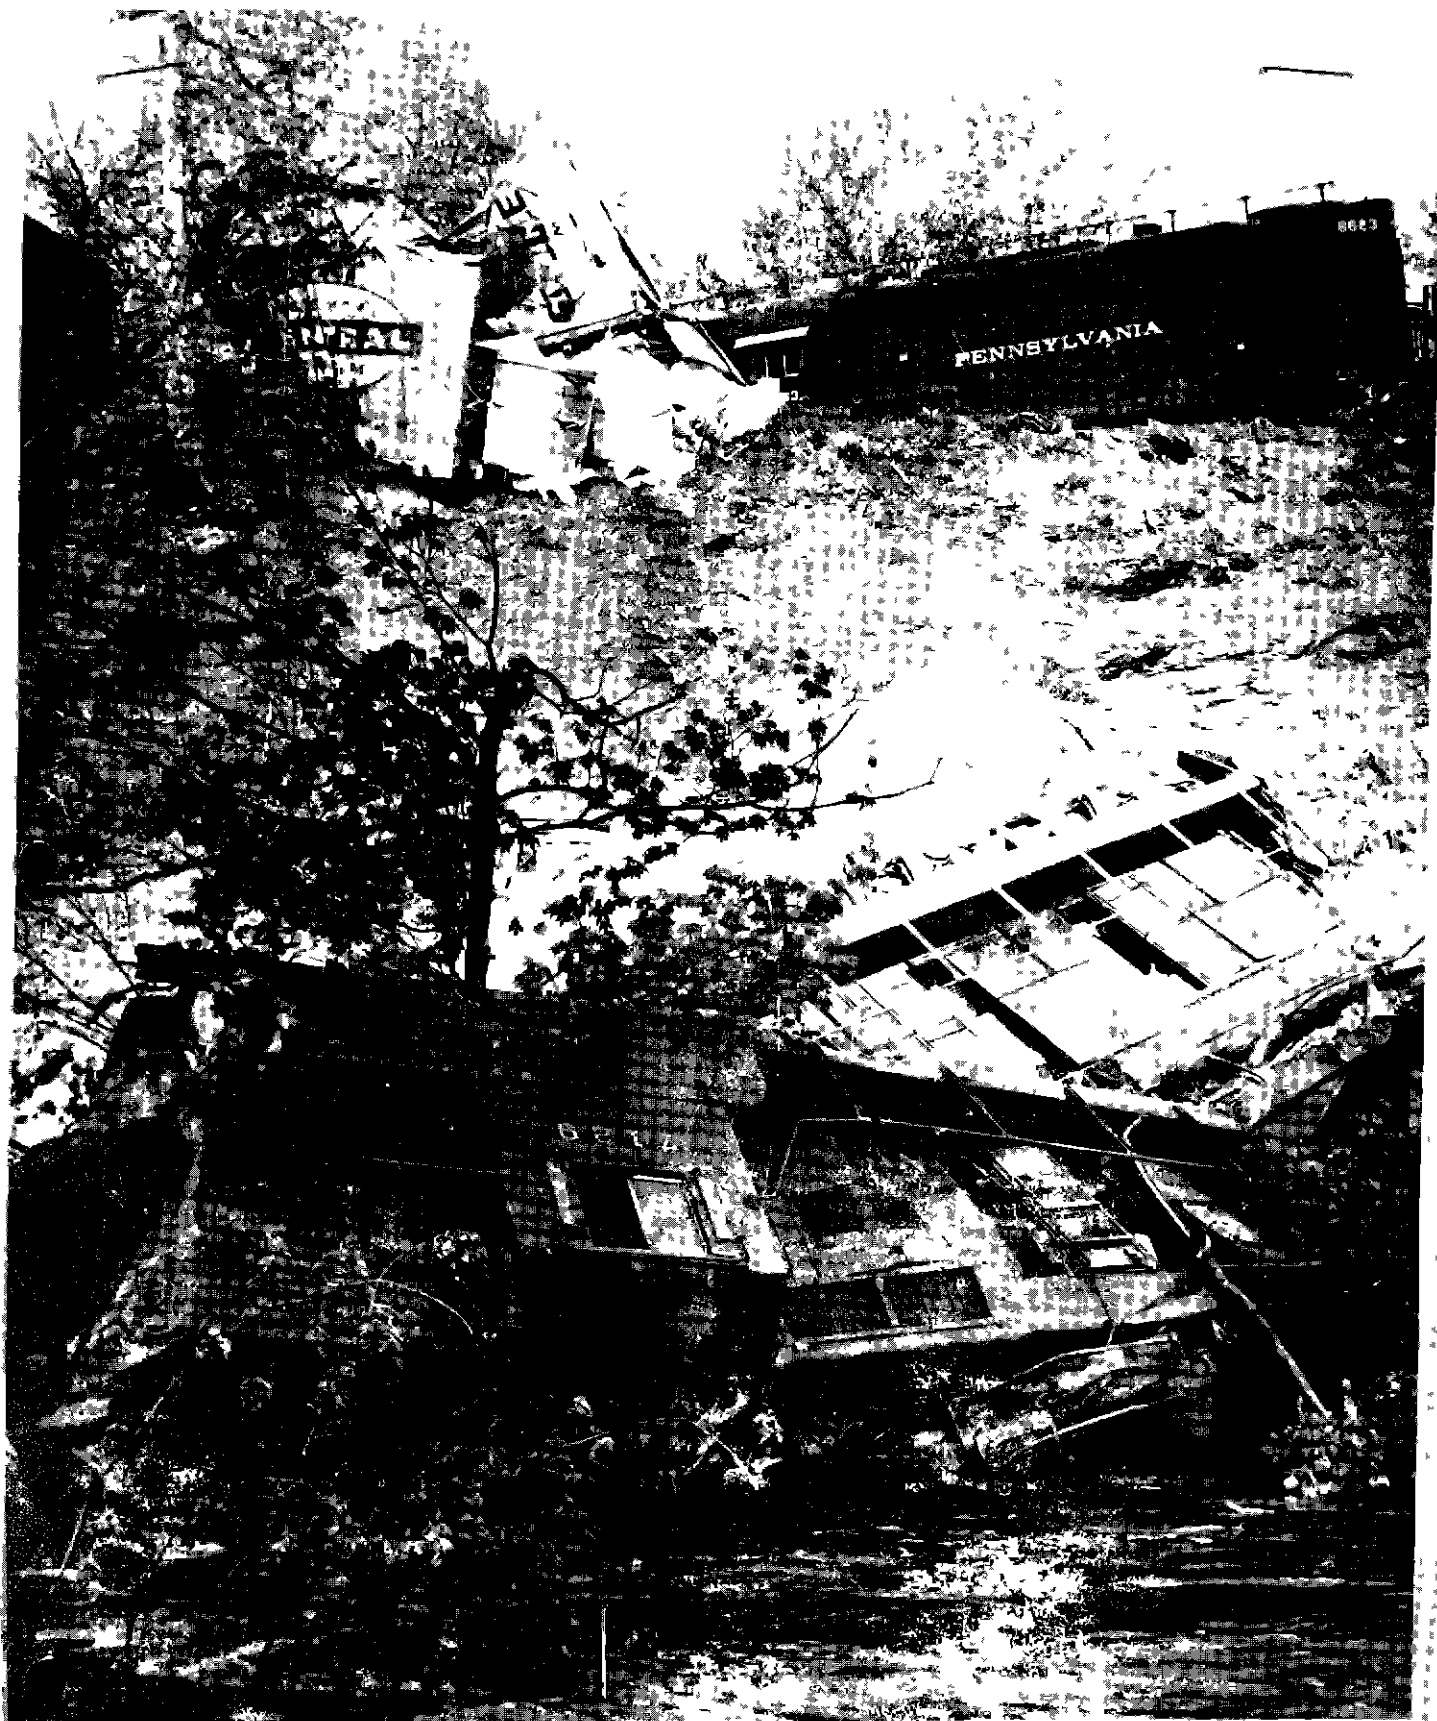
First and second diesel-electric units of Extra 7129 North shown at bottom of photo, and electric unit 8623 in tow

The three locomotive units, the diesel-electric unit in tow, and the first to eighth cars, inclusive, of Extra 7129 North were derailed. The first diesel-electric unit overturned to the right and stopped upside-down with the front end on the west bank of Flint Creek about 120 feet north of the accident point. Its rear end extended diagonally southward into the creek and was slightly submerged. The second unit also overturned to the right and stopped on the bank of the creek, adjacent to and above the first unit. The third diesel-electric unit and the unit in tow jackknifed to the right, and each stopped upright with one end on the track structure and the other on the shoulder of the sidehill cut. The derailed cars stopped in various positions on the track structure and the slope to Flint Creek. The first and second diesel-electric units were destroyed, the third unit was heavily damaged, and the unit in tow was somewhat damaged. Of the derailed cars, three were destroyed, three heavily damaged, and two slightly damaged. The ninth and tenth cars were also destroyed.
