RAILROAD ACCIDENT INVESTIGATION

REPORT NO. 4056

THE PENNSYLVANIA RAILROAD COMPANY

AUGUST 19, 1965

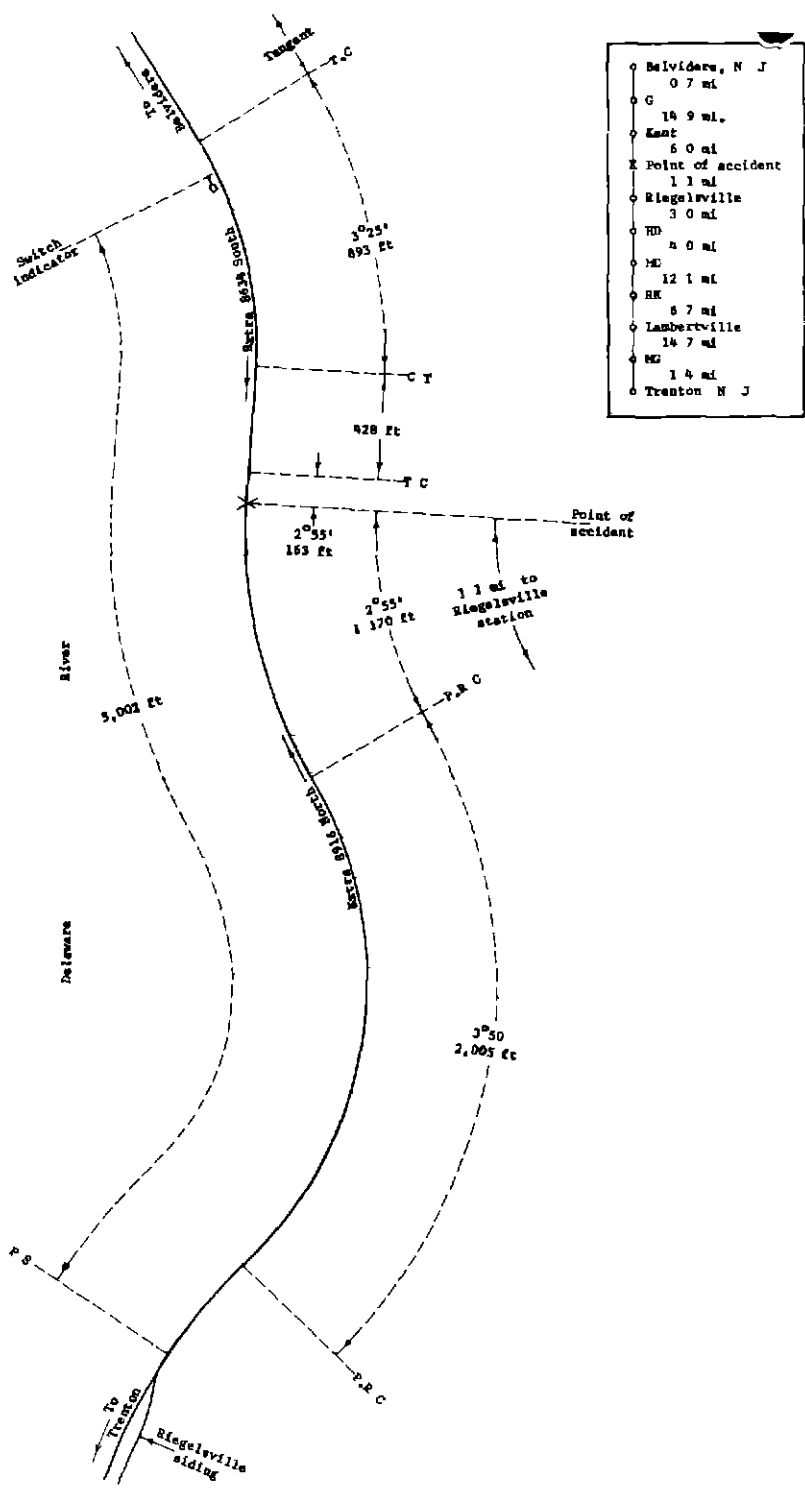
The Pennsylvania Railroad
 Riegelville N. J
 August 19 1965

The collision occurred on the main track, 43.0 miles north of Trenton and 1.1 miles north of Riegelsville.

to about 10 miles per hour as the train approached the curve where the accident occurred. A few moments after the train entered the north end of the curve, the front brakeman saw the locomotive of Extra 8916 North come into his view at a distance which he estimated to be about 800 feet. He called a warning and the engineer promptly moved the automatic-brake valve handle to emergency position. Moments later, apparently before its speed was reduced materially, Extra 8634 South collided with Extra 8916 North, 1.1 miles north of the Riegelsville station.
