# RAILROAD ACCIDENT INVESTIGATION

Report No 3839

THE PENNSYLVANIA RAILROAD COMPANY

Accident near Vandalia, Ill , on March 14, 1959, caused by a broken wheel

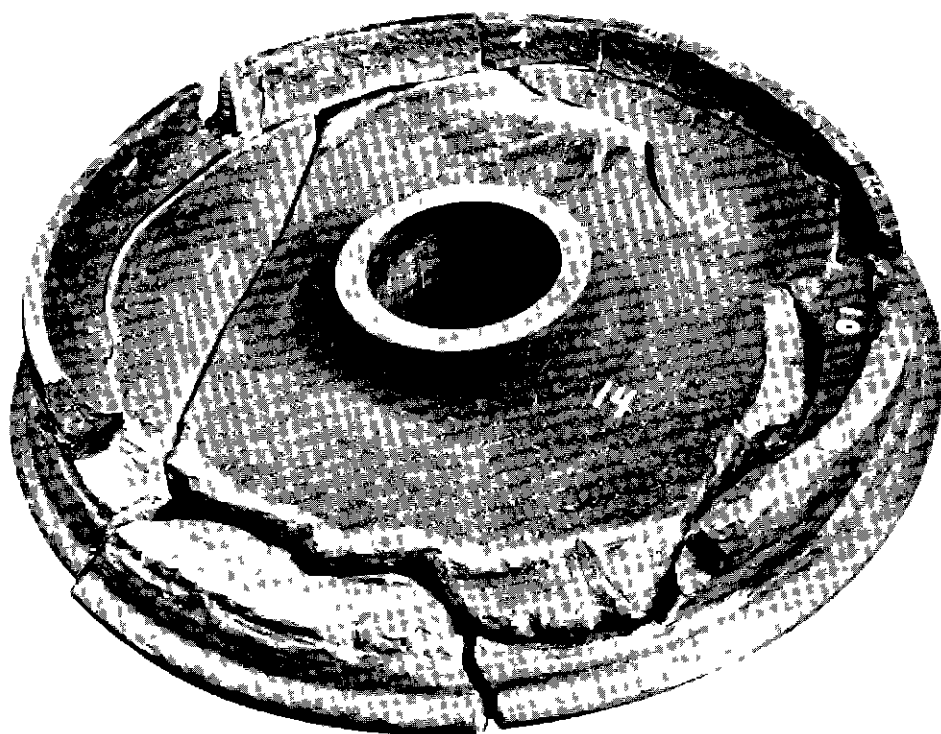
Further investigation developed that the entire rim, with the exception of a small segment, was separated from the plate and broken into numerous pieces as shown in Plate 1. The hub and a portion of the plate remained fixed to the axle (No. 14, Plate 1). A piece of the rim, approximately 20 inches in length and of triangular cross section (No. 1, Plates 1 and 2), penetrated the floor of the third car at a point in line with the wheel and about 15 feet from the west end of the car. Other portions of the wheel were found on the track structure throughout a distance of 1,400 feet eastward beginning at a point 1,200 feet east of the west switch of the siding at Vandalia.

Measurements of the broken wheel disclosed a rim thickness of  $1 \frac{1}{16}$  inches, a flange height of  $1 \frac{15}{32}$  inches, and the development of a double flange. The mate wheel had a rim thickness of  $1 \frac{3}{32}$  inches, a flange height of  $1 \frac{14}{32}$  inches, and a flange thickness of  $\frac{61}{64}$  inch. No visual evidence of overheating was found on either wheel. There was no indication that either wheel had moved on the axle wheel seat, and a pressure of 140 tons was required to dismount the broken wheel. Back to back measurements could not be determined because the small segment of rim remaining on the plate was bent. The wheels were last mounted by the carrier on January 8, 1957, and applied to PRR 1131 during the same month.

Laboratory analysis of the failed wheel disclosed that the steel met the chemical requirements of AAR Specification M-107-57 for class B wheels, and that the Brinell hardness was within the specification range of 277-341 BHN for Class BE wheels. Magnetic particle examination revealed numerous small thermal cracks on the periphery of the broken rim pieces. Evidence of subsurface shelling was found on the tread of numerous pieces of the rim. This condition varied in depth from approximately  $\frac{1}{8}$  to  $\frac{3}{8}$  inch and was about  $2 \frac{1}{2}$  to 3 inches from the edge of the rim. The maximum width of the shelled area was about  $\frac{5}{8}$  inch. All breaks in the wheel had characteristics of sudden fractures.
