REPORT NO. 3410

PENNSYLVANIA-READING SEASHORE LINES

Accident near Delair, N. J., on July 20, 1951, caused by the
failure of a main rod.

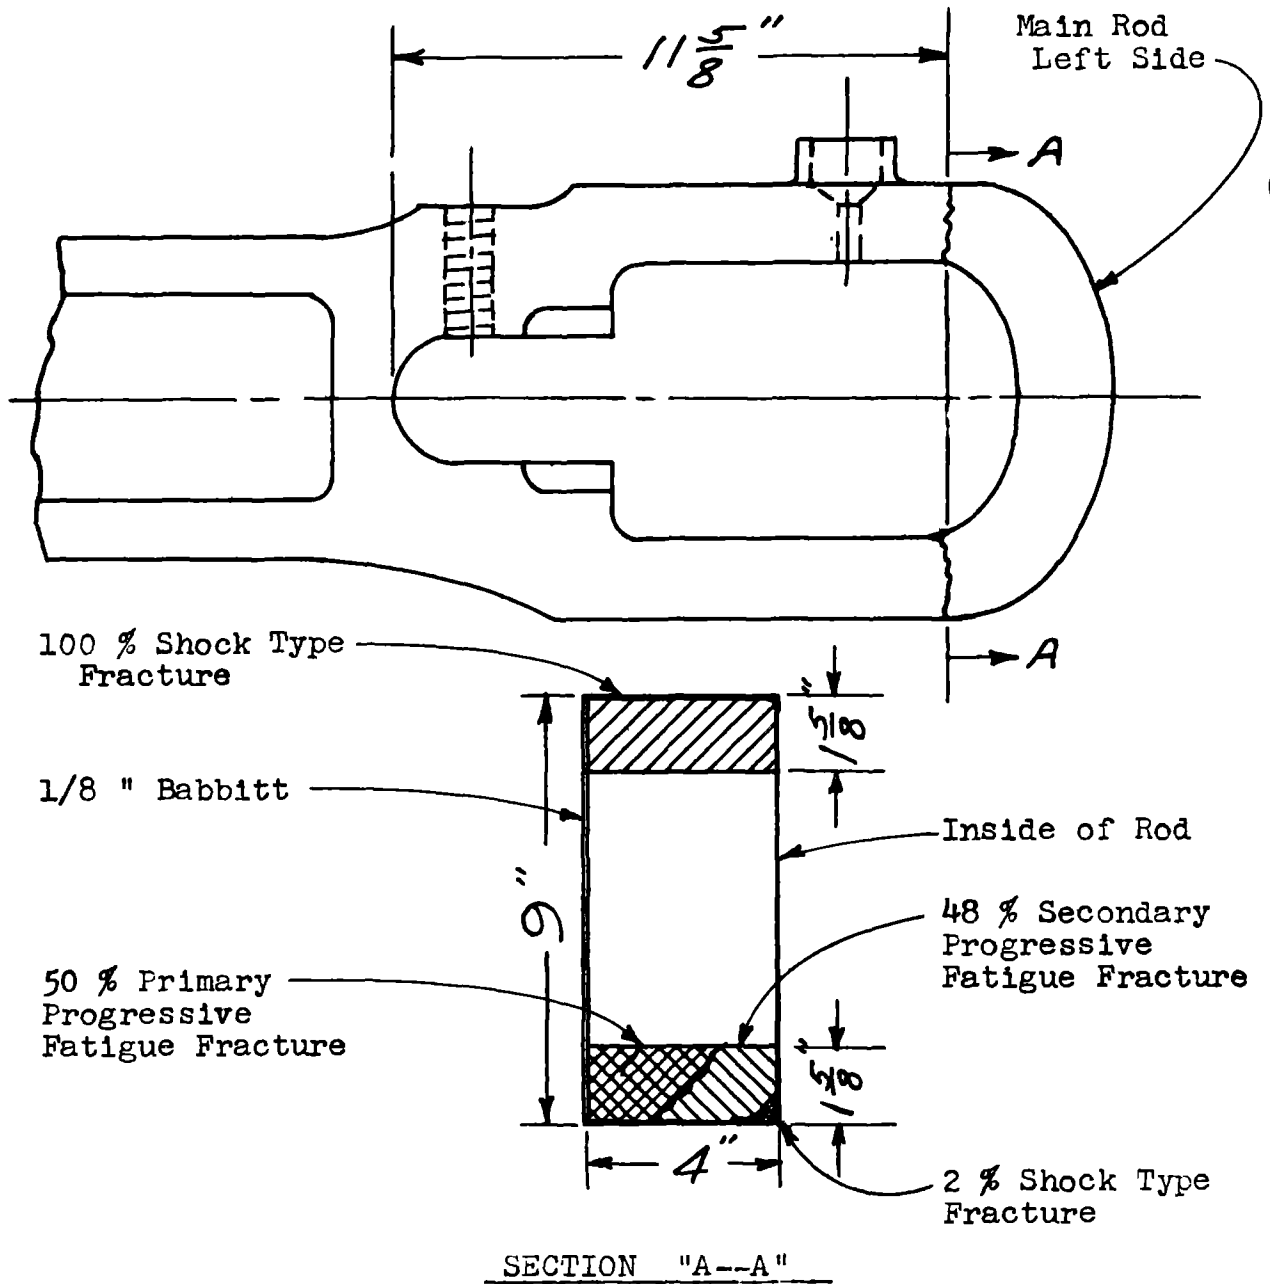
SKETCH OF FAILED FRONT END OF MAIN ROD
 READING COMPANY LOCOMOTIVE 130

The failure of the rod occurred at the front end of the bottom section of front brass fit, 2-3/8 inches ahead of the center line of wrist pin, through a progressive fracture which started at a gall mark under the rabbitt-metal liner on the outside face of the rod and progressed inward. Approximately 50 percent of the progressive fracture appeared to be long standing, 48 percent of more recent origin and the remaining 2 percent of cross-sectional area was a new break. The top section of the rod also broke at the front end of the brass fit, 2-3/8 inches ahead of the center line of the wrist pin, and was a 100 percent new shock break. The top and bottom sections of the rod at points of the breaks were 1-5/8 inches thick and 3-7/8 inches wide. The main rod was bent 12 inches out of alignment. Sketch of failed rod appears on page 8.

The failure in the main rod which caused this accident occurred through a progressive fracture at the juncture of the bottom rail and curved end of the box section that housed crosshead wrist pin brasses. The point of origin of the primary progressive fatigue fracture appeared to be in a gall or tool mark at the corner of the outer face of the rod and the top surface of the lower rail and was hidden beneath the face babbitt that had been applied because of excess lateral wear.

It is found that this accident was caused by the failure of a main rod through progressive fracture at gall mark under babbitt-metal liner at front end of the bottom section of brass fit in outside face of the rod.

It is recommended that application of face babbitt to crosshead ends of main rods be prohibited; that tool marks or surface defects be eliminated from highly stressed rod sections and that filleted corners be properly maintained.
