RAILROAD ACCIDENT INVESTIGATION

REPORT NO. 4130

PENNSYLVANIA-READING SEASHORE LINES

SOMERDALE, N. J.

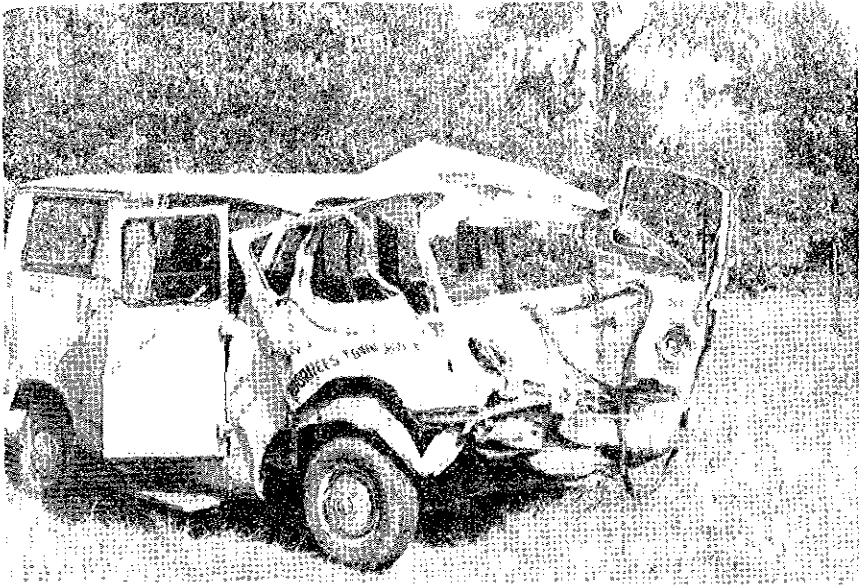
The school bus spun around on Somerdale Road as a result of the impact, throwing the bus driver and three school children to the ground. It stopped upright in the eastward curb lane, with its front end facing eastward and its rear end about three feet from the east side of the caboose. It was destroyed (see photo).

The school bus was a 1966 General Motors Handi-bus with a seating capacity for nine persons (see photo). It had a 6-cylinder, 120-horsepower gasoline engine; a transmission with three forward speeds; two axles and hydraulic brakes. It carried New Jersey license plates No. MG 5858, and was owned by the Voorhees Township Board of Education. The bus was used for the transportation of retarded children to and from various schools in the general area of Somerdale. It did not meet construction requirements of school bus specifications prescribed by the New Jersey State Department of Education, and bore no marking which designated it as a "school bus."

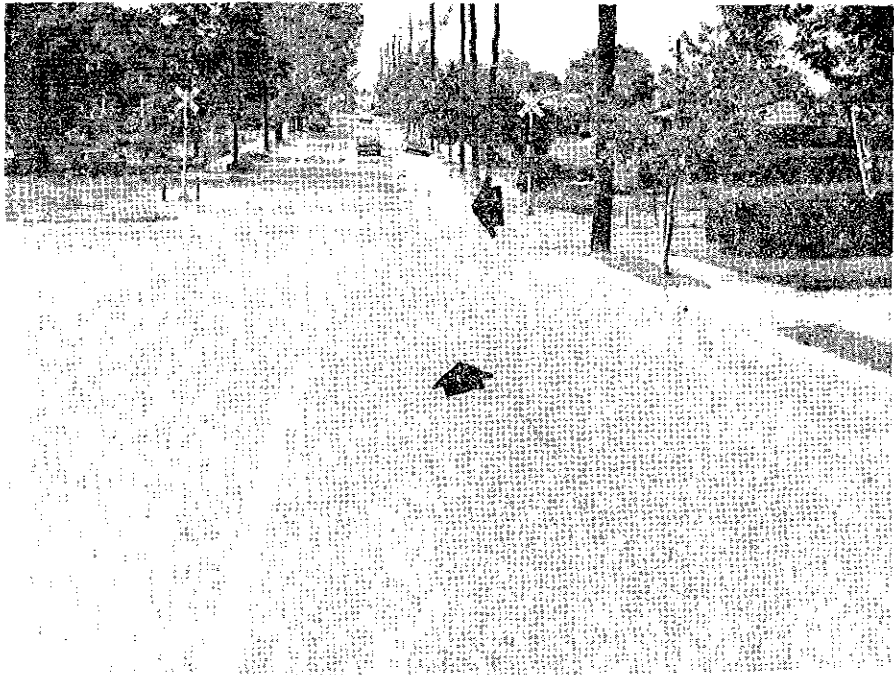
The crossing is protected by two automatic railroad-crossing warning signals of the flashing red-light type Because of houses, trees and shrubbery in the northeast angle of the crossing (see photo and sketch), the view between a southbound train approaching the crossing and a vehicle moving westward on Somerdale Road in approach to the railroad is materially restricted

Somerdale Road crossing. Arrows show directions of train and school bus.
