REPORT NO. 3701

PENNSYLVANIA-READING SEASHORE LINES

IN RE ACCIDENT

JULY 27, 1956

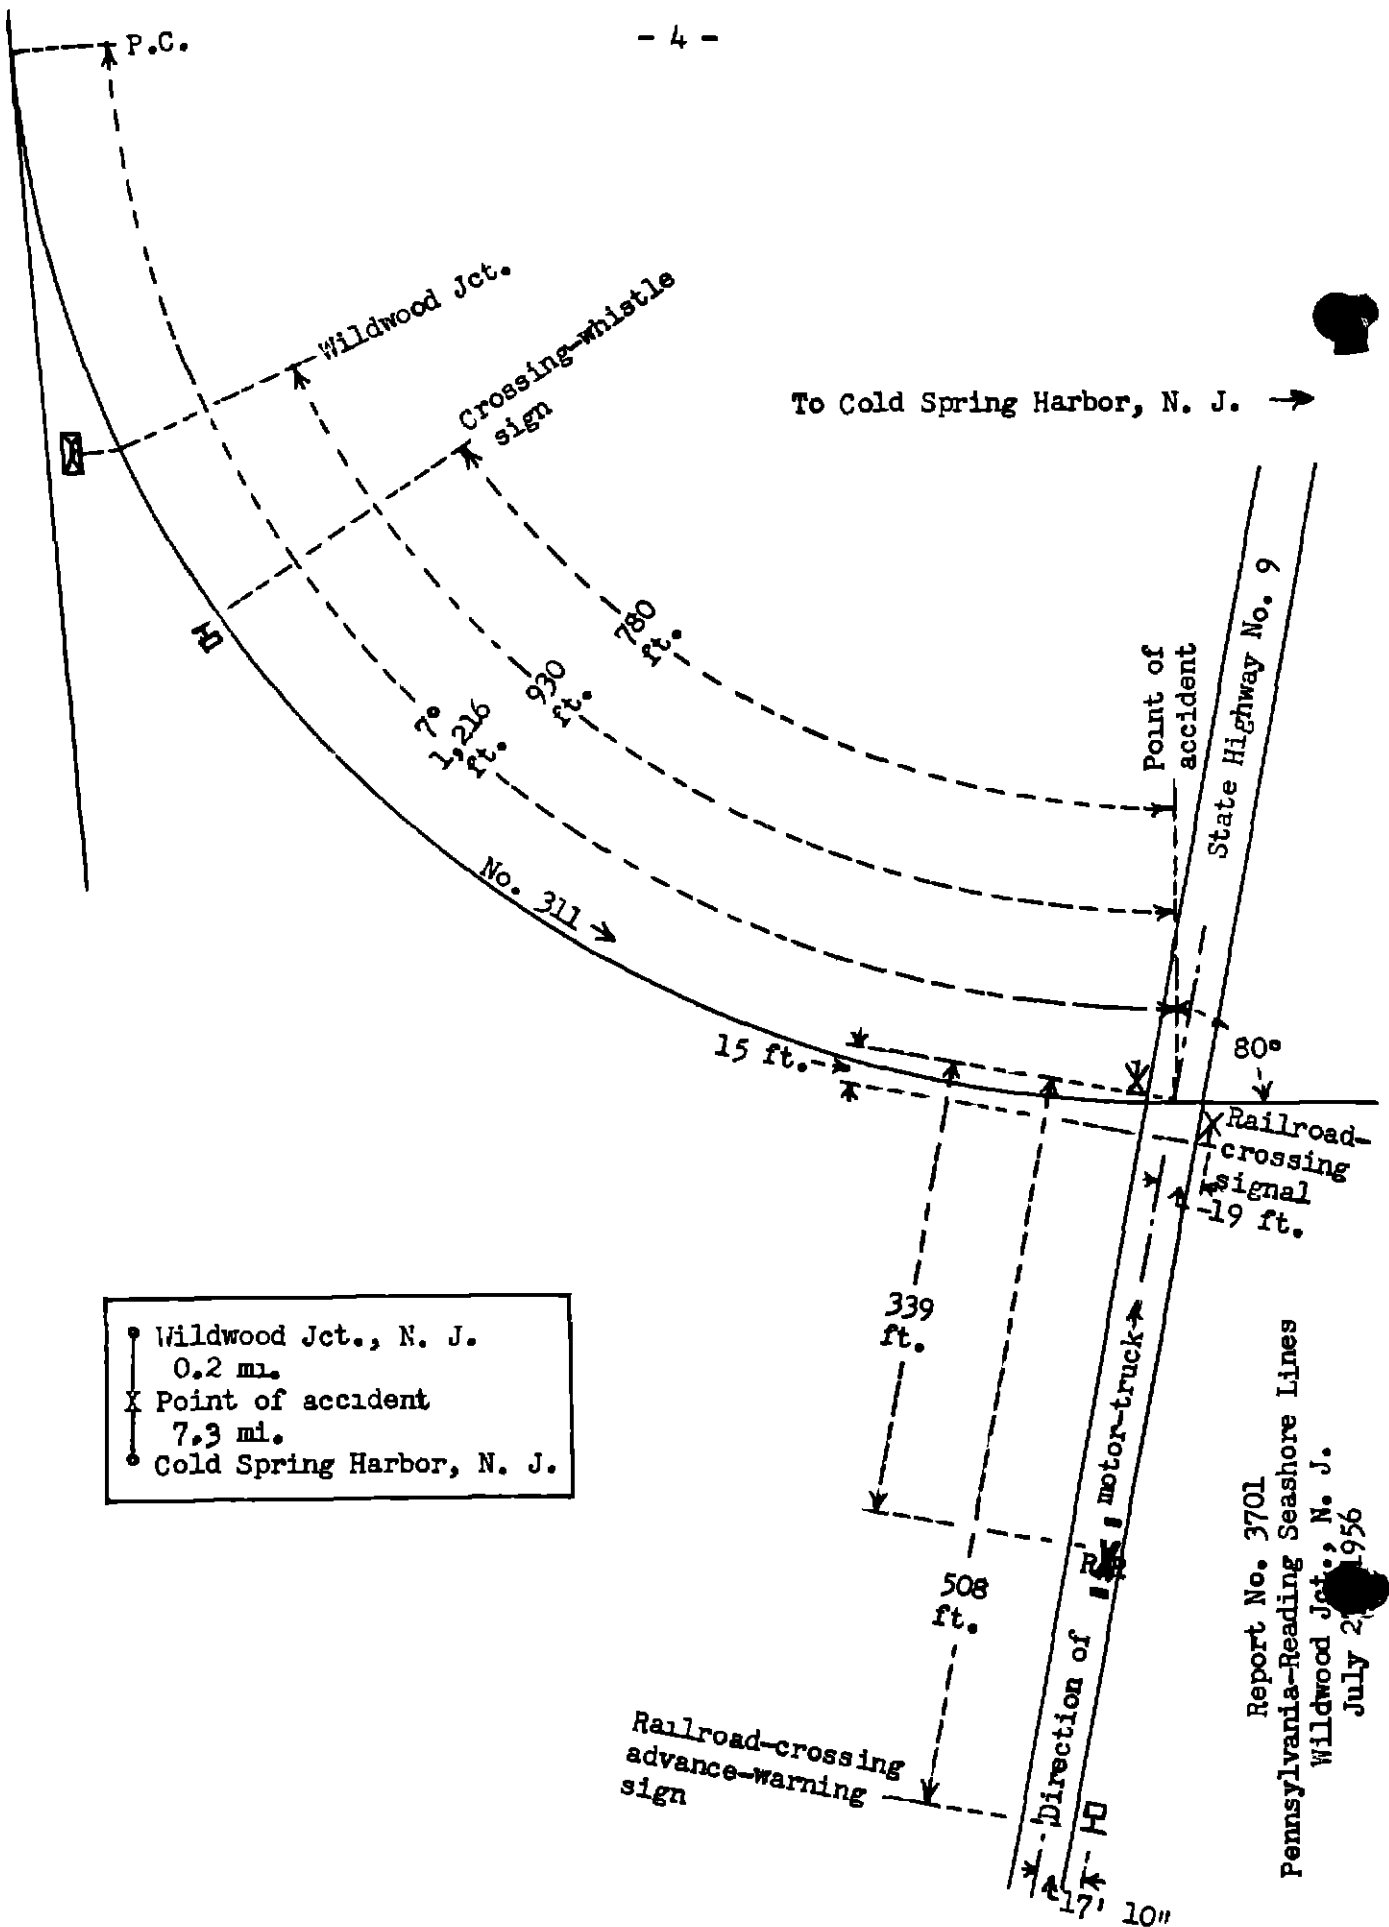
Report No. 3701  
 Pennsylvania-Reading Seashore Lines  
 Wildwood Jct., N. J.  
 July 21, 1956

•	Wildwood Jct., N. J.
	0.2 mi.
X	Point of accident
	7.3 mi.
•	Cold Spring Harbor, N. J.

Railroad-crossing advance-warning sign

Direction of motor-truck  
17' 10"
