REPORT OF THE DIRECTOR

PERE MARQUETTE RAILWAY

BEECH, MICH.

INVESTIGATION NO. 2236

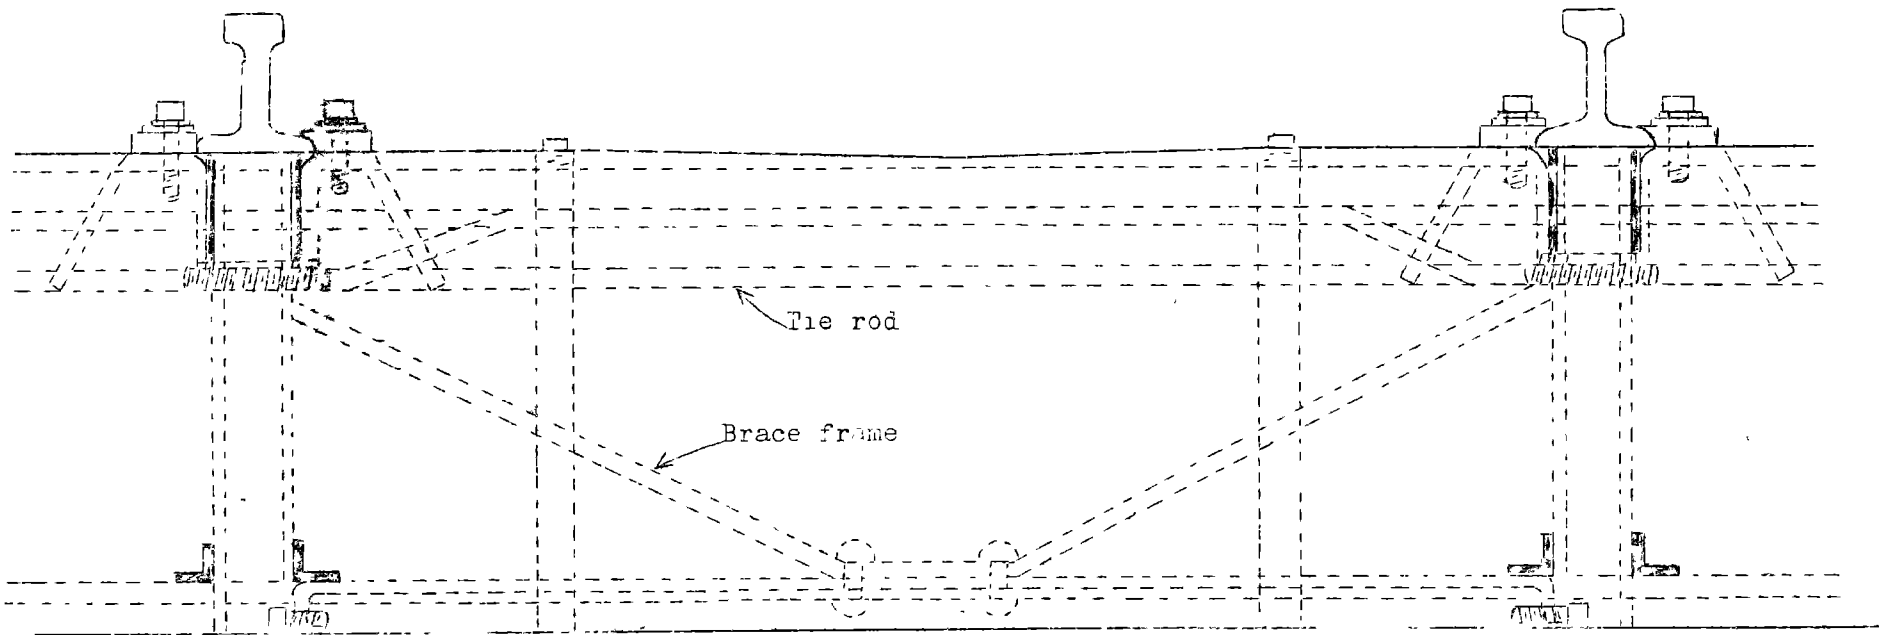
Detail of rail fastenings

Track Supervisor Meier stated that the principal trouble experienced with the track on the old section of concrete roadbed was due to breakage of the track anchor bolts at or beneath

first winter of operation numerous failures in the operation of the block signals required replacement of the Fiberock with standard insulation fibre. This fibre is 1/8 inch thick and has proved satisfactory for insulating purposes. The rail clips and anchor bolts are insulated with the same material. He was of the opinion that the wide gauge east of the point of derailment developed under train No. 103 or the train immediately preceding it, and thought that a factor of considerable importance among the possible causes of derailment was the icy condition caused by the rain and sleet storm of December 14th. While it was evident that spreading of the rails was the immediate cause of derailment, the manner in which the north rail was bent around the last bolt that remained in place indicates that some abnormal stress was applied, but just what this stress might have been he was unable to state. However, inasmuch as the inspection and maintenance at the present time is the same as that which has been practiced for the last 11 years without derailment occurring, he concluded that this accident was occasioned by the application of some unknown powerful force, as above suggested, or by swelling of the insulating materials due to having become saturated and then frozen. The resultant swelling raised the rail clips, permitting the rail to move outward and establish a track gauge 1 inch wide. He stated that during the year 1937 up to the date of derailment 410 anchor bolts were replaced on the concrete roadbed; the number replaced monthly ranged from zero in September to 150 in February. Most of these bolts were damaged during the renewal of insulation. After the derailment the track for over 500 feet east of the point of derailment was gauged and the gauge ranged from 4 feet 9 inches to 4 feet 10 $\frac{1}{2}$ inches; on the same stretch the track levels varied from 1/8 inch high to 3/8 inch low. West of the point of derailment 261 rail fastenings were broken off on the north side of the north rail and 9 on the south side.

This derailment was caused by spreading of the track, apparently due to failure of rail fastenings used on track of special construction.
