## INTERSTATE COMMERCE COMMISSION

REPORT OF THE DIRECTOR OF THE BUREAU OF SAFETY CONCERNING AN  
ACCIDENT ON THE PERE MARQUETTE RAILWAY AT PLYMOUTH,  
MICH., ON SEPTEMBER 30, 1932.

December 6, 1932

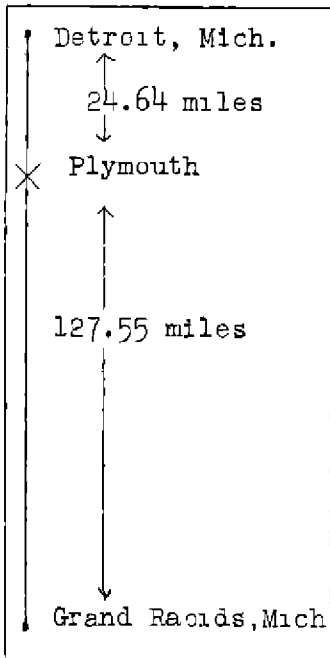
Inv. No 1788  
Pere Marquette Railway  
Plymouth, Mich.  
September 30, 1932.

Point of accident

Dwarf Signal

Direction of Train 99

Direction  
of Ex 1022
