INTERSTATE COMMERCE COMMISSION

ACCIDENT OF THE

PITTSBURGH & LAKE ERIE RAILROAD

INVESTIGATION NO. 2144

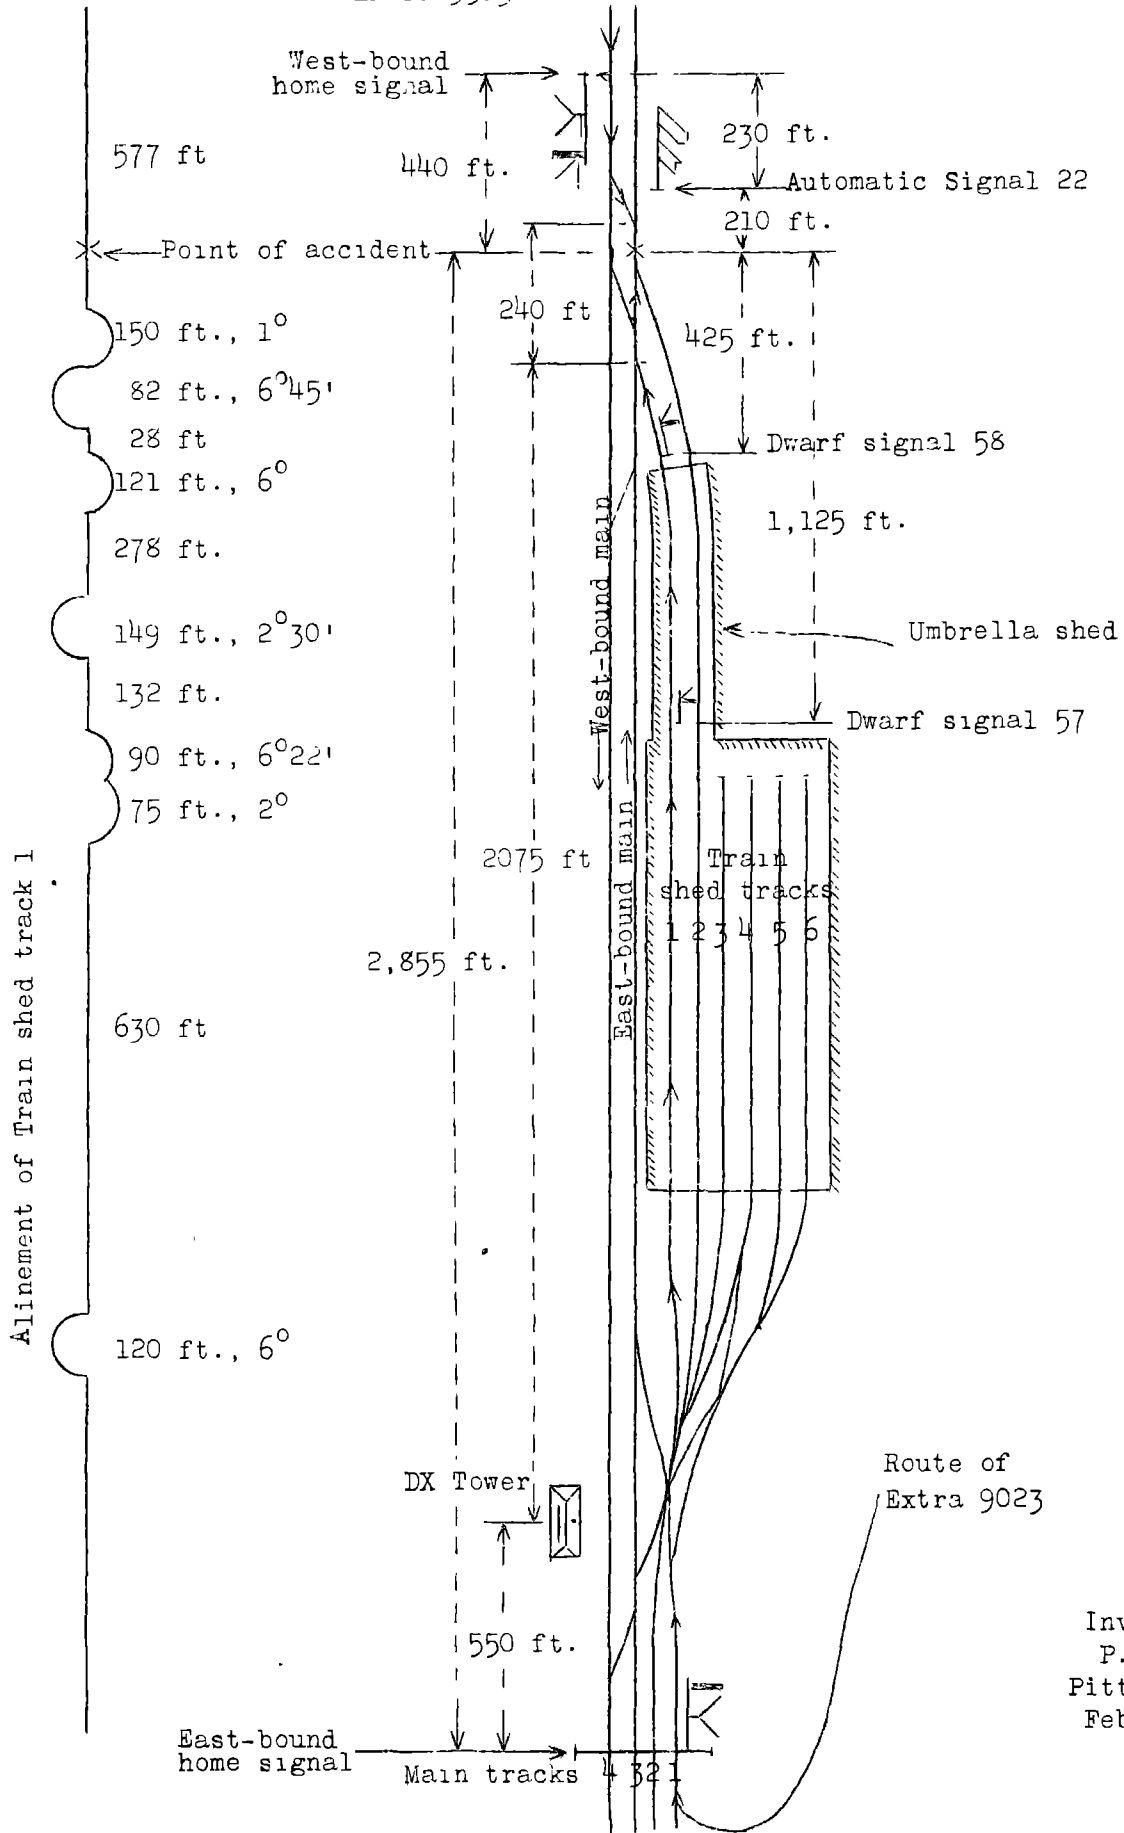
Route of
Extra 9513

DX interlocking tower is located about 1,000 feet west of the passenger station at Pittsburgh and the accident occurred within interlocking and yard limits a short distance east of the station. West of the interlocking plant this is a 4-track line, all tracks of which are used for either freight or passenger service; these tracks, numbered from south to north are 1, east-bound; 2, west-bound; 3, east-bound; 4, west-bound. At a point opposite the interlocking tower tracks 1 and 2 merge with the tracks leading to the station shed and lose their identity, while tracks 3 and 4 pass the station on the north and form the east-bound and west-bound main tracks of a double-track line eastward from DX tower. There are 6 passenger tracks serving the passenger station, numbered 1 to 6 inclusive from north to south; tracks 1 and 2 are station running tracks; track 1 is elevated about 4 feet above, and parallels the east-bound main track on the south, at a distance of from 18 to 28 feet between track centers, and connects with that track through a switch located 2,075 feet east of DX tower. East of this switch there is a facing-point crossover connecting the east-bound and the west-bound main tracks, the west switch of which is located 240 feet east of the switch leading from station track 1. The accident occurred on the east-bound main track at a point about 10 feet west of the west switch of this crossover.

Approaching the point of accident from the east there are numerous short curves and tangents, followed by a compound curve to the right for a distance of 725 feet, consisting of a 6°05' curve for 230 feet, a 3°30' curve for 210 feet, and a 4°40' curve for 285 feet, then tangent track for 577 feet; the accident occurred on this tangent at a point 80 feet from its western end. Approaching the point of accident from the west on station track 1, there are numerous short curves and tangents. The tracks are practically level at the point of accident.

In DX tower there is an 88-lever, straight-electric type interlocking machine. The east-bound home signal, governing movements on east-bound main track 1, is located on a signal bridge 550 feet west of the tower and is a 2-unit, position light signal, the top unit of which permanently displays a stop indication; the bottom unit is capable of displaying either a medium-speed or a restricted-speed indication, the restricted speed indication being a calling-on signal. Any route from main track 1, other than to the station tracks, is authorized by the calling-on signal; the medium speed indication provides for a movement to any of the station tracks when the route is clear, but if the route is not clear, such a movement is authorized by the calling-on signal. Further movements over station tracks are authorized by dwarf signals; dwarf signals 57 and 58, governing east-bound movements leaving station track 1, are located 1,180 and 1,880 feet, respectively, east of DX tower and are 2-indication, position-light signals displaying proceed-at-restricted-speed or stop indications.

Automatic block signal 22, governing movements over the east-bound main track beyond interlocking limits, is located 635 feet east of dwarf signal 58.
