INTERSTATE COMMERCE COMMISSION
WASHINGTON

ACCIDENT ON THE
PITTSBURGH & LAKE ERIE RAILROAD

SOUTH HEIGHTS, PA.

INVESTIGATION NO. 2120

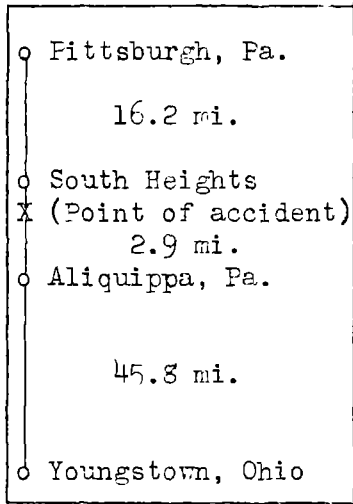
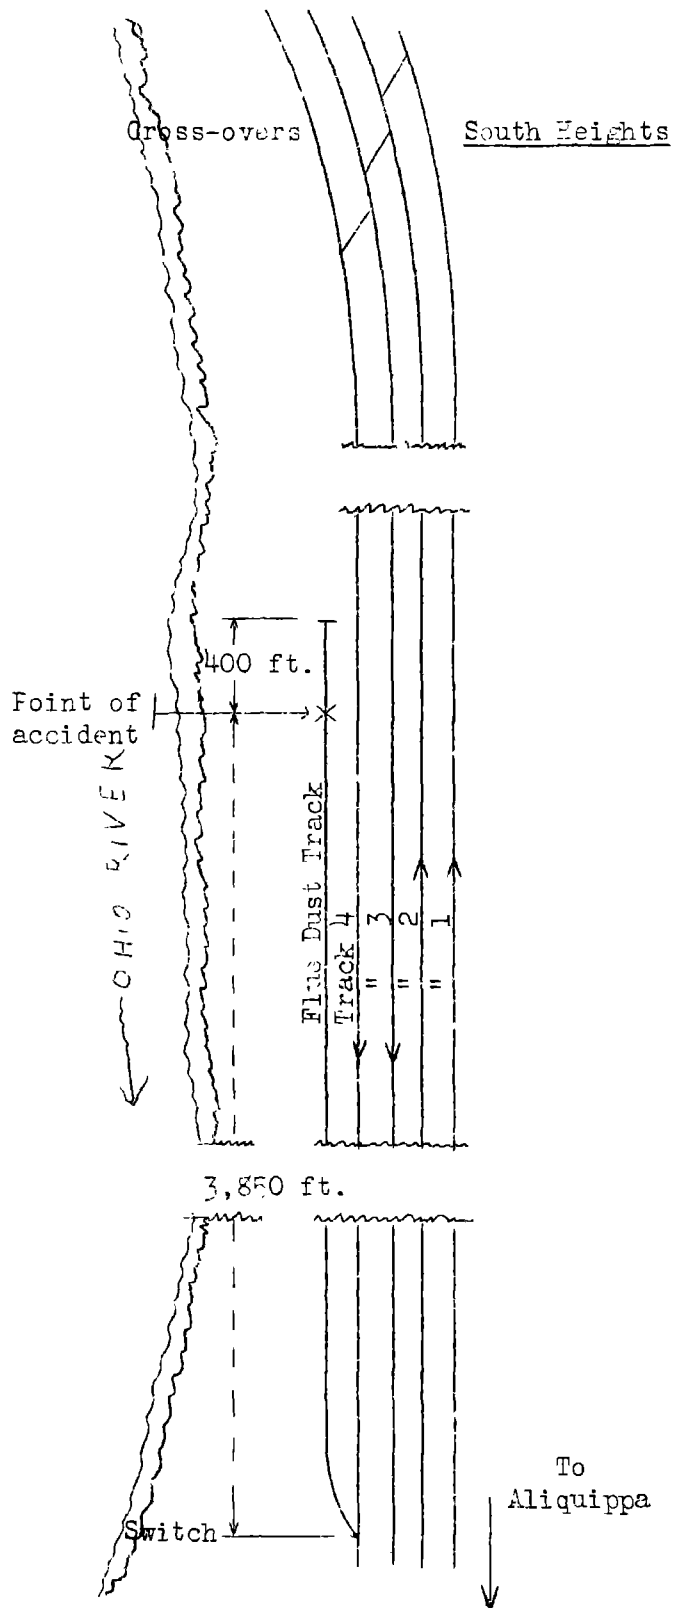
Inv. No. 2120
 Pittsburgh & Lake Erie R.R.
 South Heights, Pa.
 Nov. 22, 1936

The flue-dust track is a stub-end track extending eastward off track 4 for a distance of about 4,250 feet, and parallels the main tracks on the north, being laid on the south bank of the Ohio River. At the point of accident it is on a fill of about 37 feet high which extends across a ravine about 330 feet wide. It is laid with 90-pound rails, 30 feet in length, with 15 to 17 ties to the rail length, and ballasted with cinders to a depth of from 12 to 18 inches.

The engine and its tender toppled over on their left sides and slid down the fill about 25 feet. The employees killed were the fireman and a yard helper, and the employees injured were the engineman and a yard helper.

According to the records, the last work of filling on the flue-dust track where the derailment occurred was performed on August 23, 1920, and no repairs had been made at that point with respect to grading or renewal of ties and rails since construction of that portion of the track was completed at that time. Inspection of the engine failed to disclose any condition which would have caused or contributed to the accident, but examination of the track at various points, after the removal of 2 or 3 inches of cinders, showed that the ties were badly rotted; in fact, the majority of those examined appeared to be of little use for any purpose. The fill, where not disturbed in the accident, appeared to be firm.
