INTERSTATE COMMERCE COMMISSION

BUREAU OF SAFETY

PITTSBURGH & LAKE ERIE RAILROAD

INVESTIGATION NO. 2134

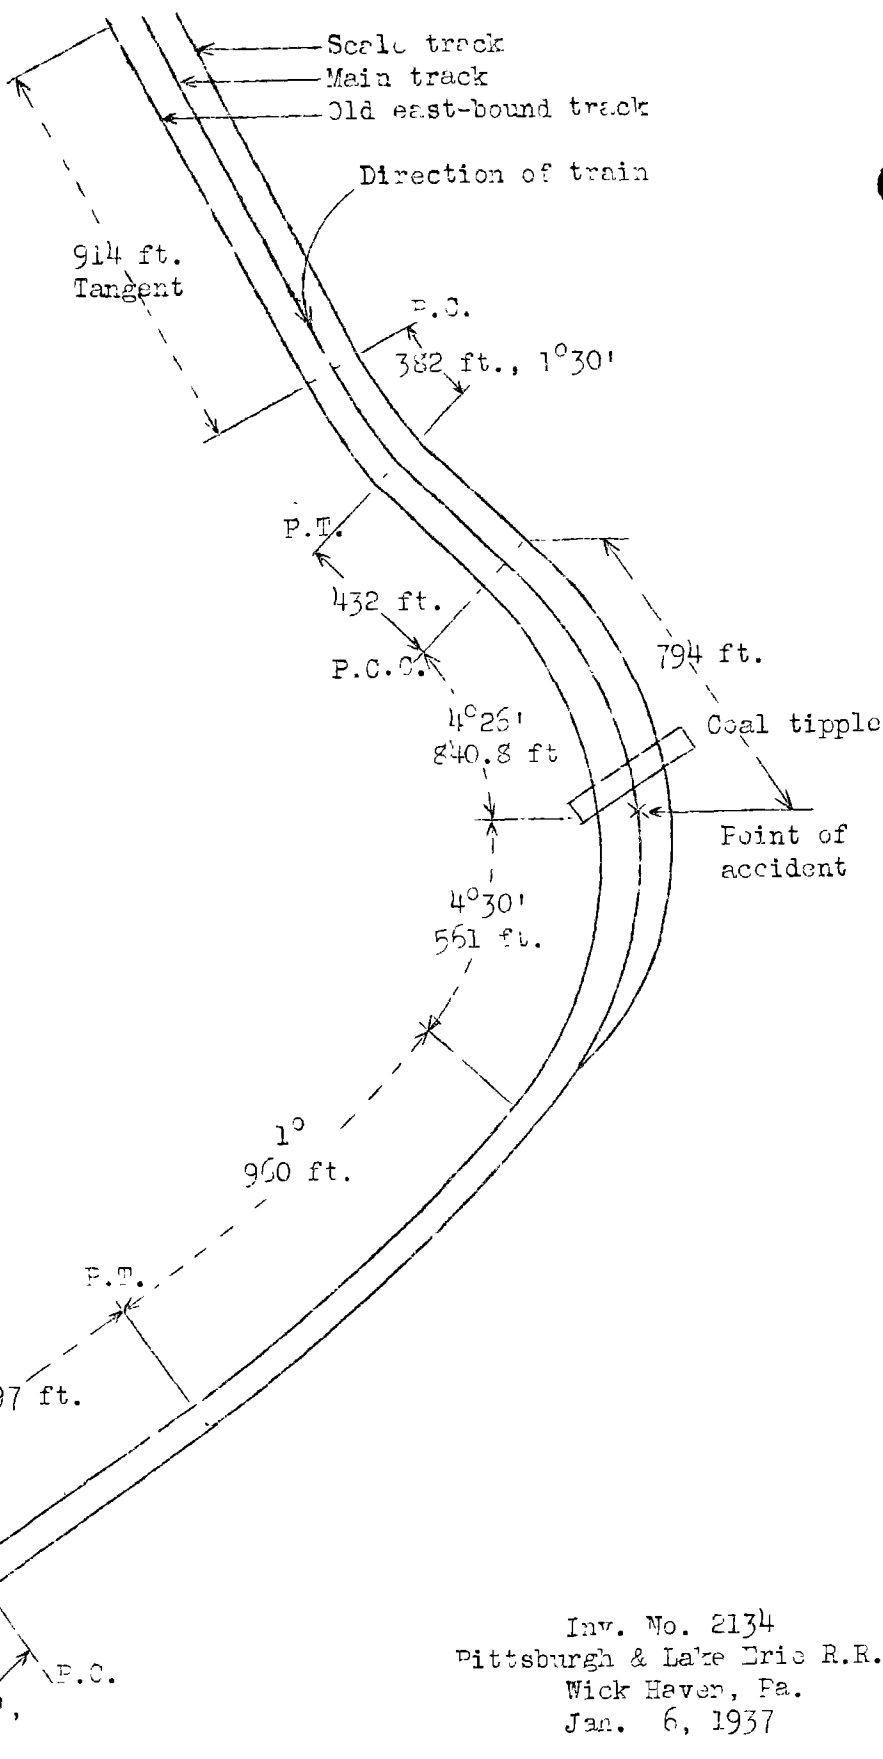
Inv. No. 2134
 Pittsburgh & Lake Erie R.R.
 Wick Haven, Pa.
 Jan. 6, 1937

The point of accident was 2,460 feet west of the station at Wick Haven; approaching this point from the west, the track is tangent for a distance of 432 feet, followed by a compound curve to the right 2,361 feet in length, which consists of a 4°26' curve for a distance of 840 feet, a 4°30' curve for a distance of 561 feet, and a 1° curve for a distance of 960 feet, including spirals, the accident occurring on the 4°26' curve at a point 794 feet from its western end. The grade at the point of accident is 0.12 percent ascending for east-bound trains.

The main track is paralleled on the south by a track known as the old east-bound main, and on the north by a scale track. A cross-over connecting the main track and the old east-bound main is located 322 feet west of Wick Haven station. The view approaching from the west is restricted to a distance of 450 feet by the curvature of the track and by the buildings of a coal tipple on each side of the tracks, a portion of the structure also spanning the tracks. The maximum authorized speed for freight trains is 25 miles per hour.
