INVESTIGATION NO. 3219

THE PITTSBURGH & WEST VIRGINIA RAILWAY COMPANY

REPORT IN RE ACCIDENT

NEAR NEW ALEXANDRIA, OHIO, ON

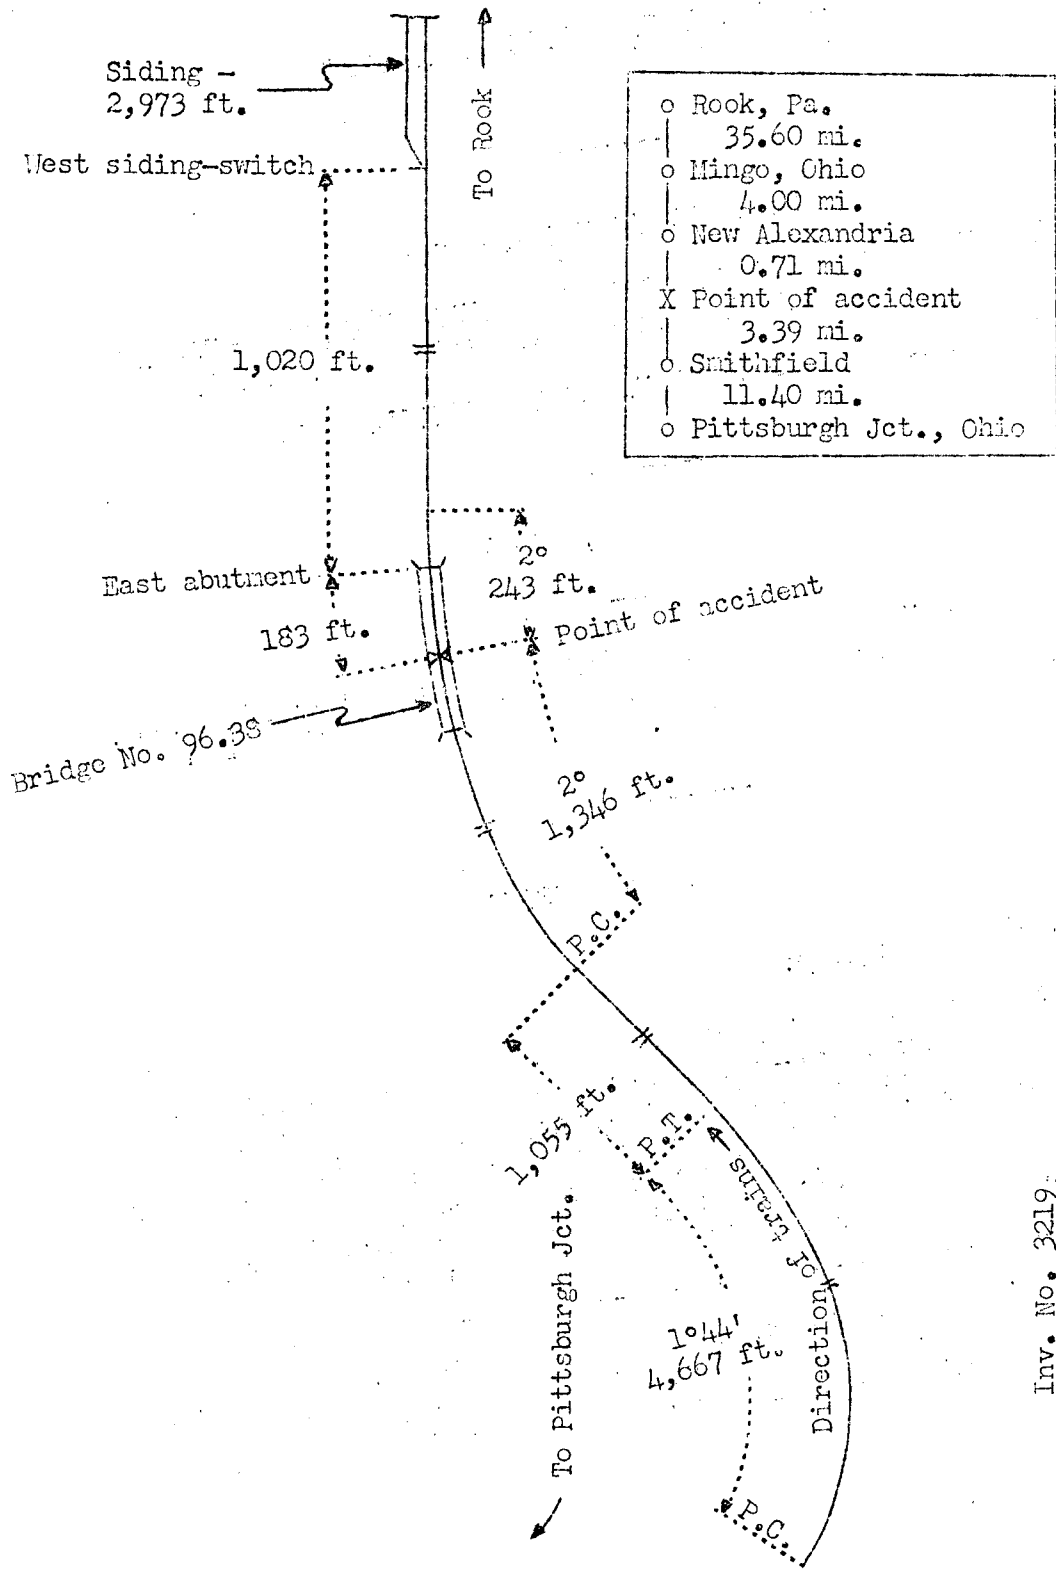
Inv. No. 3219  
Pittsburgh & West Virginia Railway  
New Alexandria, Ohio  
December 11, 1948

Location of Accident and Method of Operation

This accident occurred on the Pittsburgh Division, which extends between Pittsburgh Jct., Ohio, and Rook, Pa., 55.1 miles, a single-track line, over which trains are operated by timetable and train orders. There is no block system in use. At New Alexandria, 15.5 miles east of Pittsburgh Jct., a siding 2,973 feet in length parallels the main track on the north. This accident occurred on the main track at a point 1,020 feet west of the west siding-switch. From the west there are, in succession, a  $1^{\circ}44'$  curve to the left 4,667 feet in length, a tangent 1,055 feet and a  $2^{\circ}$  curve to the right 1,346 feet to the point of accident and 243 feet eastward. The grade varies between 0.7 percent and 0.62 percent descending eastward throughout a distance of 1.34 miles immediately west of the point of accident and is 0.62 percent descending at that point.
