REPORT OF THE DIRECTOR
BUREAU OF SAFETY

ACCIDENT ON THE
PITTSBURGH & WEST VIRGINIA RAILWAY

ROCKDALE, W. VA.

INVESTIGATION NO. 2344

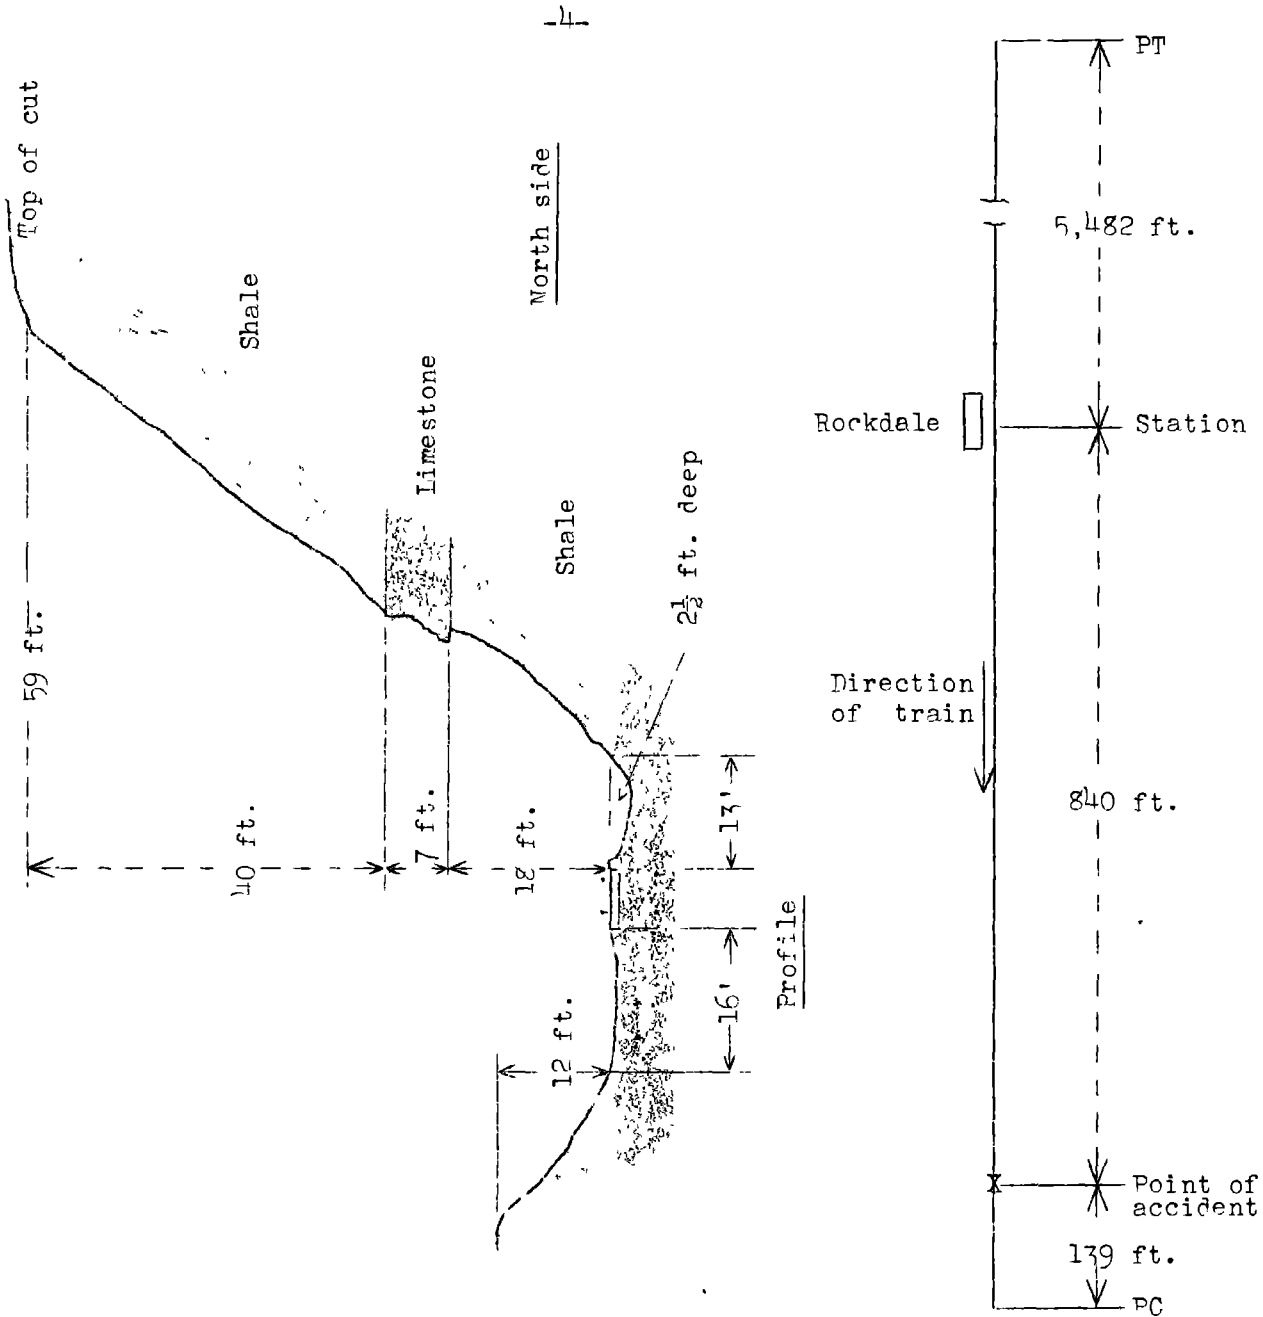
Inv. No. 2744
 P. & W. Va. Ry
 Rockdale, W. Va
 April 9, 1939

The investigation developed that prior to the derailment a section of limestone about 5 feet thick, 8 feet wide, and 30 feet long had broken off on the north side of a hillside cut between 18 and 23 feet above the level of the ties and, with a large amount of shale, slid from the side of the cut. The slide was about 40 feet in width, consisted of approximately 850 tons, filled the 13-foot space between the track and the wall of the cut, and covered the track to a depth of from 6 to 9 feet. Apparently the large rock fell on the track, but was broken in falling and in being struck by the engine; however, after the accident a piece about 3 by 8 by 10 feet remained on the track at the east end of the slide.

It was the opinion of the engineer maintenance-of-way that there had existed over a period of years a concealed fissure about 8 feet behind the face of the rock; this, combined with frost action and the softening of the shale below the limestone, caused the slide to occur. There were indications of a crack behind the face of the rock west of the section which fell; this rock has since been blasted down and arrangements have been made to remove all jutting rocks throughout this cut.
