REPORT OF THE DIRECTOR

PITTSBURGH & WEST VIRGINIA RAILWAY

WEST BELT JUNCTION, PA.

INVESTIGATION NO. 2118

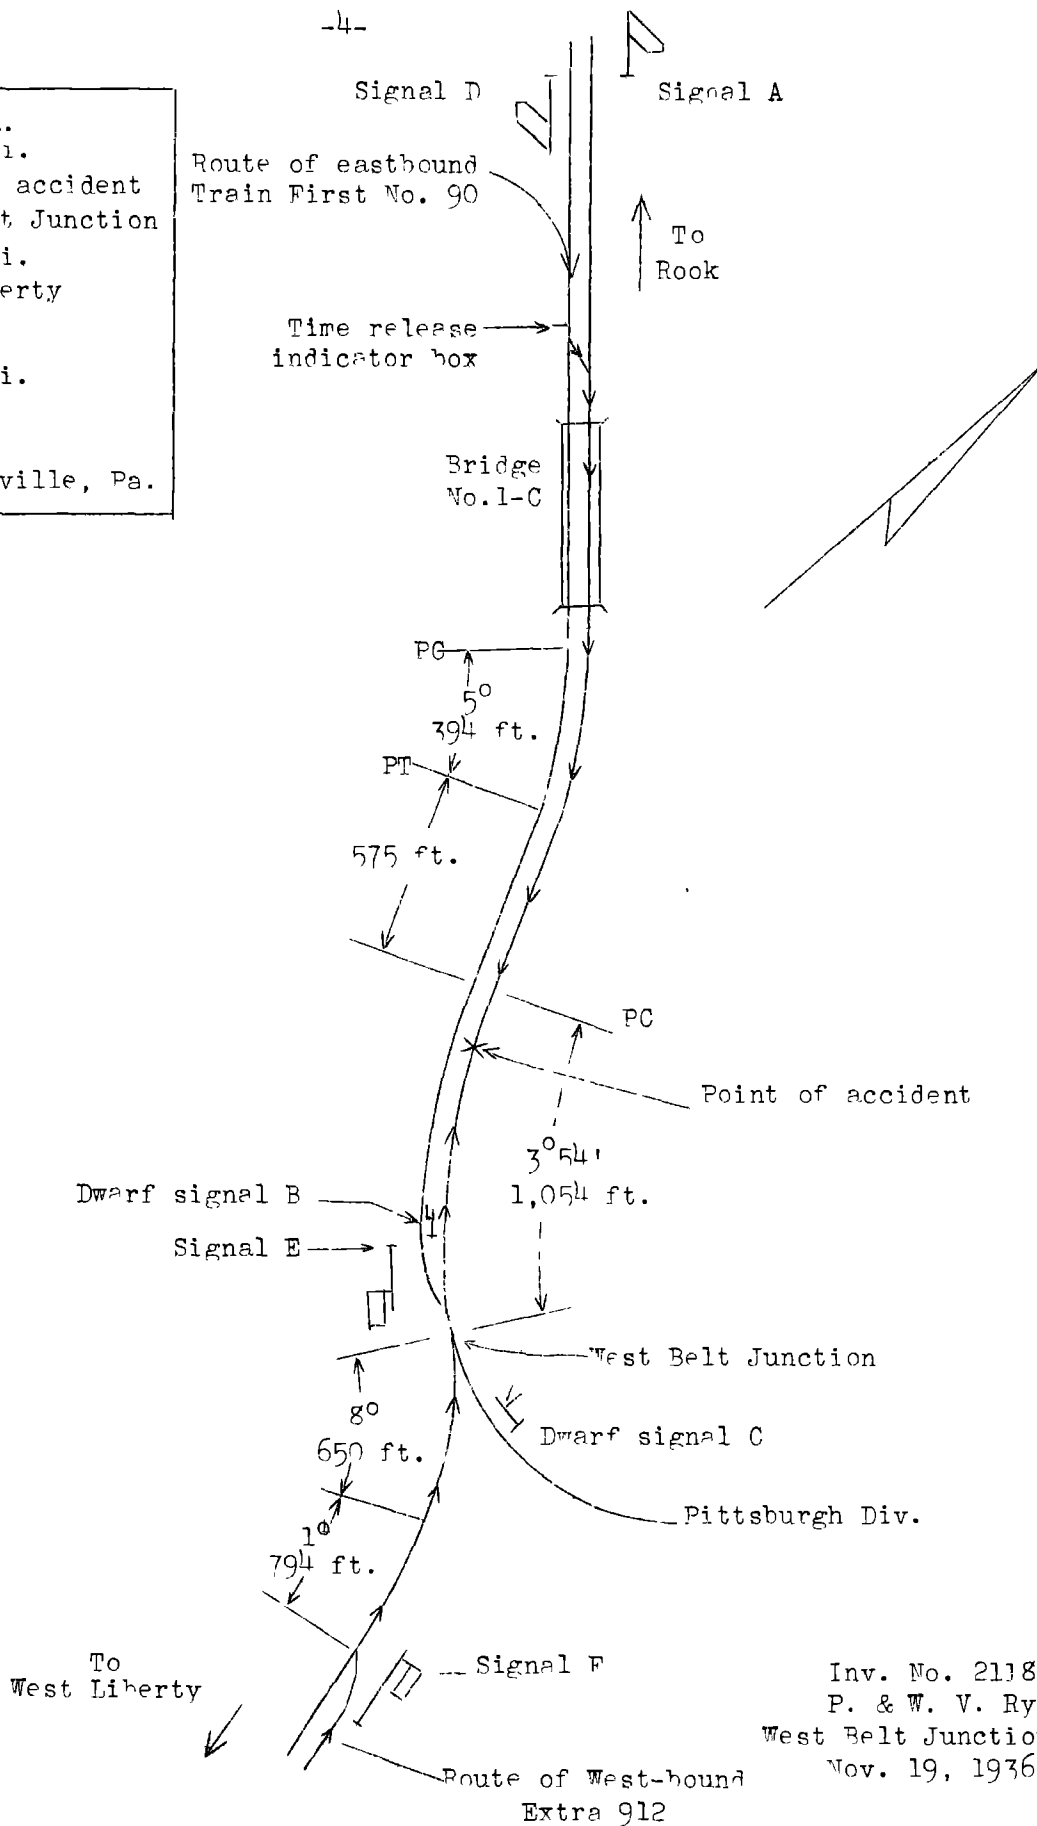
Inv. No. 2118
 P. & W. V. Ry.
 West Belt Junction, Pa.
 Nov. 19, 1936

Route of West-bound
 Extra 912
