RAILROAD ACCIDENT REPORT

**COLLISION OF
PORT AUTHORITY OF ALLEGHENY COUNTY
TROLLEY CAR NO. 1790 AND BUS NO. 2413
PITTSBURGH, PENNSYLVANIA
FEBRUARY 10, 1978**

REPORT NUMBER: NTSB-RAR-78-5

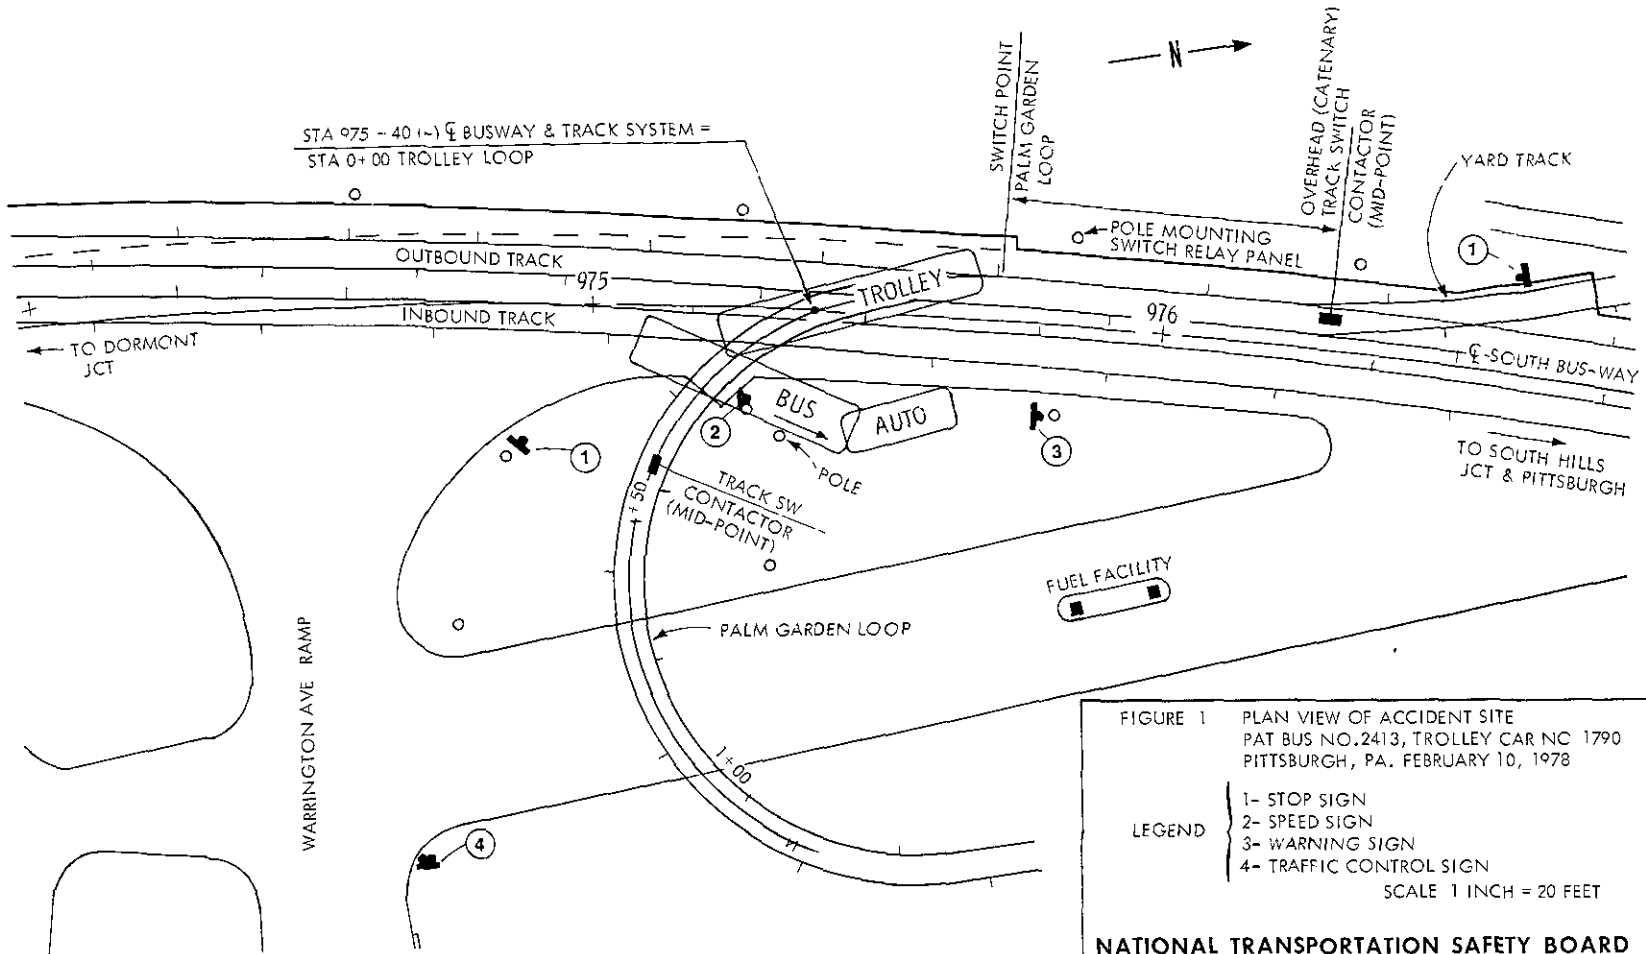
There are two main tracks which run north and south through the accident area. The west track is the "outbound" track and the east track is the "inbound" track. The two tracks are embedded in concrete, thus permitting the surface to be used as a roadway. The roadway is on a 3-percent descending grade outbound. The roadway curvature varies to a maximum of 5° to the left outbound through the Palm Garden Loop switch area. There are no pertinent sight impediments near the switch. (See figure 1.)

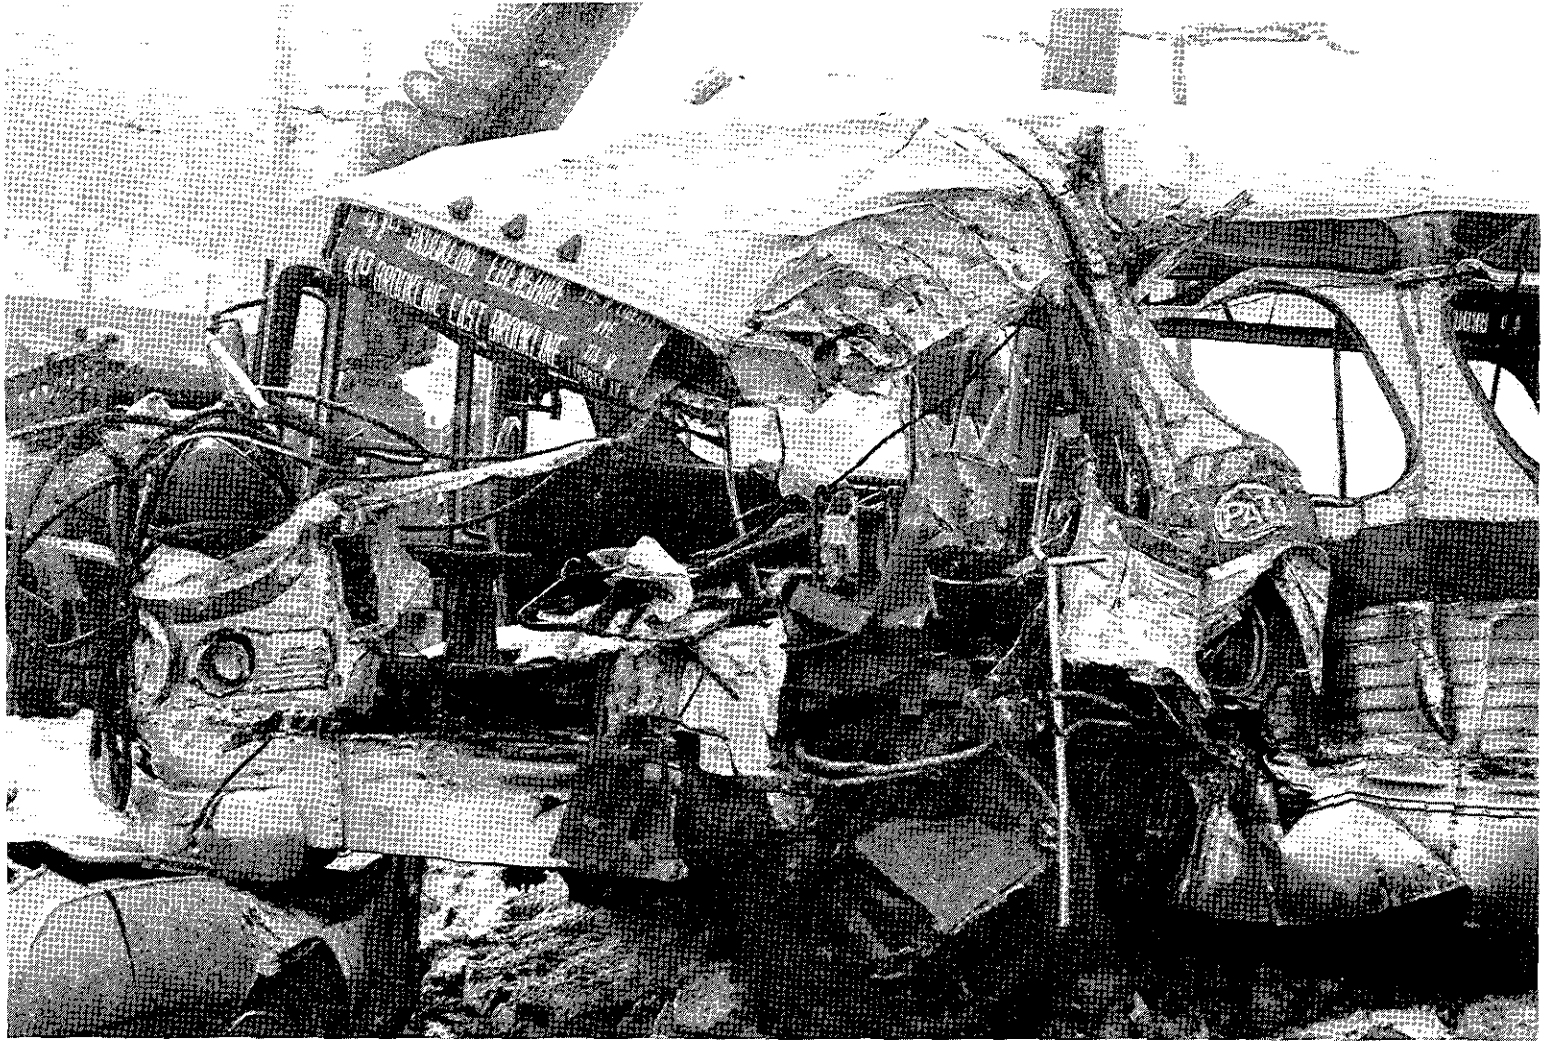
Figure 2. PAT bus No. 2413.

The trolley car struck the bus on the left front corner. The upper section of the bus was displaced rearward approximately 5 feet and downward 3 feet. The roof structure above the windshield frame was displaced to the left 2 feet, and the windshield was missing. The trolley car penetrated into the bus about 3 feet at the deepest point. Major deformation was evident along the left side for almost 15 feet. (See figure 2.)

An 11-inch-wide indentation on the rim of the left front wheel contained deposits of red paint where the trolley car's anticlimber hit the wheel. The bus came to rest against a catenary pole, which contacted the bus on the right front side causing the two front side windows to jam.

The bus instrument panel was damaged extensively. The steering wheel drive mechanism was inoperable. Seats and stanchions on the left side from the front of the bus through seats L-8-9 were detached and bent to varying degrees. The backs of several seats behind L-8-9 were bent forward. There was minimal damage to the interior on the right side of the bus. Some damage was caused by rescue personnel during their efforts to evacuate the injured.

The trolley car struck and penetrated the left side of the bus with virtually no penetration resistance, and because of the relative motion of the two vehicles, the penetration was effectively extended along the side. This action caused the greatest amount of energy to be absorbed in the immediate area occupied by the driver and the three passengers who were killed. The driver was not using his seatbelt, but even so it would not have prevented his injuries nor would seatbelts have helped the passengers. All of the fatalities received their injuries because of the impact crushing of their occupiable space. The deforming metal and left front axle/wheel assembly absorbed much of the kinetic energy and thus reduced the potential for injury to passengers outside of the "crush zone." If the impact had been head-on, or if the left front side had been more resistant to crushing, more of the impact energy would have been transmitted through the bus body and there may have been more injuries.

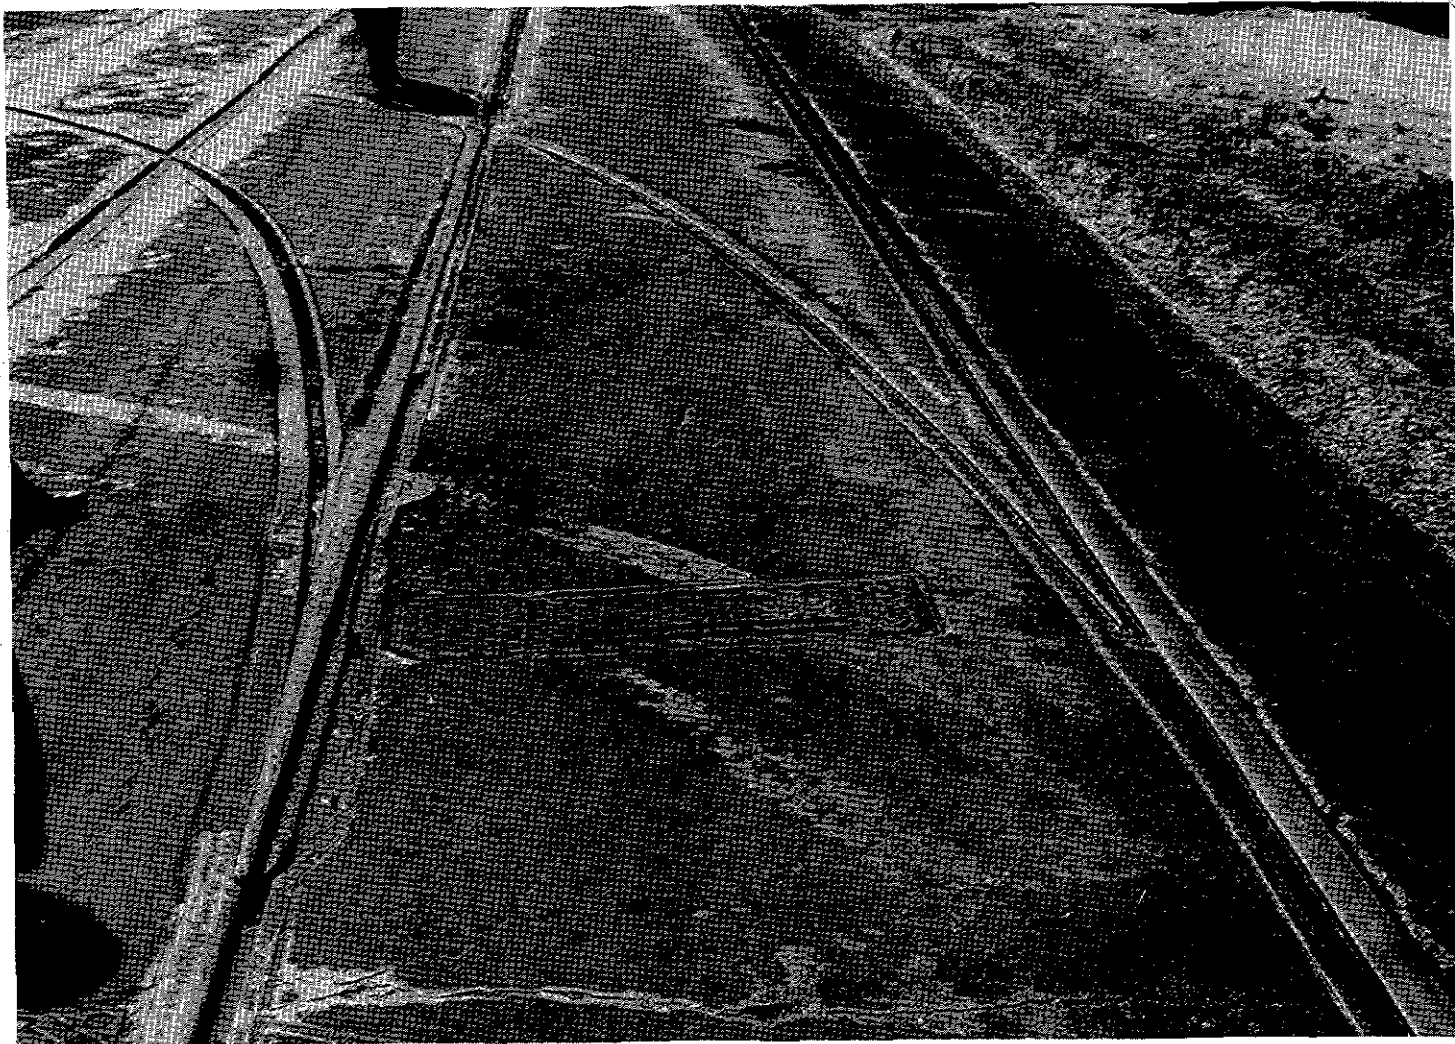
Figures 3. Track switch.

The switch has one movable point which is operated by the electromagnetic switch machine. (See figure 3.) The switch machine consists of two coils which, when separately energized, lines the route for either a straight movement or for the curve. There is no positive locking device, and the switch is held in either position by spring pressure. Power to energize and operate the switch machine and the relay panel is obtained from the 600-volt d.c. catenary.

The left front wheel contour and flange were found to be in good condition with no marks to indicate that the wheel "picked" 3/ the switch. The switch point had no marks to indicate it had been picked. The switch point fitted the stock rail, and it did not roll or raise when a car moved over it.

On February 14, 1978, the track switch for the Palm Garden Loop was made to operate semi-automatically. An operator entering the Palm Garden Loop now has to stop his car and position the switch for the curve manually. It will then restore for a straight move automatically after a trolley car passes a closure contactor in the loop catenary. Specific instructions are given for operating a trolley car over an electric switch. (See appendix B.)

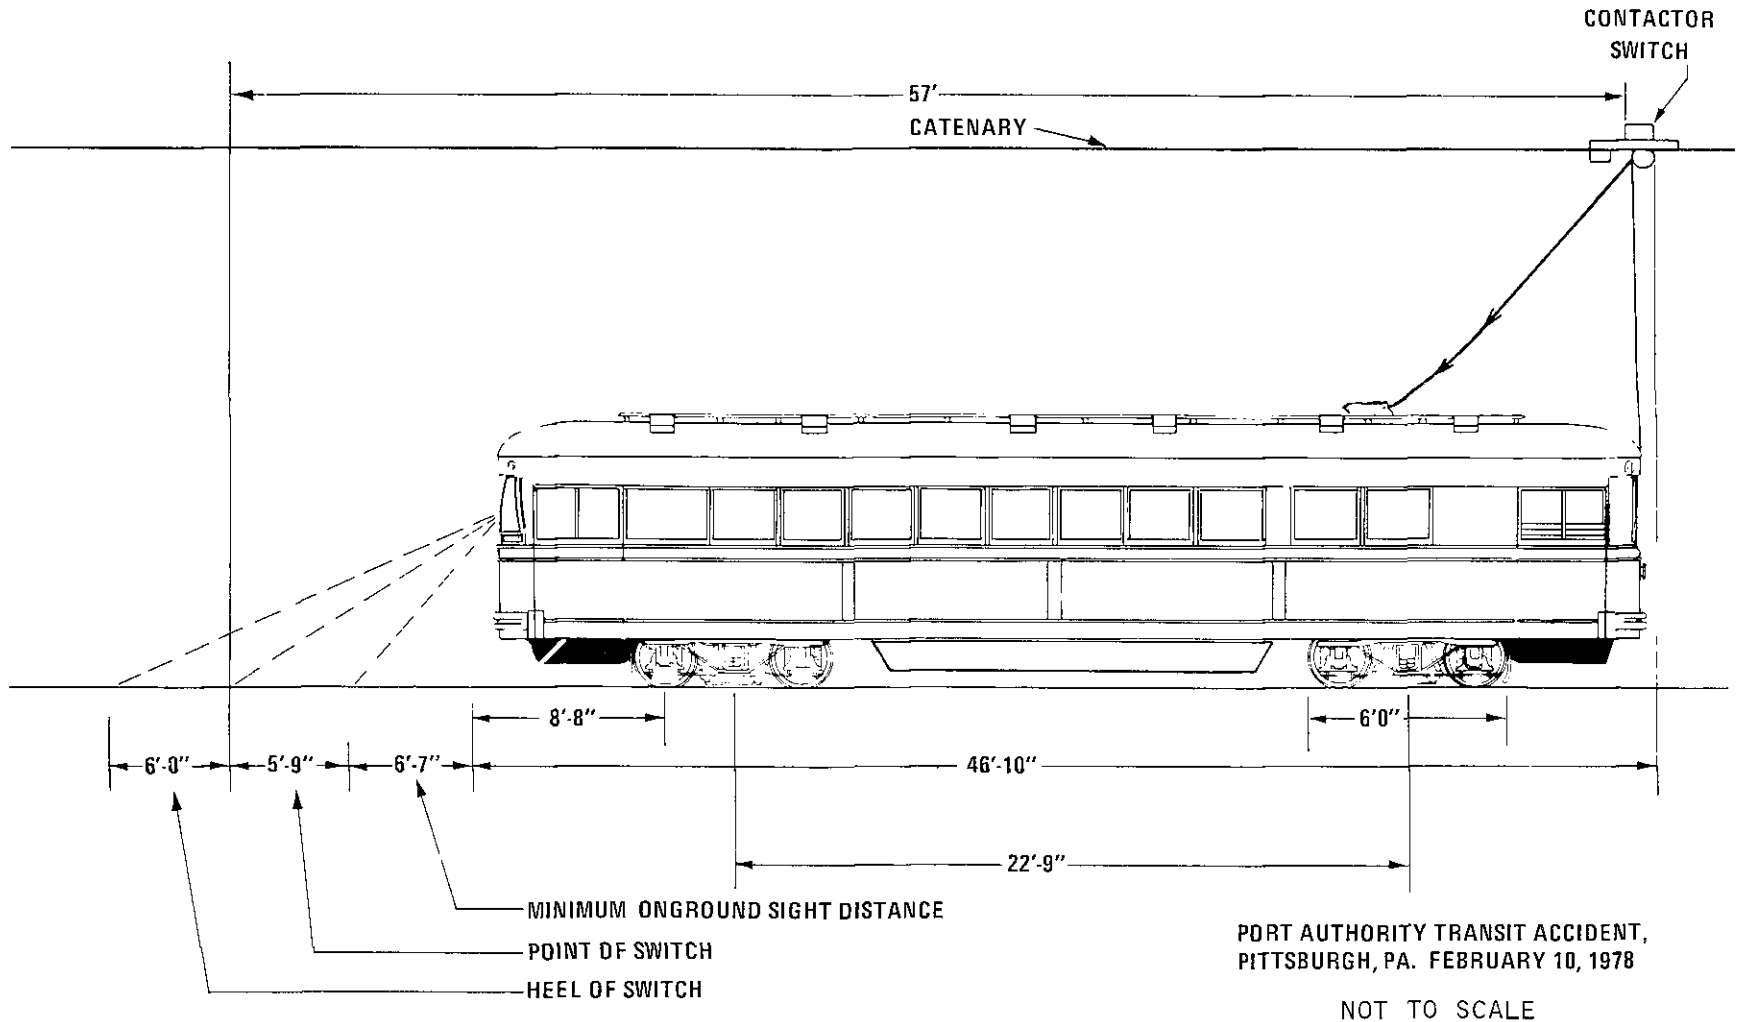
Figure 4. Trolley car dimensions and some average sight distances for a typical operator.

The contactor is located 57 feet from the switch point so that an operator will have time to stop his car if the switch does not respond properly. The closest the operator can see the ground ahead is 6 to 8 feet because of the car overhang. When the trolley pole is just engaging the contactor, the point of the switch is 12 feet from the front of the car, which gives the operator about 4 to 6 feet ground view of the switch point. After the trolley pole clears the contactor, the operator's ground view of the switch point would still be 2 to 4 feet. The front of the car would be about 10 feet from the switch point, and this distance, if extended to the heel of the switch, would be about 16 feet. (See figure 4.) Movement of the switch point can be observed throughout its 6-foot length.

Trolley operators do not have positive identifying markings to let them know when the trolley pole is on the contactor. Through experience, they listen for a "thump" that is transmitted through the car as the pole leaves the contactor. This is their only indication of the trolley pole's location relative to the contactor, other than using an estimated distance from the front of the car to the switch point.

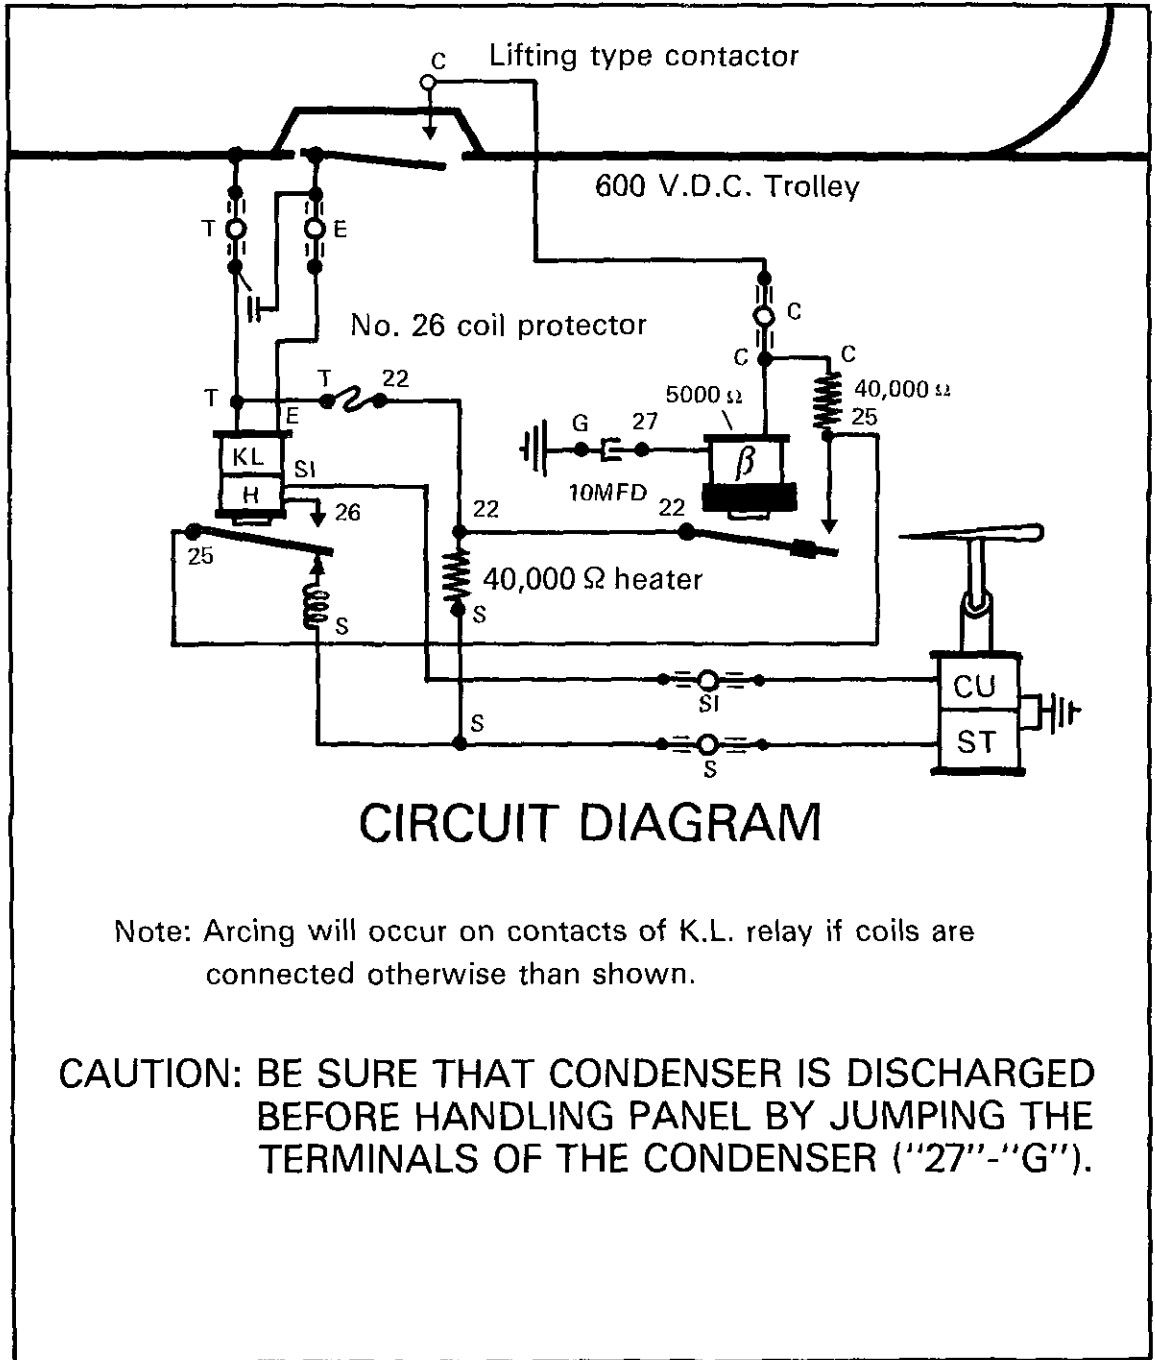
SWITCH RELAY CIRCUIT

The relay panel consists of two relays, identified as "KL" and "B," and miscellaneous components. The position of relay "KL" determines whether the switch point will be positioned for the curve or straight track. The "KL" relay operates on 60 amperes d.c. current or more. The "B" relay has to operate for the switch to assume either position. (See appendix A.)

Circuit is shown at rest. To operate switch for straight track: Contactor is closed by trolley pole, "B" relay is energized momentarily by energy through closed contact in contactor, over "C" lead, through "B" relay winding, over 27 lead, through capacitor and "G" lead to ground. At the same time, current flows over "T" lead, over 22 lead, through closed contact of "B" relay, over 25 lead, through down contact of "KL" relay, over "S" lead to energize coil "ST" and position switch straight.
