INTERSTATE COMMERCE COMMISSION

REPORT OF THE DIRECTOR OF THE BUREAU OF SAFETY CONCERNING AN
ACCIDENT ON THE LINE OF THE READING COMPANY AT BLANDON, PA.,
ON JANUARY 25, 1934.

Inv. No. 1886
Reading Company,
Blendon, Pa.
Jan. 25, 1934

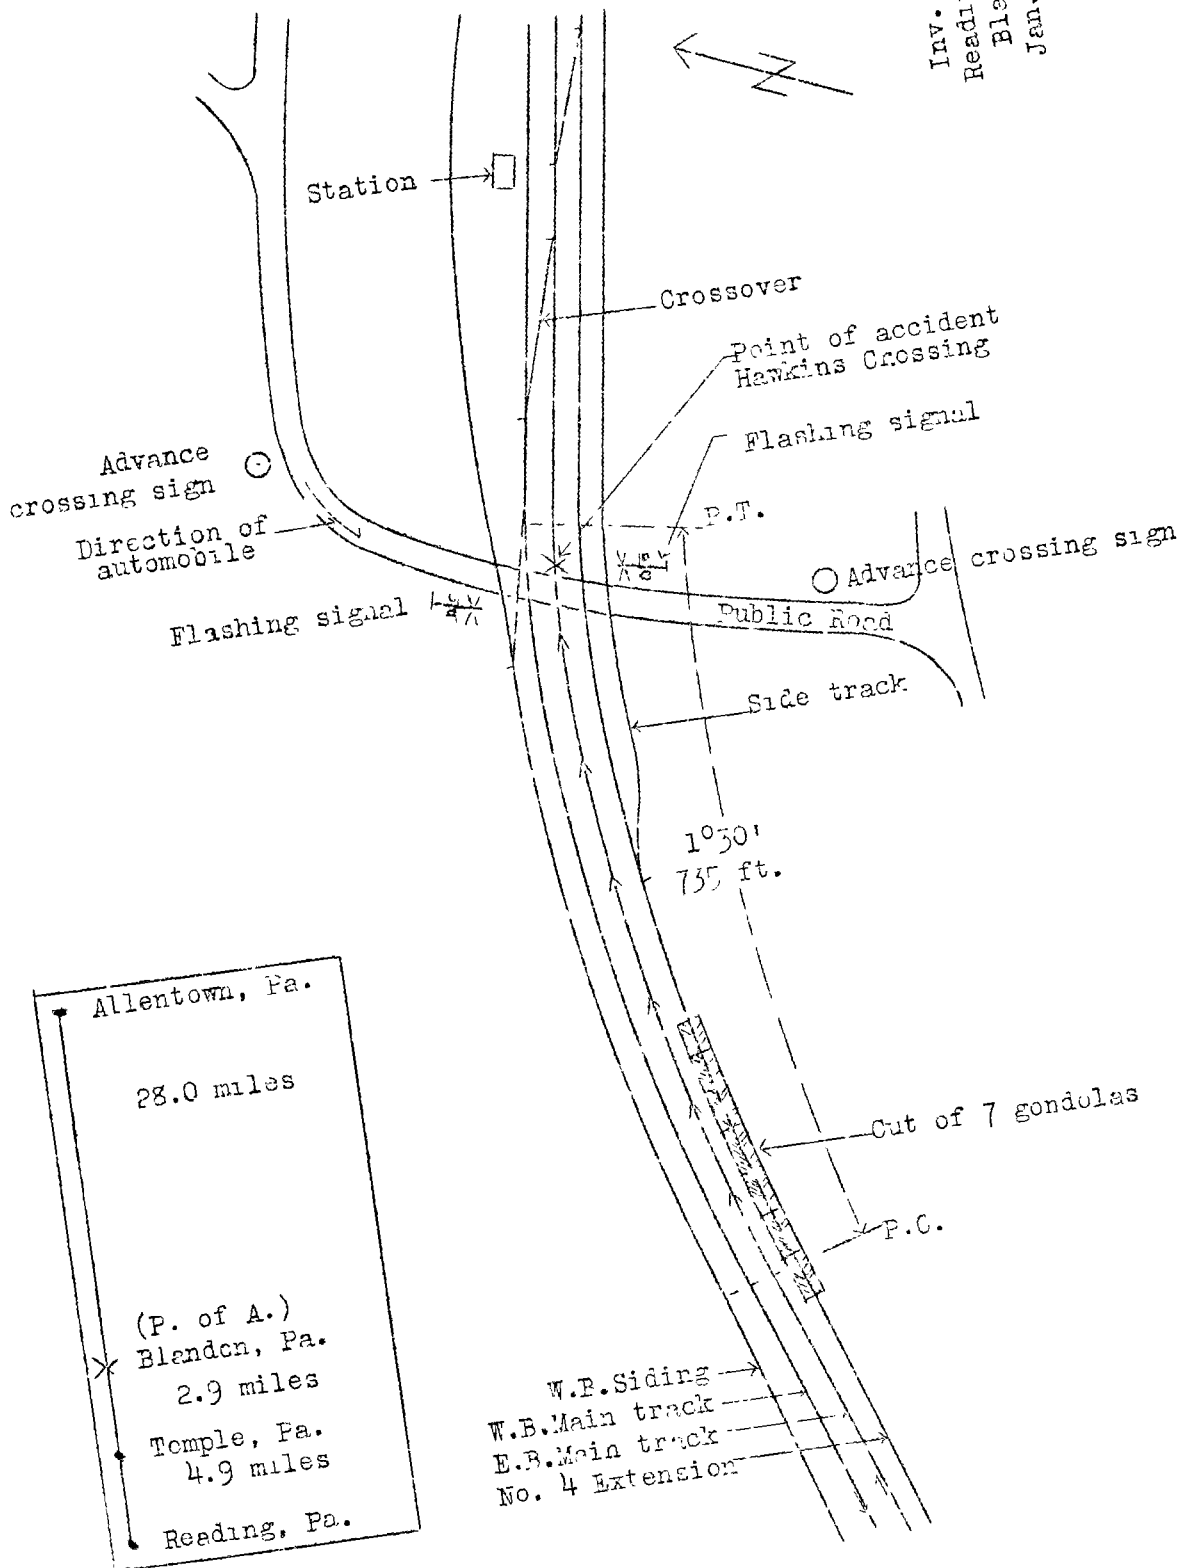
The highway crosses the tracks at an angle, and, from north to south, it first passes over the westbound siding, then the westbound main track, the eastbound main track, and two more side tracks; the accident occurred on the east-bound main track at a point 10 feet east of the crossing, where the automobile involved had run off the side of the highway and become stalled on the track.

The crossing is protected on each side of the tracks by an advance crossing sign and also by a flashing light signal; on the north side of the tracks the advance crossing sign is located on the west side of the highway about 150 feet from the nearest track, while the flashing light signal and cross-bar sign, located on the same east, is also on the west side of the highway and immediately north of the tracks. The grade for south-bound vehicular traffic is slightly ascending toward the railroad.

The highway is fairly wide where it crosses the tracks and the surface is maintained in reasonably good condition, but the edges are uneven, not being in a straight line from one side to the other side of the right of way.
